Technical Service Information

RE4RO1A BEARING CHANGE

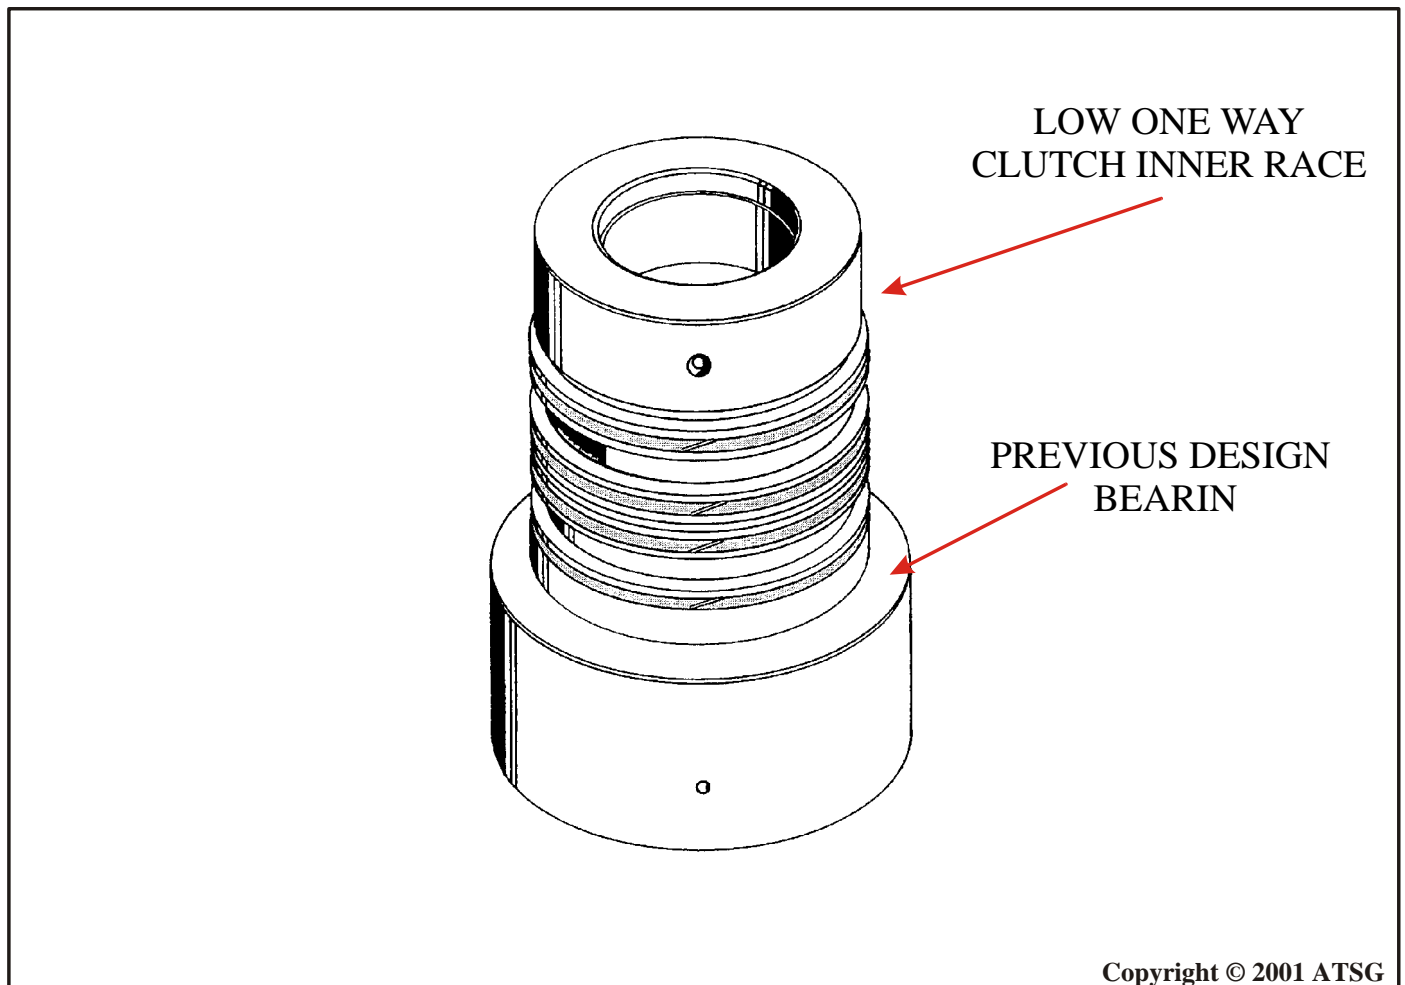
Figure 1

CHANGE: The three piece needle bearing located at the rear of the low one way clutch inner race in RE4RO1A transmissions has changed (See Figure 1).

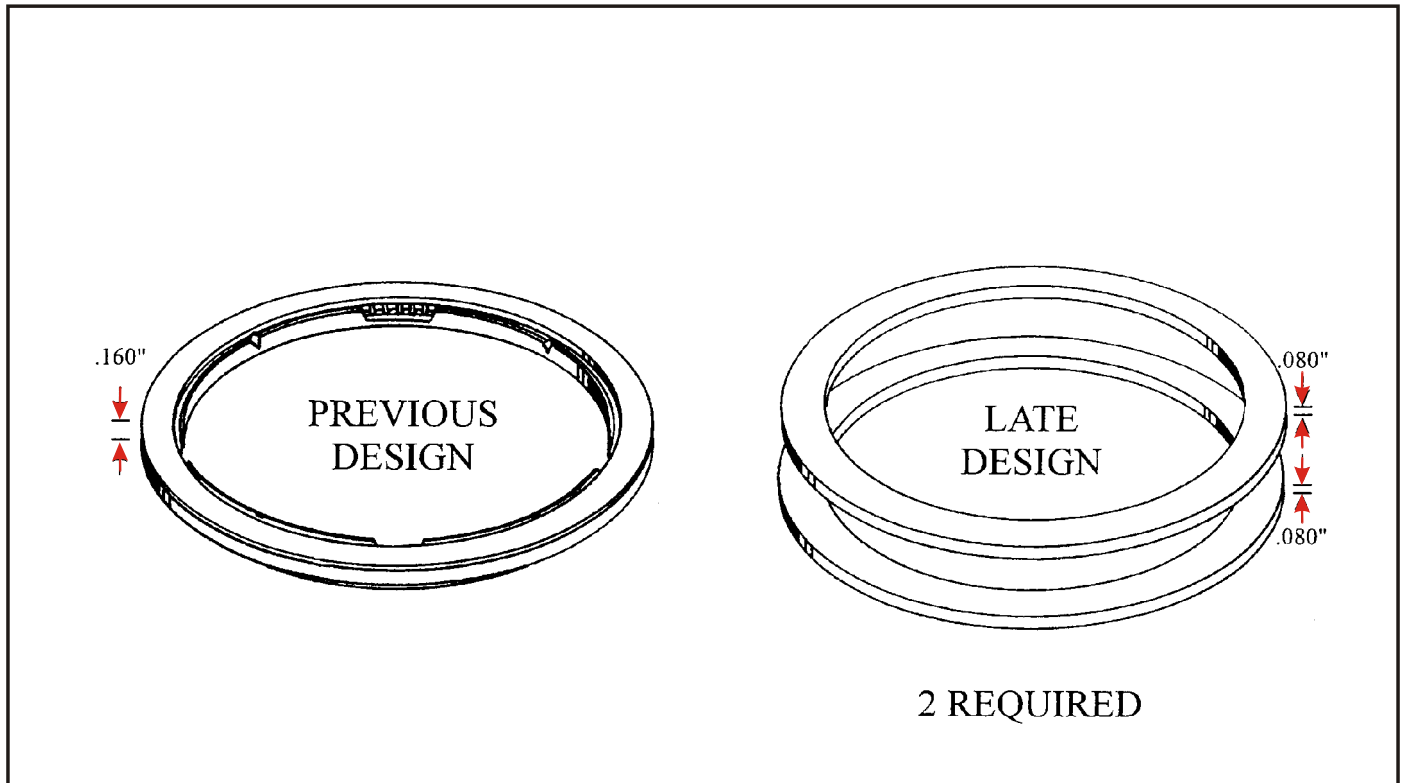
Figure 2

PARTS AFFECTED:
The previous design 3 piece bearing has been replaced by 2 thrust washers (See Figure 2).

INTERCHANGEABILITY:
The 2 new design thrust washers will retro fit backwards. These thrust washers must be used in a pair. If not, premature bearing failure, lubrication and or end play problems **will** arise.

SERVICE INFORMATION:
THRUST WASHER (NEW DESIGN-2 REQUIRED).....31508-41X01
