# Technical Service Information

## FORD 5R55W

### NO 2nd OR 5th

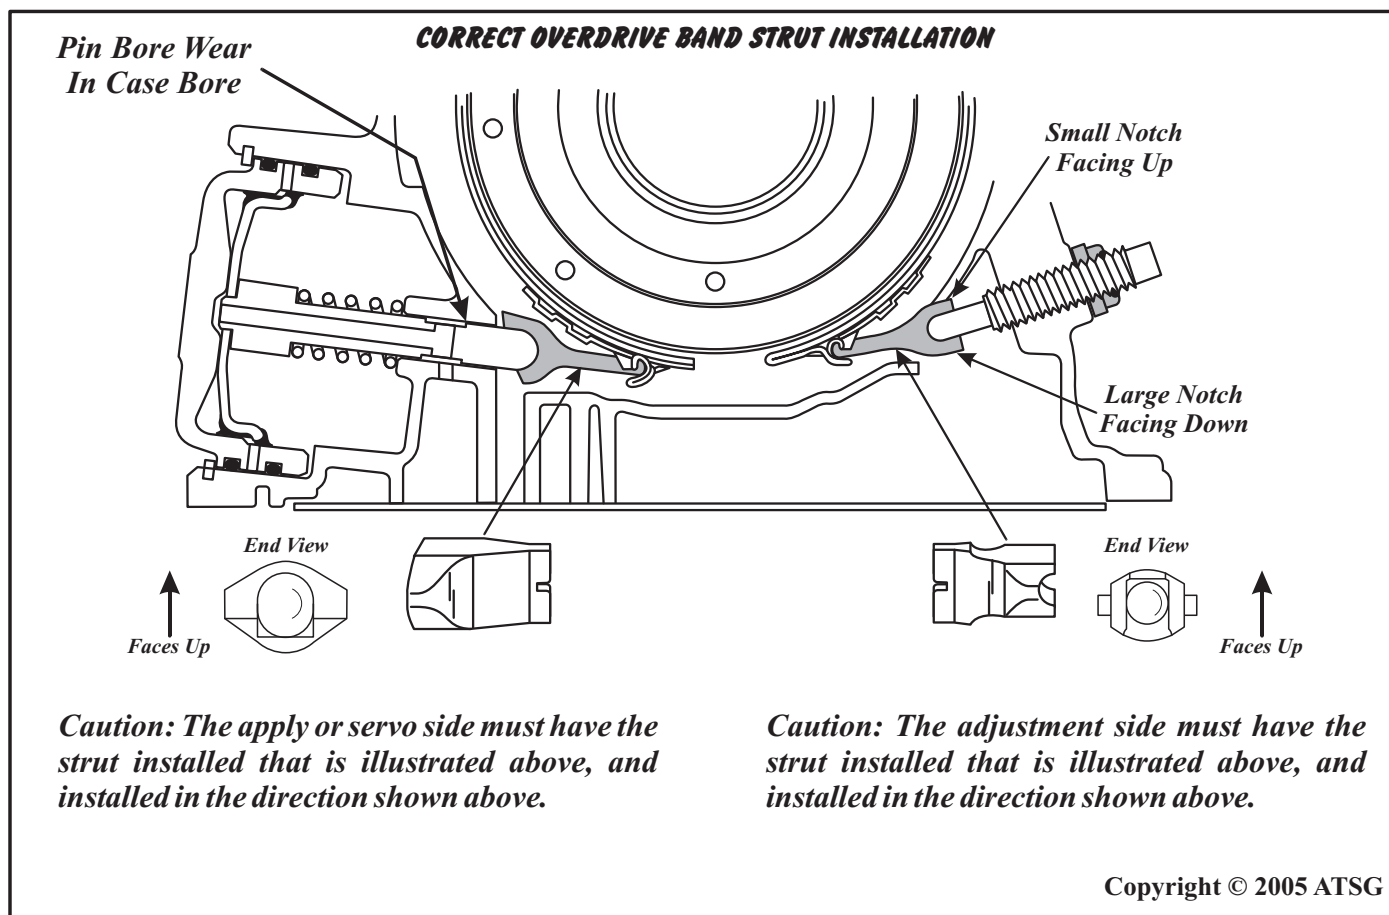
**COMPLAINT:** Vehicles equipped with the 5R55W transmission may exhibit a no 2nd or no 5th gear condition, before or after overhaul.

**CAUSE:** The cause may be, that the band struts were installed upside down, or the servo bore is worn. The Overdrive servo is fed thru the center of the apply pin. Wear in the case, where the servo pin rides, may cause a pressure loss, creating the band failure. See Figure 1.

**CORRECTION:** To correct this condition, refer to Figure 1 for the correct assembly of the band struts. Replace the case or re-sleeve the case where the pin rides and install a bushing for a new sealing surface. *Northland transmission Inc. has a Re-boring kit available to repair the case bore, with a bushing, to fix the leak.*  
*Phone: 715-458-2617*
