Technical Service Information

THM 4L60-E 2ND GEAR STARTS AFTER REBUILD

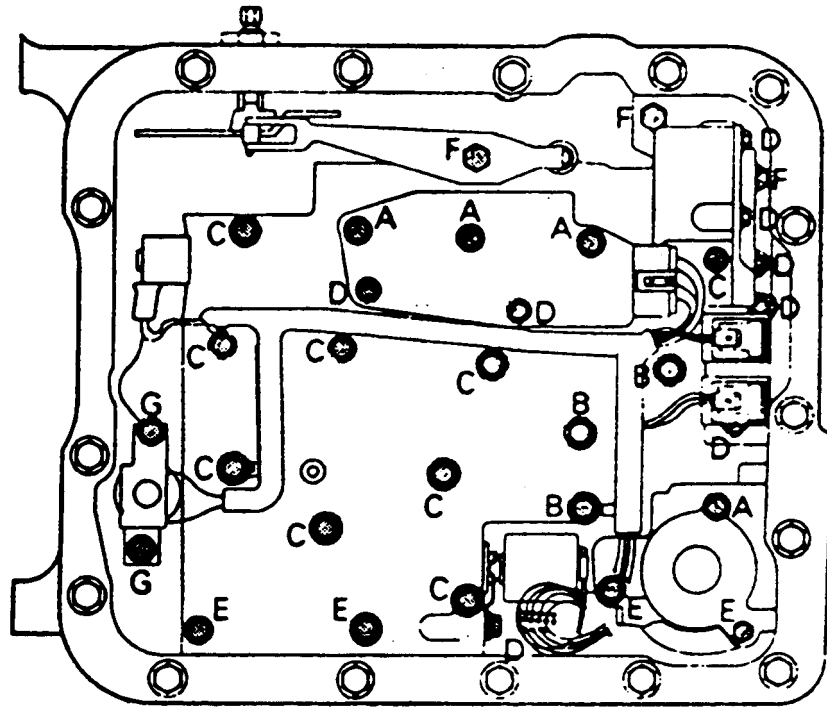
Figure 1

CAUSE: The cause may be valve body bolts installed in the wrong positions. Most common mix-up is bolt "B" (54.4mm long) installed in rearmost "C" position along the transmission centerline. The longer bolt in this location will now lock the sun gear shell from turning.

CORRECTION: Install the valve body bolts in their proper locations using the illustration and bolt chart below.
