THM 4L30-E

NO T.C.C.

COMPLAINT: No torque converter clutch engagement commanded by computer, even though all of the shifts are on time. When the computer is bypassed, torque converter clutch operates fine.

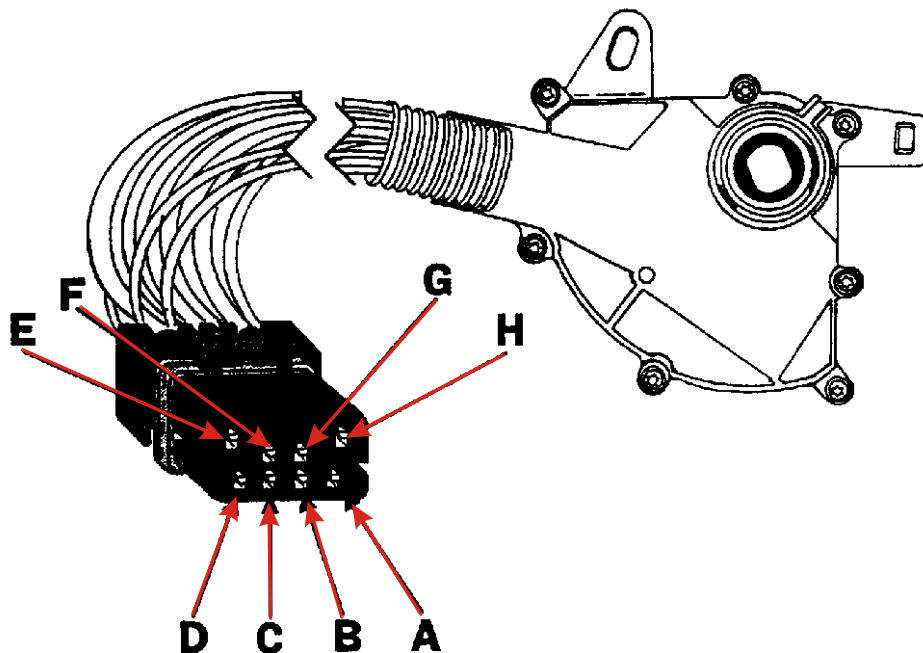
CAUSE: The Mode Switch (Inhibitor Switch) may be defective. This switch carries battery voltage and sends specific information to the TCM. The TCM reads the selector position to determine shift schedule as well as torque converter clutch engagement. A "missing" or incorrect signal from the mode switch may not prevent upshift commands to the transmission, but will set trouble code 56. Trouble code 56 will **not** turn on the "Check Trans" light on the dash, nor will it activate the emergency program. What it will do is disable the torque converter clutch and then take no further action.

Note: The harness connector is located on the passenger side of the vehicle, near the fire wall. The harness itself is approximately 4 feet long and travels to the mode switch on the drivers side of the transmission.

CORRECTION: Drive the vehicle to determine if ALL of the ranges can be selected manually. If there is any problem holding 1 st gear, 2nd gear, or third gear, check the Mode Switch for continuity. Replace the Mode Switch if necessary. Figure 1 identifies the Mode Switch and the terminals of the connector. Figure 2, provides a guide to use when checking the switch.

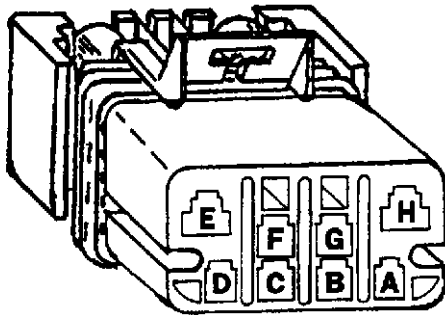
Figure 2

CONTINUITY ACROSS TERMINALS IS SHOWN IN CHART
TERMINALS E AND H HAVE CONTINUITY TO EACH OTHER ONLY
