# Technical Service Information

## FORD E40D NO FLOW TO COOLER, AFTER REBUILD

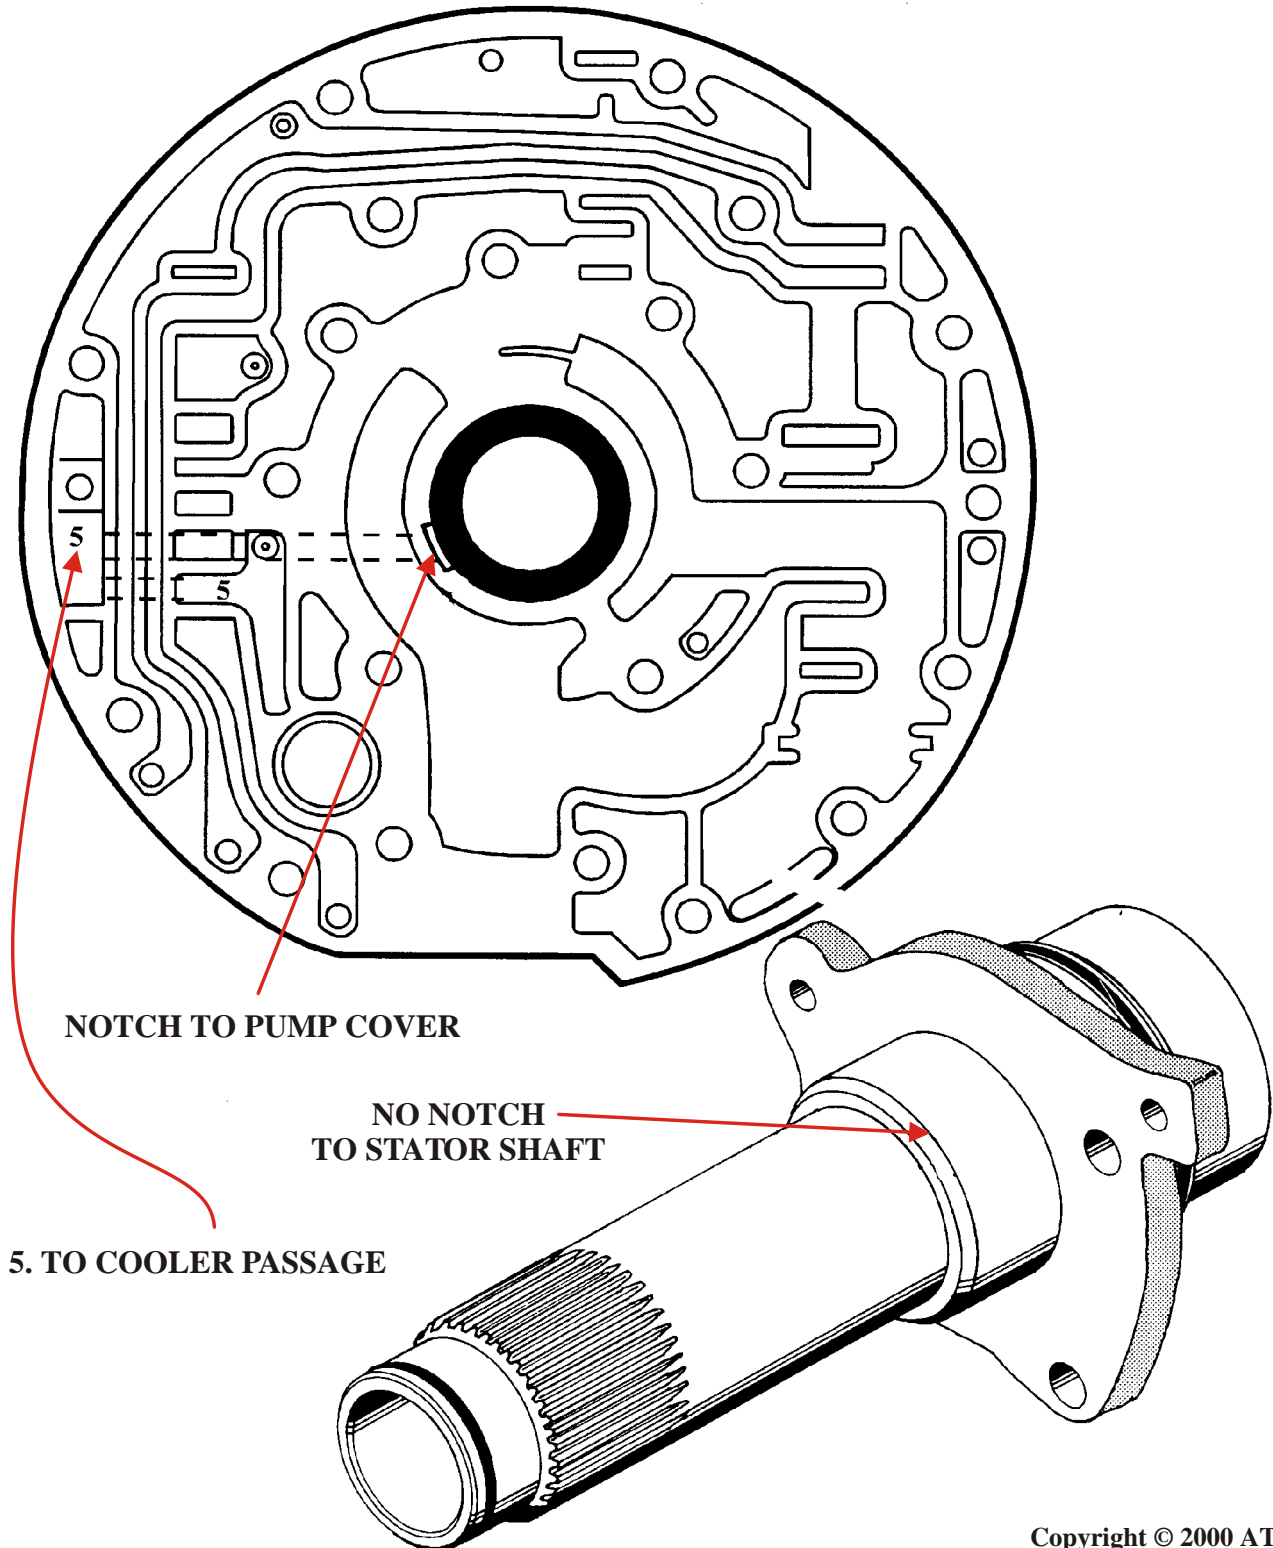
Figure 1

**(1) 89-94 MODELS** - Have a relief (Notch) cut into the pump cover on the inside diameter, where the stator shaft presses into the cover, creating a passage for converter apply oil to get into the “To Cooler” passage in the pump cover. Refer to Figure 1.

**1989 - 1994 PUMP STATOR (WITHOUT NOTCH)**  
**1989 - 1995 PUMP COVER (WITH NOTCH)**

**89-94 Model** pump cover with notch, **MUST** be used with the stator shaft without notch. Refer to Figure 1.

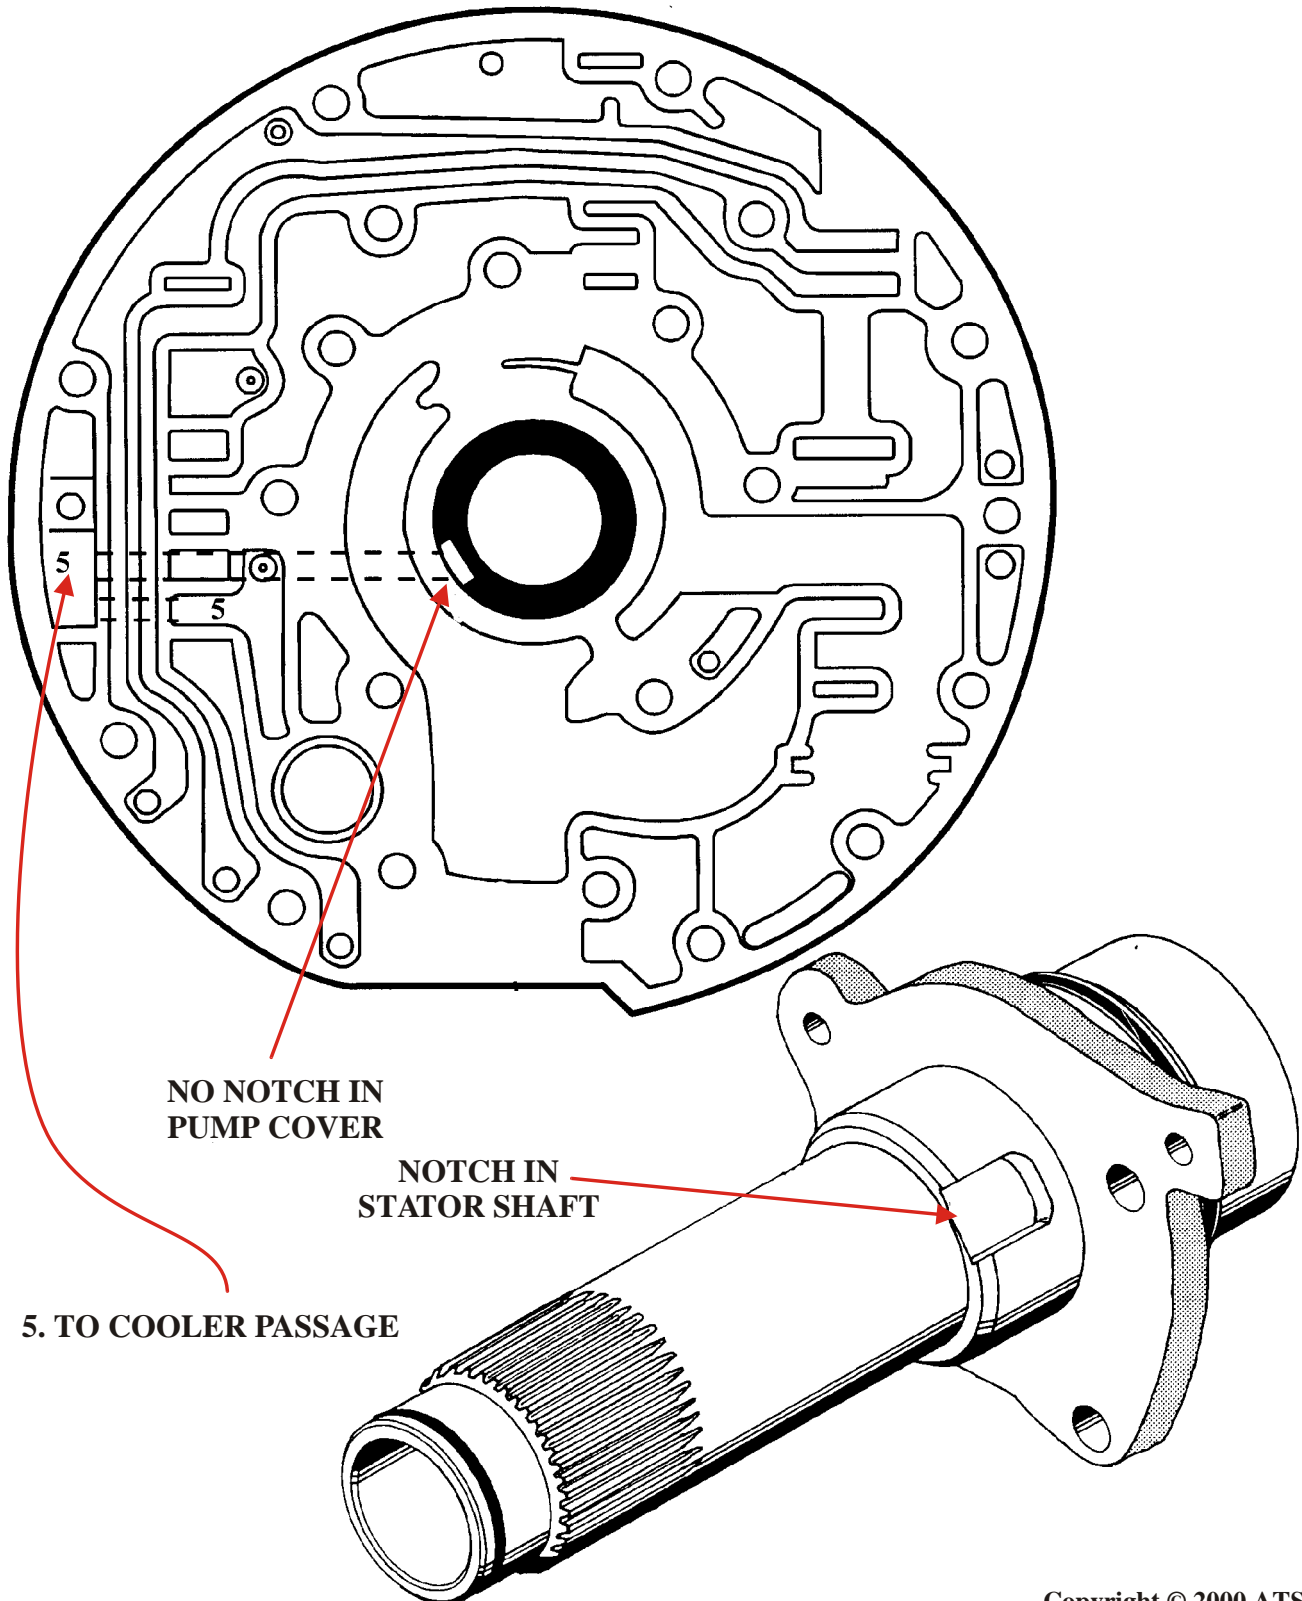
Figure 2

**(2) 95-96 MODELS** - The relief (Notch) cut in the pump cover was eliminated from the cover, and the relief (Notch) cut was added to the stator shaft (See Figure 2).

## 1995 - 1996 PUMP STATOR (WITH NOTCH) 1995 - 1996 PUMP COVER (WITHOUT NOTCH)

**95-96 Model** pump cover without notch, **MUST** be used with the stator shaft with notch. Refer to Figure 2. If you install a 89-94 stator shaft without notch, into a 95-96 pump cover without notch You will create a totally blocked “To Cooler” passage in the pump cover. Refer to Figure 3.

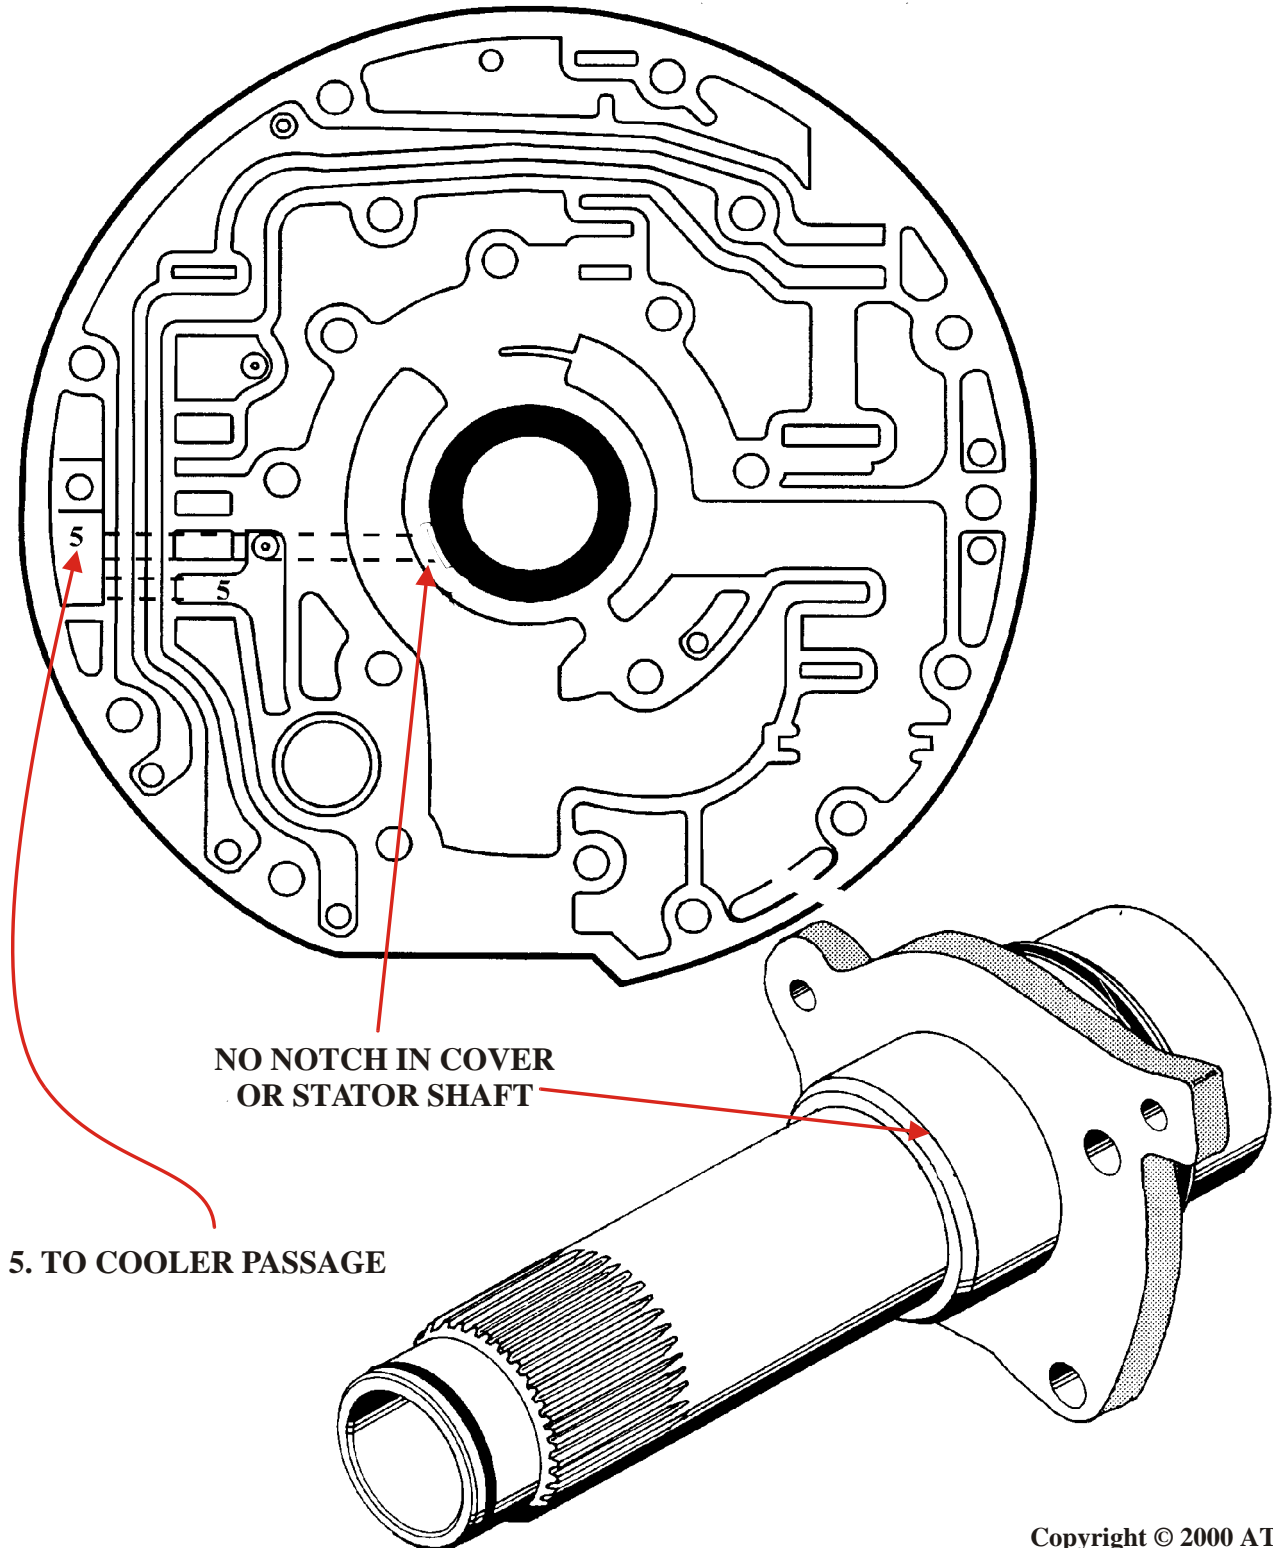
Figure 3

**REASON:** The cause may be, m&match of stator shaft and pump cover creating a totally blocked “To Cooler” passage in the pump cover.

## ***INCORRECT ASSEMBLY***

**1989 - 1994 PUMP STATOR (WITHOUT NOTCH) WITH  
1995 - 1996 PUMP COVER (WITHOUT NOTCH)  
WILL CAUSE TOTAL BLOCKAGE TO COOLER PASSAGE**

**(3)** If for any reason, it becomes necessary to install a different stator shaft into your pump cover, you must ensure that you are installing compatible parts.
