Technical Service Information

THM 4L60-E

PREMATURE LOW/REVERSE CLUTCH FAILURE

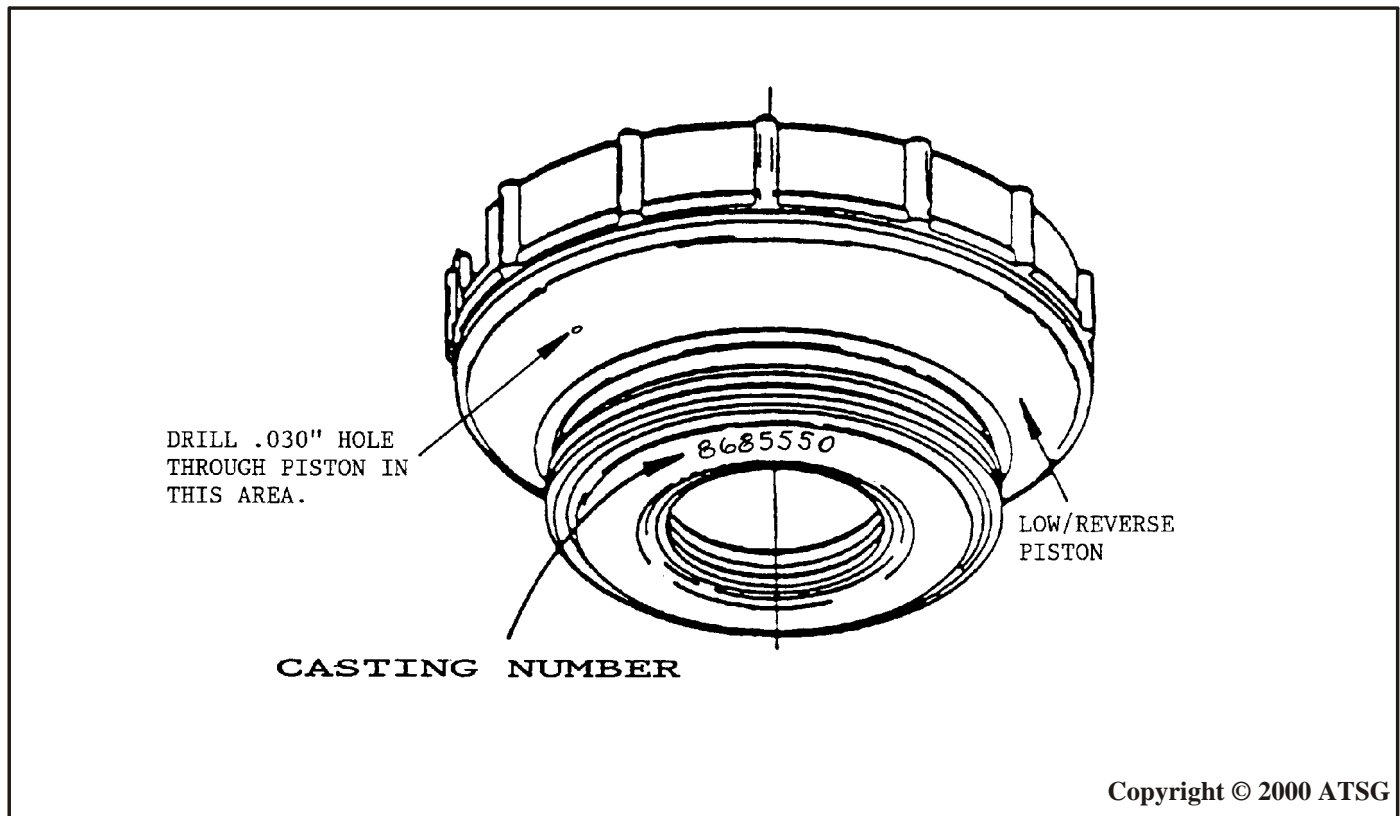
Figure 1

COMPLAINT: Premature and/or repeat failure of the Low/Reverse clutch pack, and may happen in as little as 5000 miles.

CAUSE: The cause may be, the Low/Reverse clutch not totally exhausting the apply oil when the shift lever is moved from Park to Drive position. The Low/Reverse clutch is applied in Park on this transmission.

CORRECTION: STEP 1: Drill a .030" hole through the Low/Reverse piston in the area shown in Figure 1. This will provide an immediate exhaust for reverse oil when the selector is placed in Drive.
