Technical Service Information

GM 6L80 SLIPS IN FORWARD DTC P2728

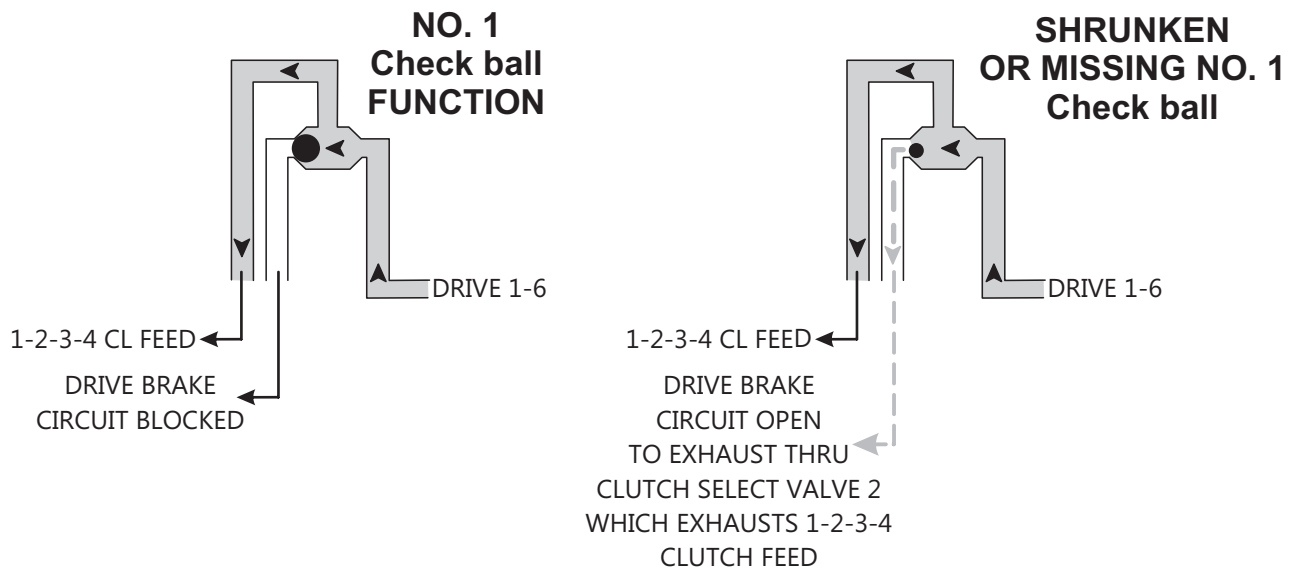
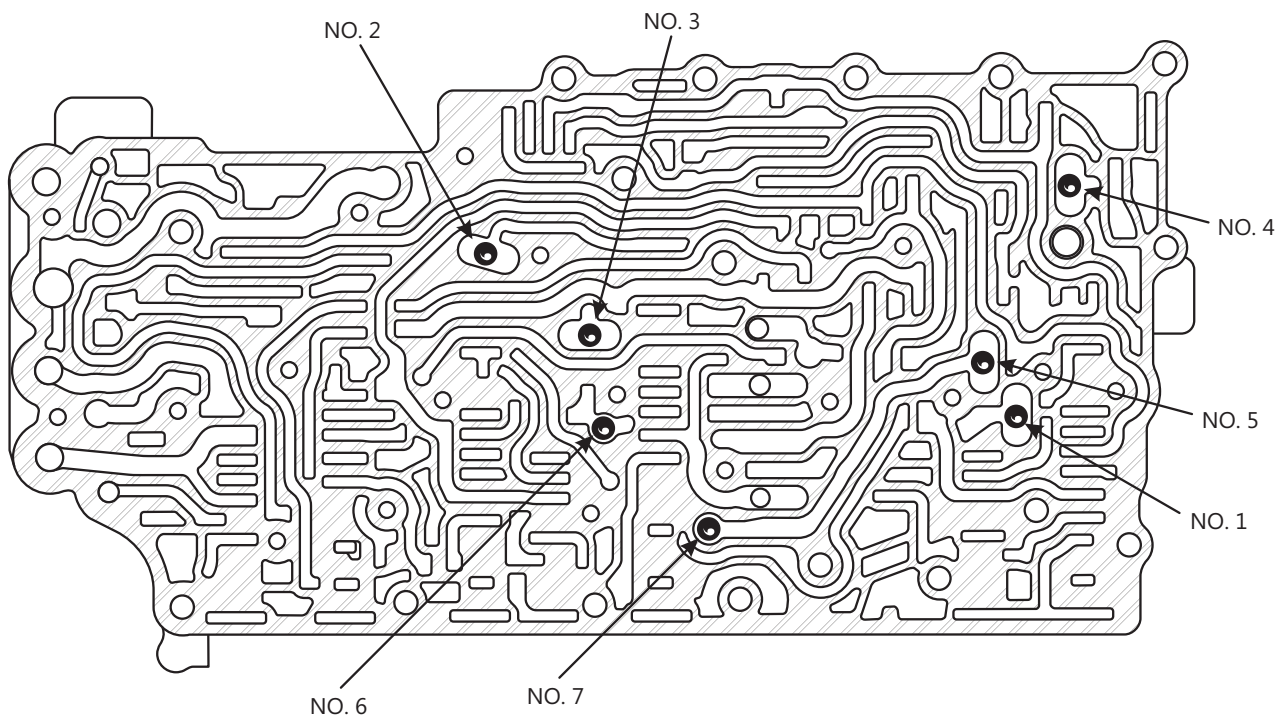
Figure 1

CAUSE: The cause may be a shrunken or missing number 1 nylon check ball. Refer to figure 1 for the location of the check ball in the upper valve body assembly. The number one check ball is located in the upper valve body, as shown in Figure 1. When the transmission is operating in drive 1st, 2nd, 3rd, 4th, 5th or 6th gear, drive 1-6 fluid seats the check ball against the drive braking passage and enters the 2-6 clutch/1-2-3-4 clutch feed circuit to apply the 1-2-3-4 clutch. When the check ball shrinks or disintegrates, 1-2-3-4 Clutch pressure will pass thru the ball seat to an exhaust provided by Clutch Select Valve 2. See figure 1 for partial schematic. **Note:** The DTC's listed above are performance codes related to the solenoid that controls the 1-2-3-4 Clutch application, a missing check ball can cause these codes to set, do not assume the TCM/Solenoid assembly is faulty, it could be a simple check ball!

6L80 NUMBER 1 CHECK BALL LOCATION AND FUNCTION IN 1ST GEAR

UPPER VALVE BODY ASSEMBLY

CORRECTION: Replace the nylon check balls with 1/4" torlon check balls available in most aftermarket Torqueflight kits, including 42-48RE. These check balls are made out of more durable material.
