Technical Service Information

THM 325/325-4L NO UPSHIFT, CUP PLUG MISSING

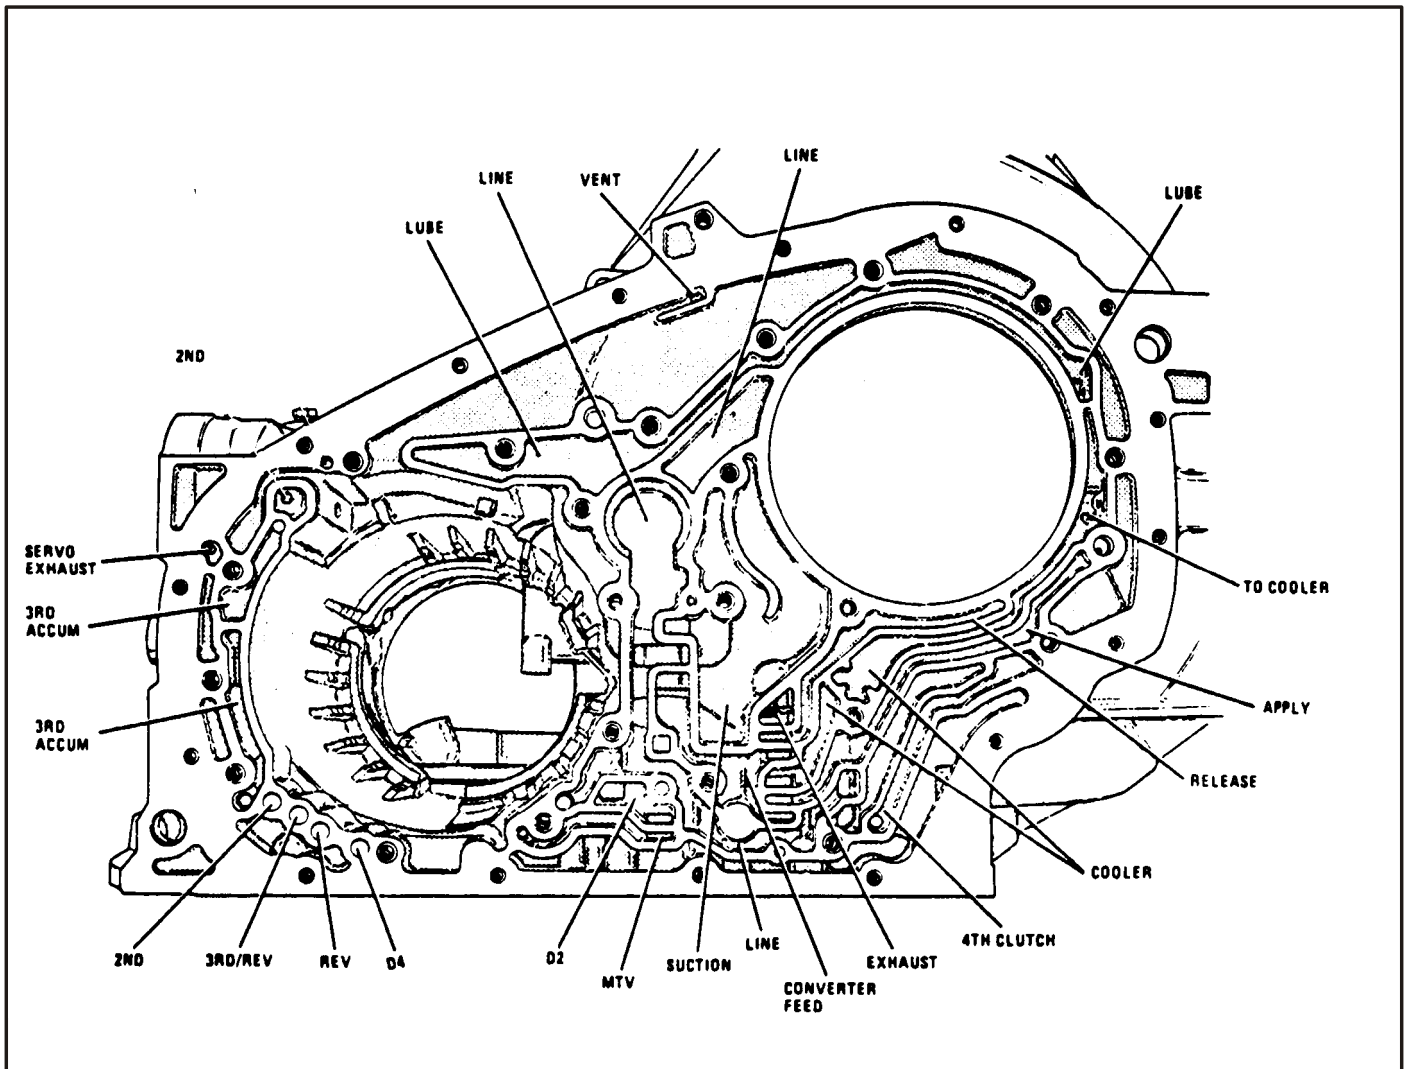
COMPLAINT: No 2-3 shift at any vehicle speed.

CAUSE: The cause may be the 3rd accumulator cup plug missing from the case, creating a loss of all direct clutch oil (See Figure 1).

CORRECTION: Install new 3rd accumulator orificed cup plug, available under OEM part number 8628864. See Figure 1 for location.
