Technical Service Information

JR403E ELECTROMATIC

ATF LEAKING FROM THE VENT

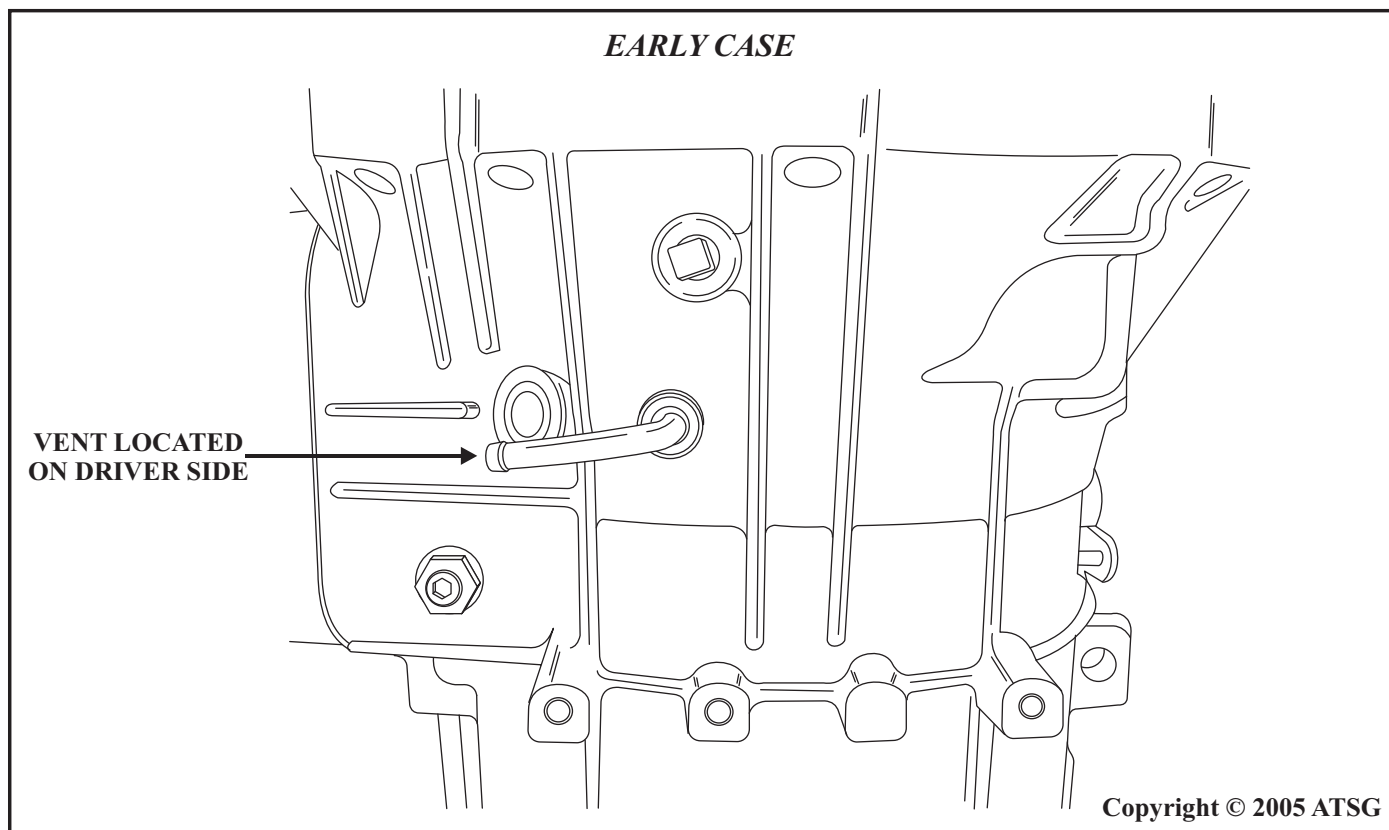
Figure 1

CORRECTION: The case in figure 1 is an *early* case, *notice* that the vent tube is located on the driver side. The case in figure 2 is a *late* case, *notice* that the vent tube is located on the passenger side and the driver side location is cast shut. The vent hose on the late case runs through the case mounting area as seen in figure 3.

The early and late pumps and cases cannot be interchanged, doing so will result in the above mentioned complaints.

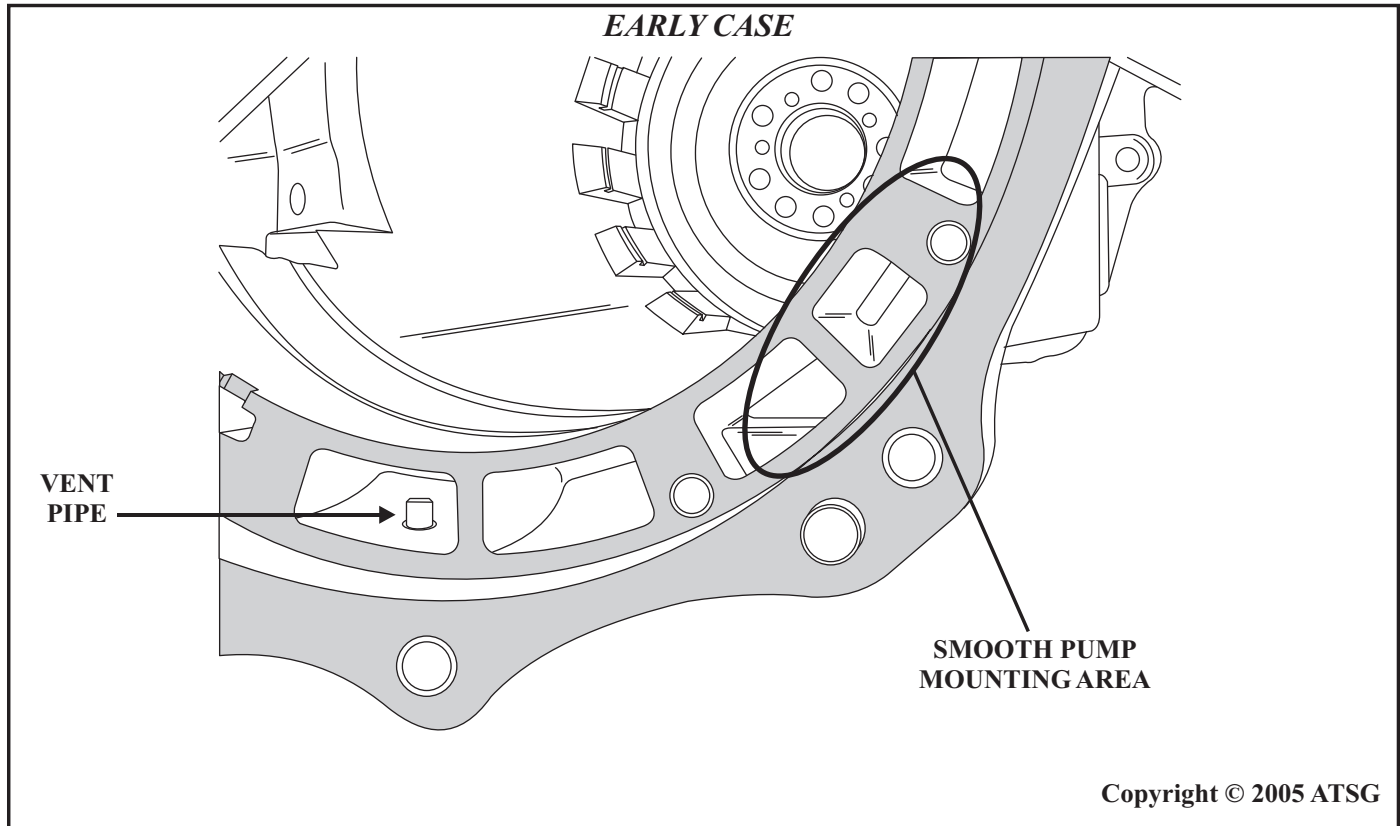
Figure 4

The pump mounting area in the case shown in figure 4 is a smooth mounting area encompassing the vent pipe, this is the *early* case. The pump mounting area in the case shown in figure 5 has channels cut in the pump mounting surface with the vent pipe on the opposite side of the case, this is the *late* case.

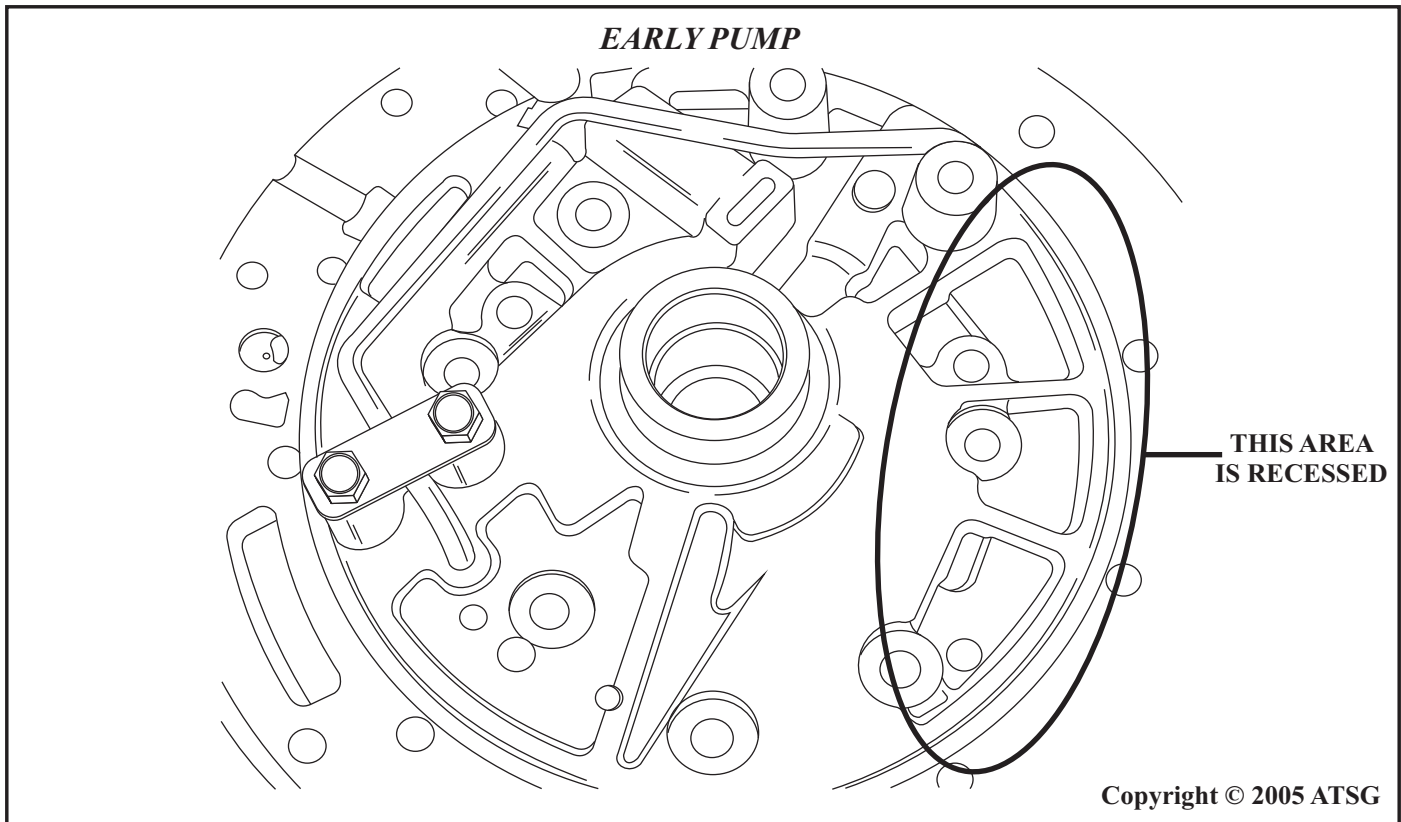
Figure 6

The pump shown in figure 6 is an *early* pump and goes with the *early* case, *notice* the highlighted area, it is recessed. The pump shown in figure 7 is a *late* pump and goes with the *late* case, *notice* the highlighted area, it is raised and contains air bleed holes.
