# Technical Service Information

## FORD 5R55W

### DELAYED ENGAGEMENT OR DTC P0705

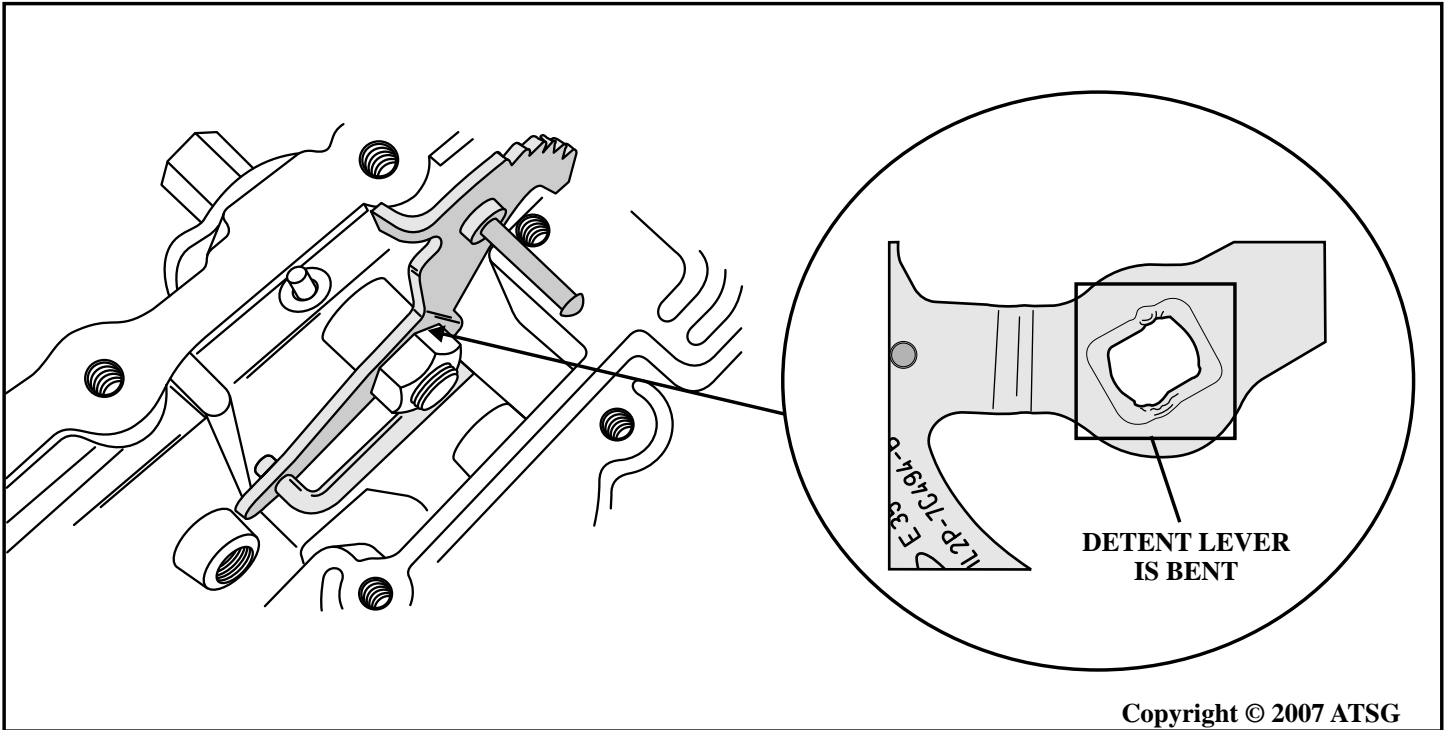
Figure 1

**CAUSE:** The internal linkage detent lever has been bent, (Refer to Figure 1), this causes a mis-alignment of the manual valve, and in some instances the manual valve may be bent as well.  
The main cause of bending the internal linkage is the manual selector shaft nut. This nut has thread lock on it from the factory, this thread lock compound creates a situation where the nut that retains the manual selector shaft is so tight, that the technician has exerted enough force to bend internal linkage components. Note: If the Manual Linkage is out of alignment the Digital Range Sensor will not be aligned correctly as well.
