Chrysler A604

Since the introduction of the Chrysler A604 Transaxle in model year 1990, there have been many engineering changes to improve Pleaseability, Driveability, and Durability concerns. These changes have affected many parts used in the A604 transaxle. This "update handbook" will explain each change, and any parts interchangeability problem created by the change, along with any part numbers deemed necessary.

CHRYSLER A604 NEW 4 RING STATOR

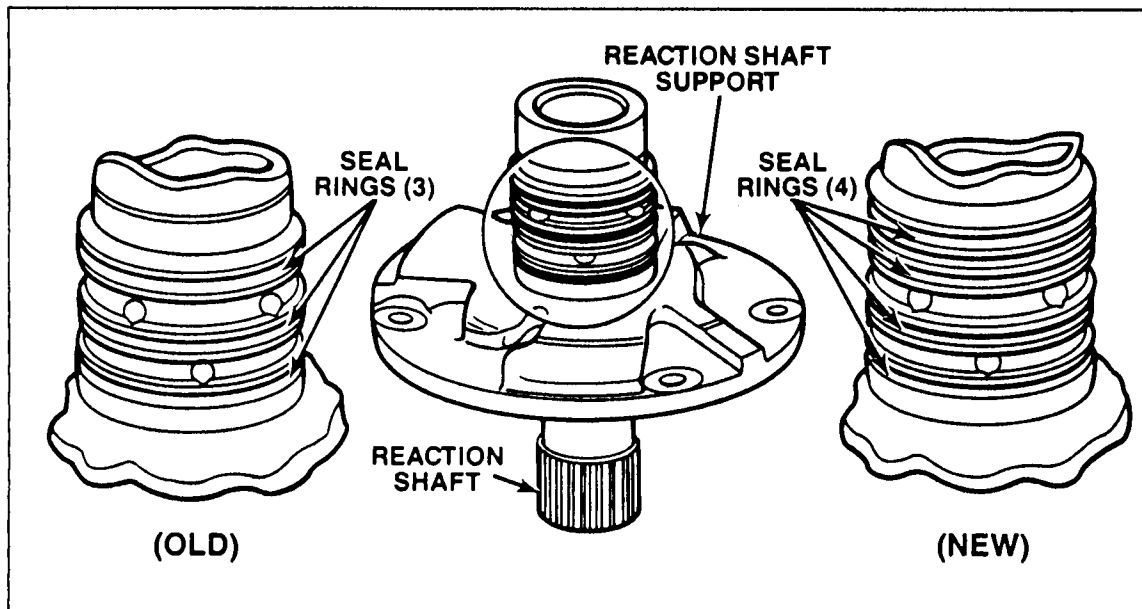
Figure 1

CHANGE: Beginning in April, 1989 a new Reaction Shaft Support (Stator) was introduced, with the addition of another ring groove and sealing ring. The old support has 3 sealing rings, and the new support has 4 sealing rings (See Figure 1).

- (1) REACTION SHAFT SUPPORT - The new support is longer, and has 4 sealing rings, where the old support only has three (See Figure 1).
- (2) INPUT SHAFT/CLUTCH HUB - The new Input Clutch Hub bore is machined deeper to accommodate the additional length of the reaction shaft, created by the added sealing ring (See Figure 2).
The "O" Ring grooves are also cut shallower than the old input clutch hub, which increases the groove diameter, and provides improved compression or "Crush", between the "O" rings and the input clutch retainer. (See Figure 2).

ALWAYS UPDATE to the four ring reaction shaft support. There is now available a repair package, OEM part number 4549248, that includes the following:

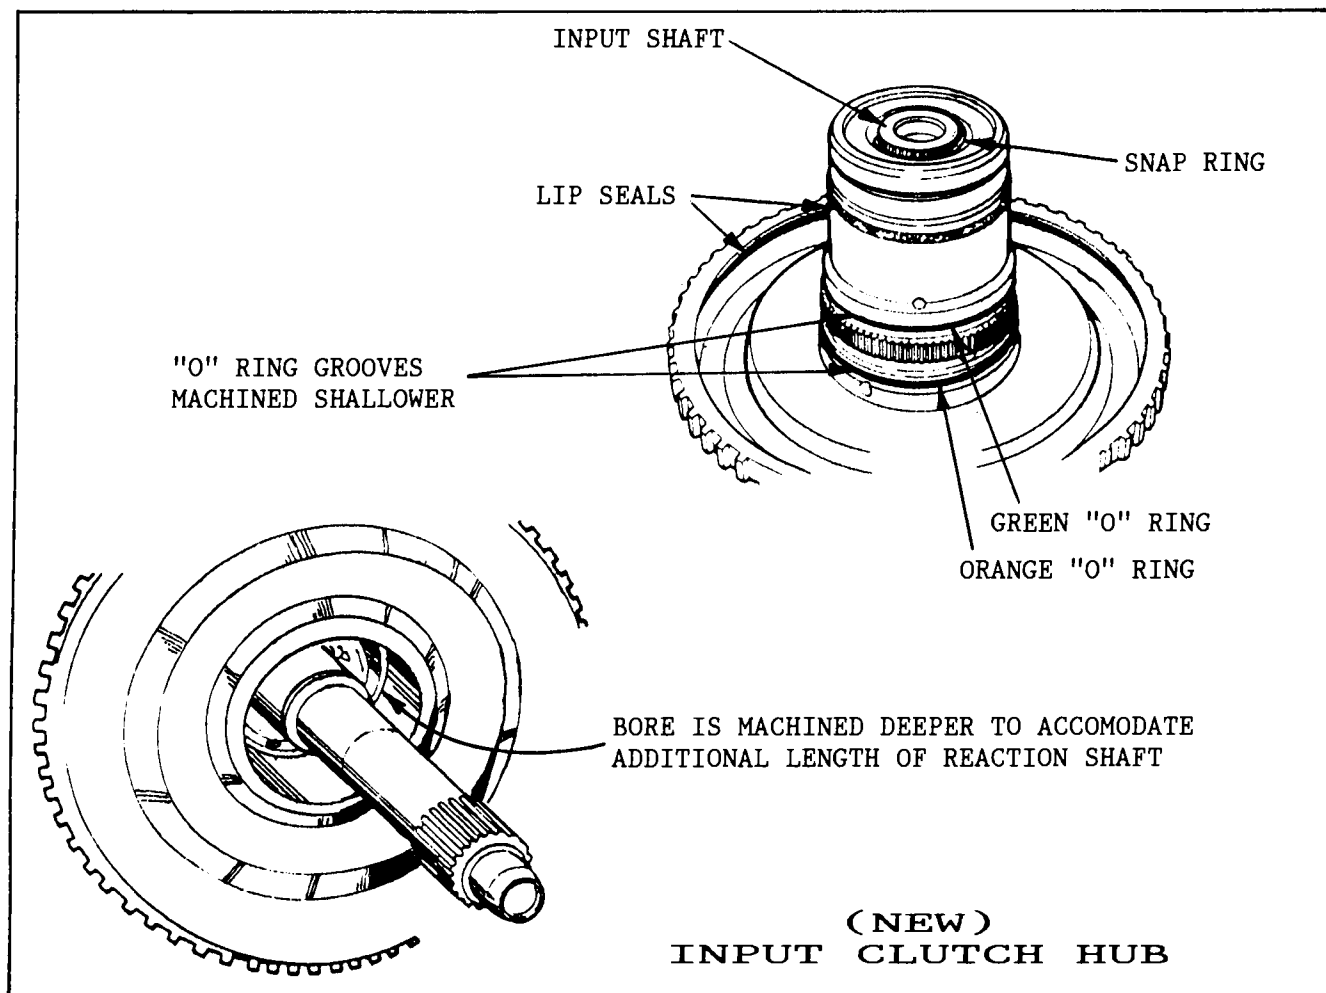
Figure 2

- (3) INPUT SHAFT/CLUTCH HUB "O" RINGS - The new "O" Rings are "Teflon Coated" for greater tear resistance during the assembly process. The coatings also identify the locations for the "O" Rings. The orange ring goes to the front, and the green one goes to the rear (See Figure 2). The early "O" rings were black.

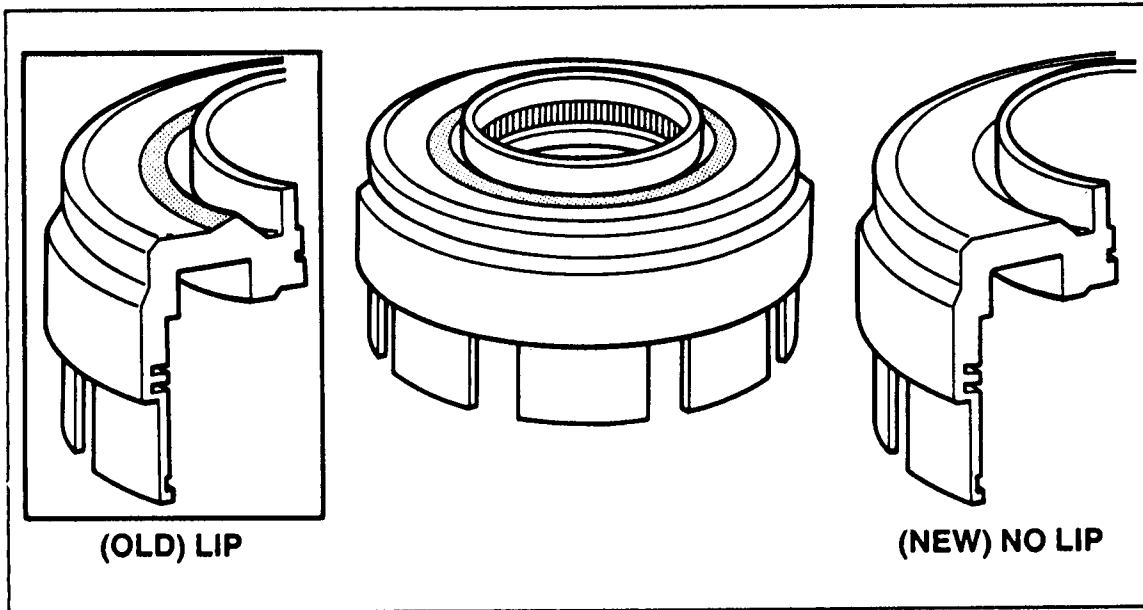
Figure 3

- (4) INPUT CLUTCH RETAINER - The Input Clutch Retainer was modified, by machining off the "Lip" (See Figure 3), to allow more travel of the overdrive/reverse piston. The old Input Clutch Retainer can be machined at the local machine shop if necessary.

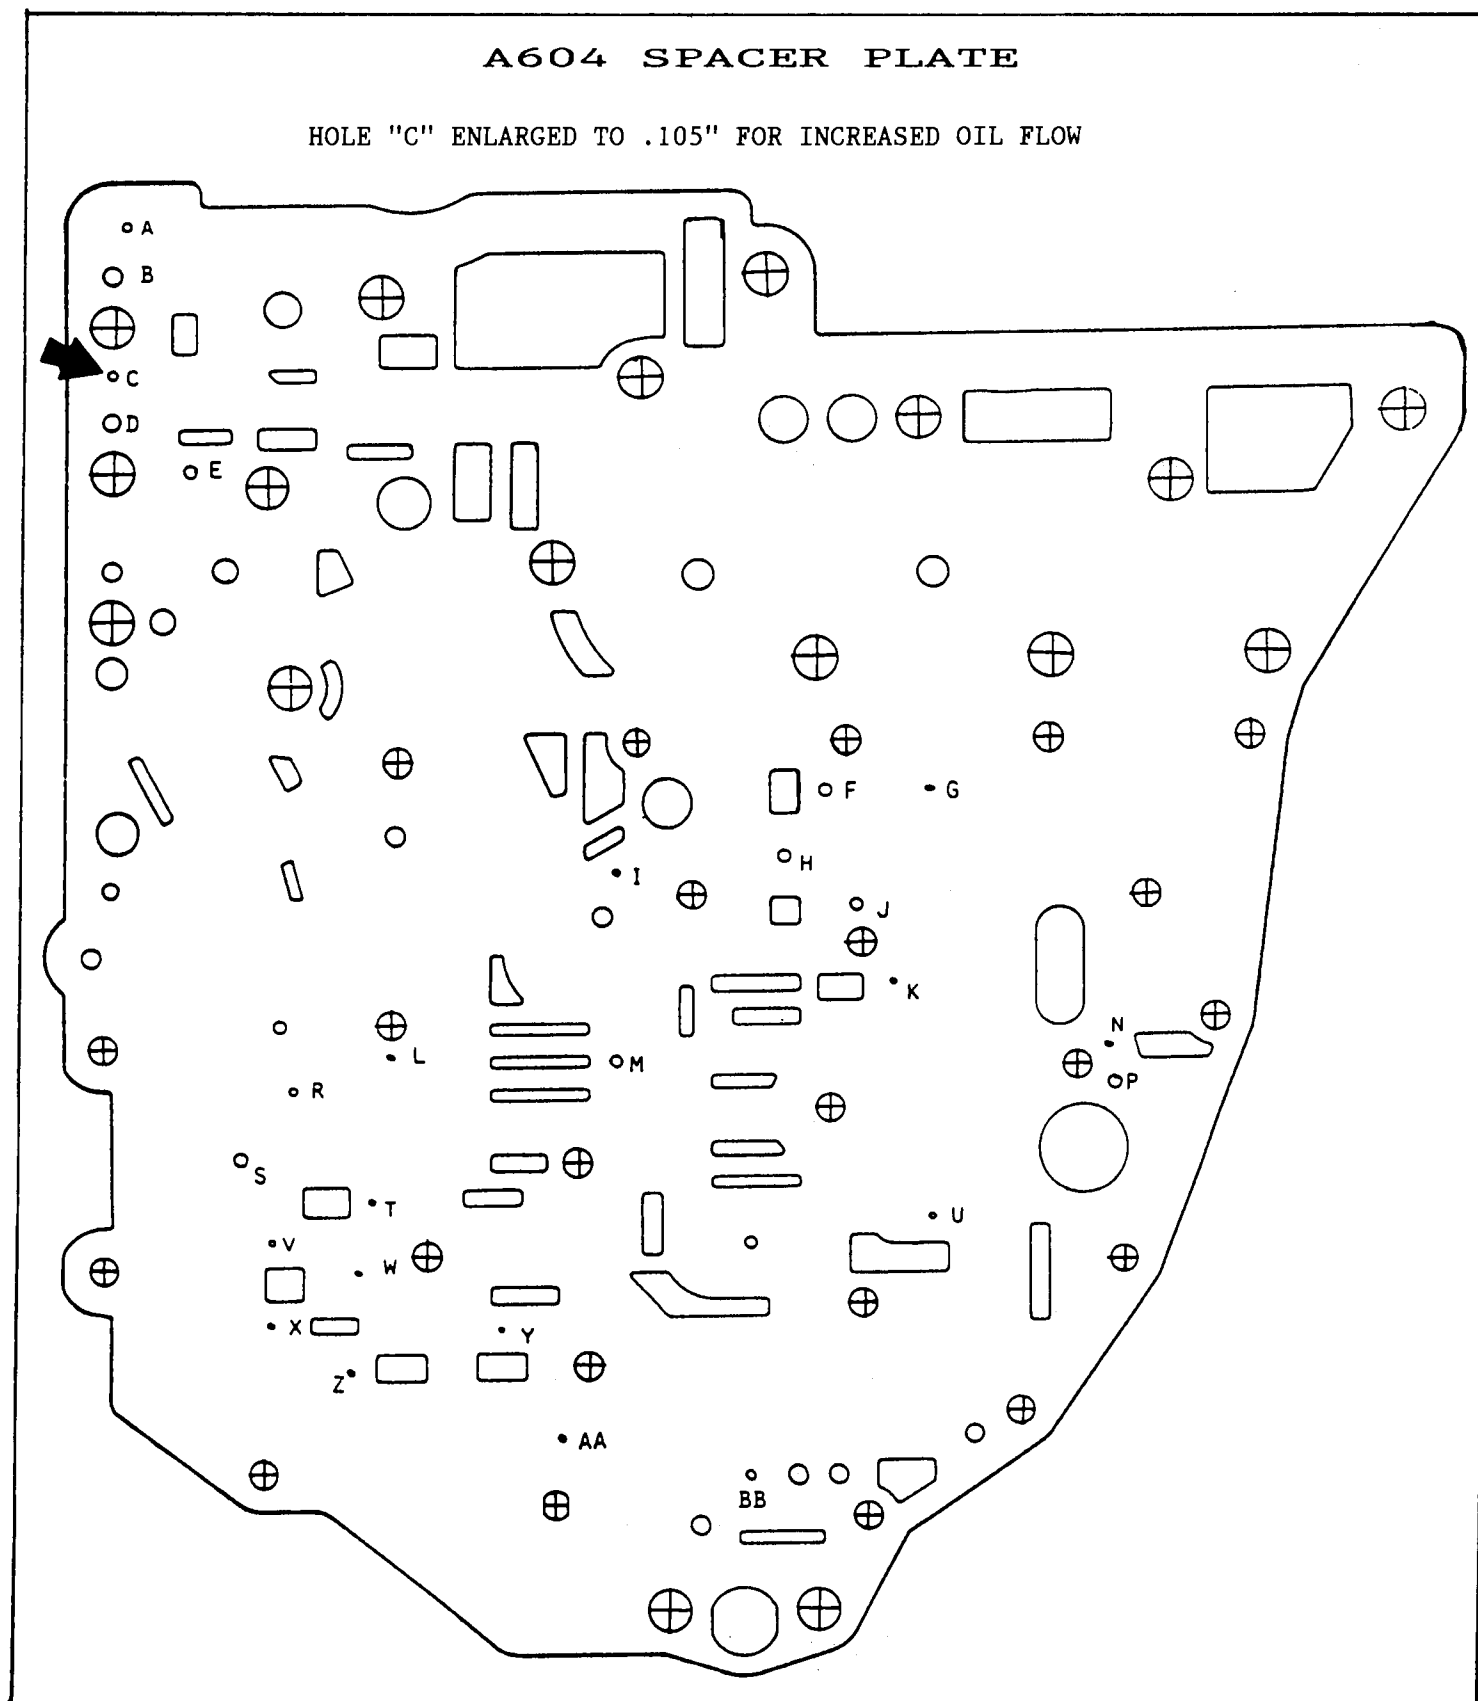
Figure 4

- (5) SPACER PLATE - The new Spacer Plate has a larger (.105") overdrive clutch feed orifice to provide increased oil flow to the overdrive clutch circuit (See Figure 4).

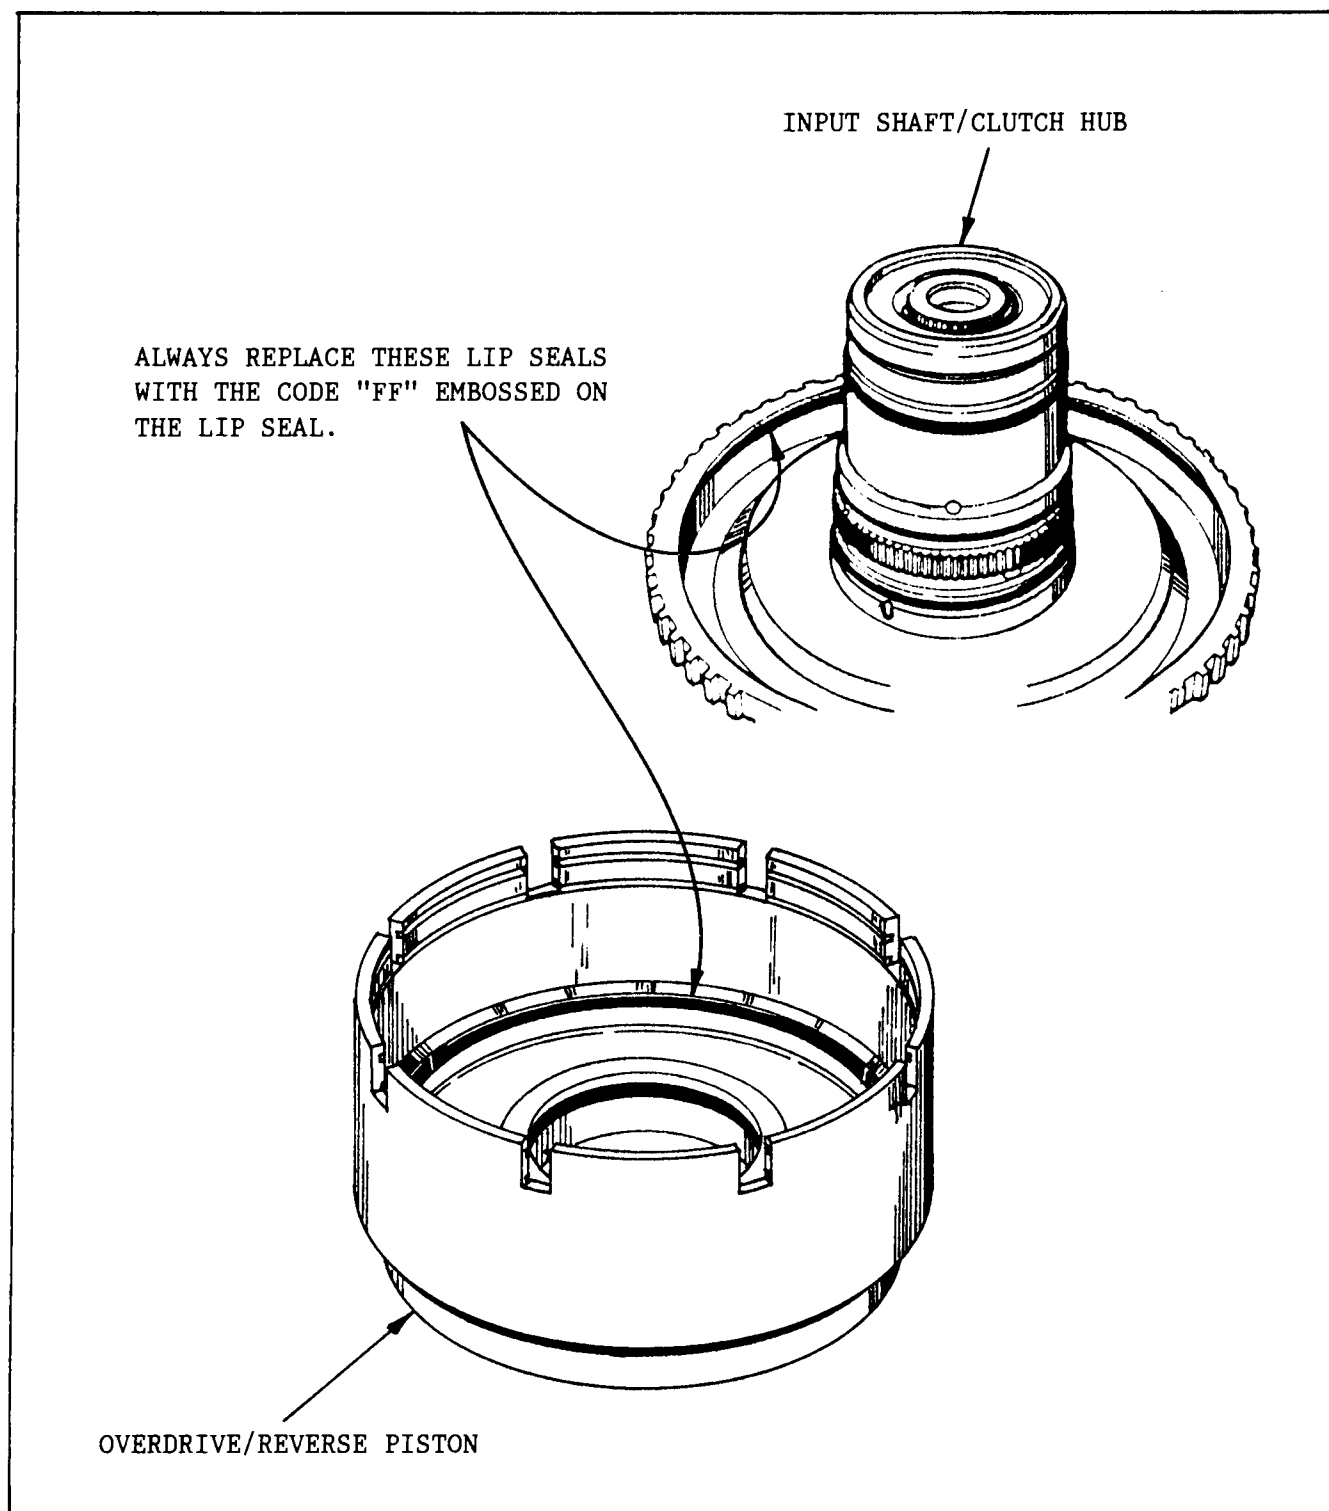
Figure 5

CHANGE: The lip seals in the Overdrive/Reverse Clutch Piston and the Input Shaft/Clutch Hub are now replaced with lip seals made of different material (See Figure 5).

- (1) OD/REVERSE PISTON LIP SEAL - No dimensional changes, but the material changes, and the new lip seals can be identified by the code "FF" embossed into the seal. The old lip seal is embossed with the code "IPC", and should not be used (See Figure 5).
- (2) INPUT CLUTCH HUB OUTER LIP SEAL - No dimensional changes, but the material changes, and the new lip seals can be identified by the code "FF" embossed into the seal. The old lip seal is embossed with the code "IPC", and should not be used (See Figure 5).

THE NEW LIP SEALS EMBOSSED WITH THE CODE "FF" WILL RETRO-FIT BACK TO ALL PREVIOUS MODELS, AND SHOULD BE USED DURING OVERHAUL.

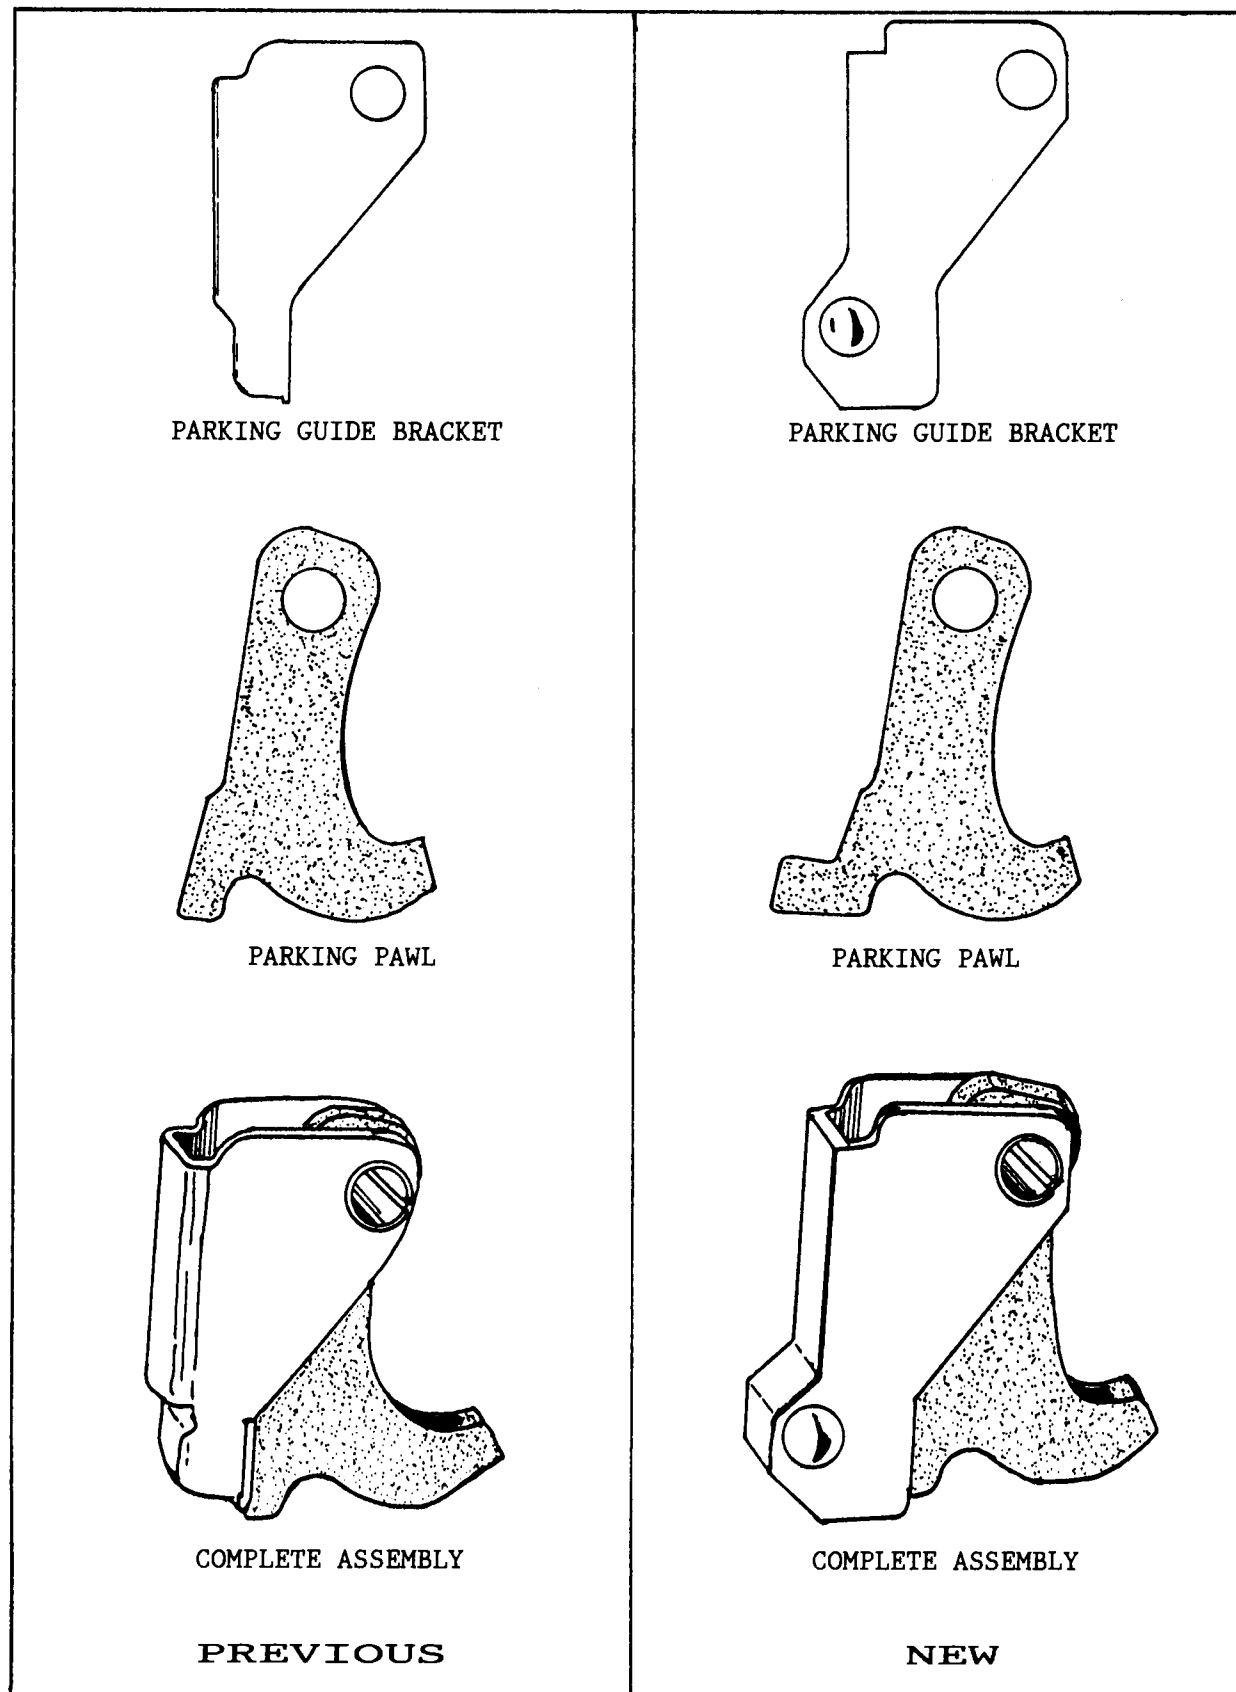
CHANGE: A new Parking Sprag Guide Bracket and Parking Pawl has been introduced as a 1989 running change (See Figure 6).

- (1) **PARKING GUIDE BRACKET** - Previously the Parking Guide Bracket was a stamped steel unit, and has been replaced by a high quality casting, along with dimensional changes. See Figure 6 for identification.
- (2) **PARKING PAWL** - The new Parking Pawl, or "Boot", also required some dimensional changes. The heel of the new "Boot" is wider than the previous models, as shown in Figure 6.

The new parts will retro-fit back to all previous models, but both pieces must be replaced as an assembly. (See Figure 6).

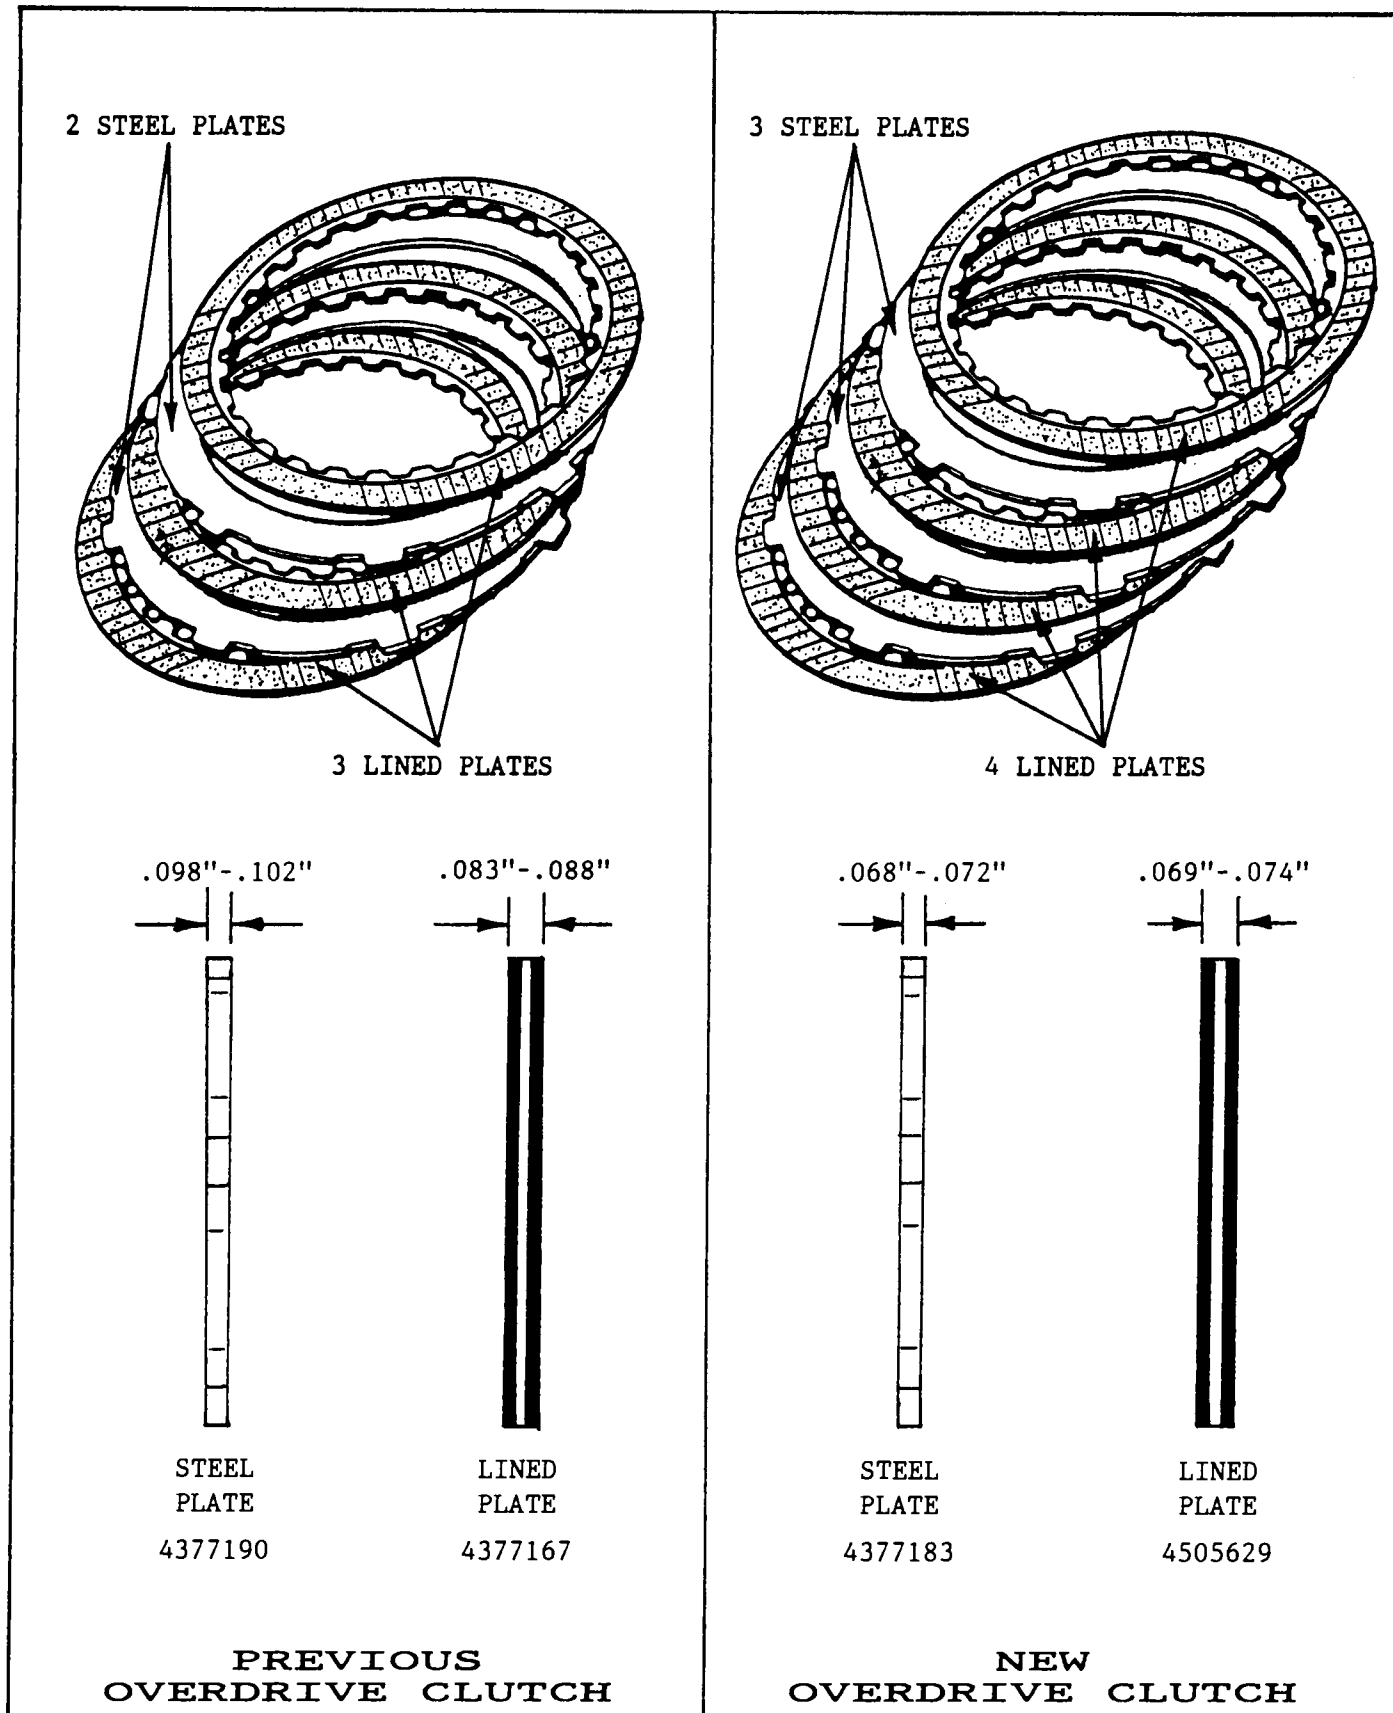
Figure 13

CHANGE: A running change for 1990 model A604 transaxles was the introduction of a four (4) disc Overdrive Clutch Assembly, to replace the previous three (3) disc assembly (See Figure 13).

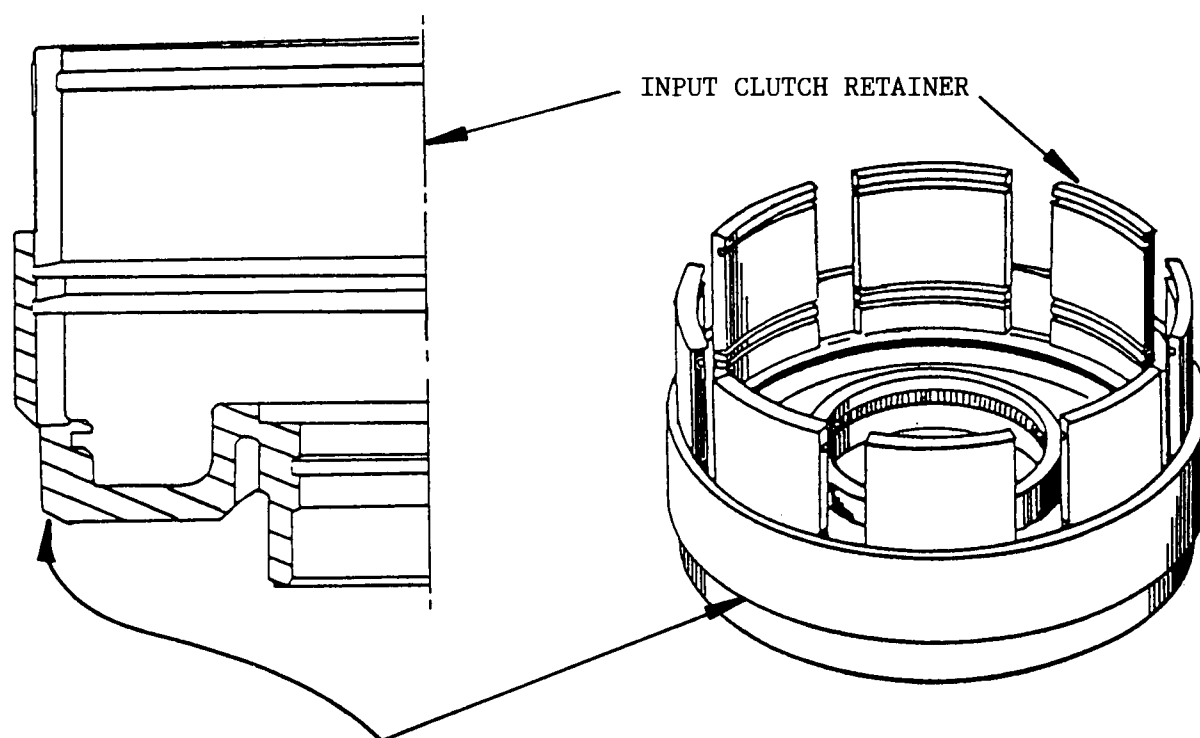
Figure 28

1990 1/4 INPUT CLUTCH RETAINER HAS A REVISED RADIUS, LOCATED HERE, ON THE OUTSIDE DIAMETER TO REDUCE THE CHANCE OF DAMAGE TO LIP SEAL.

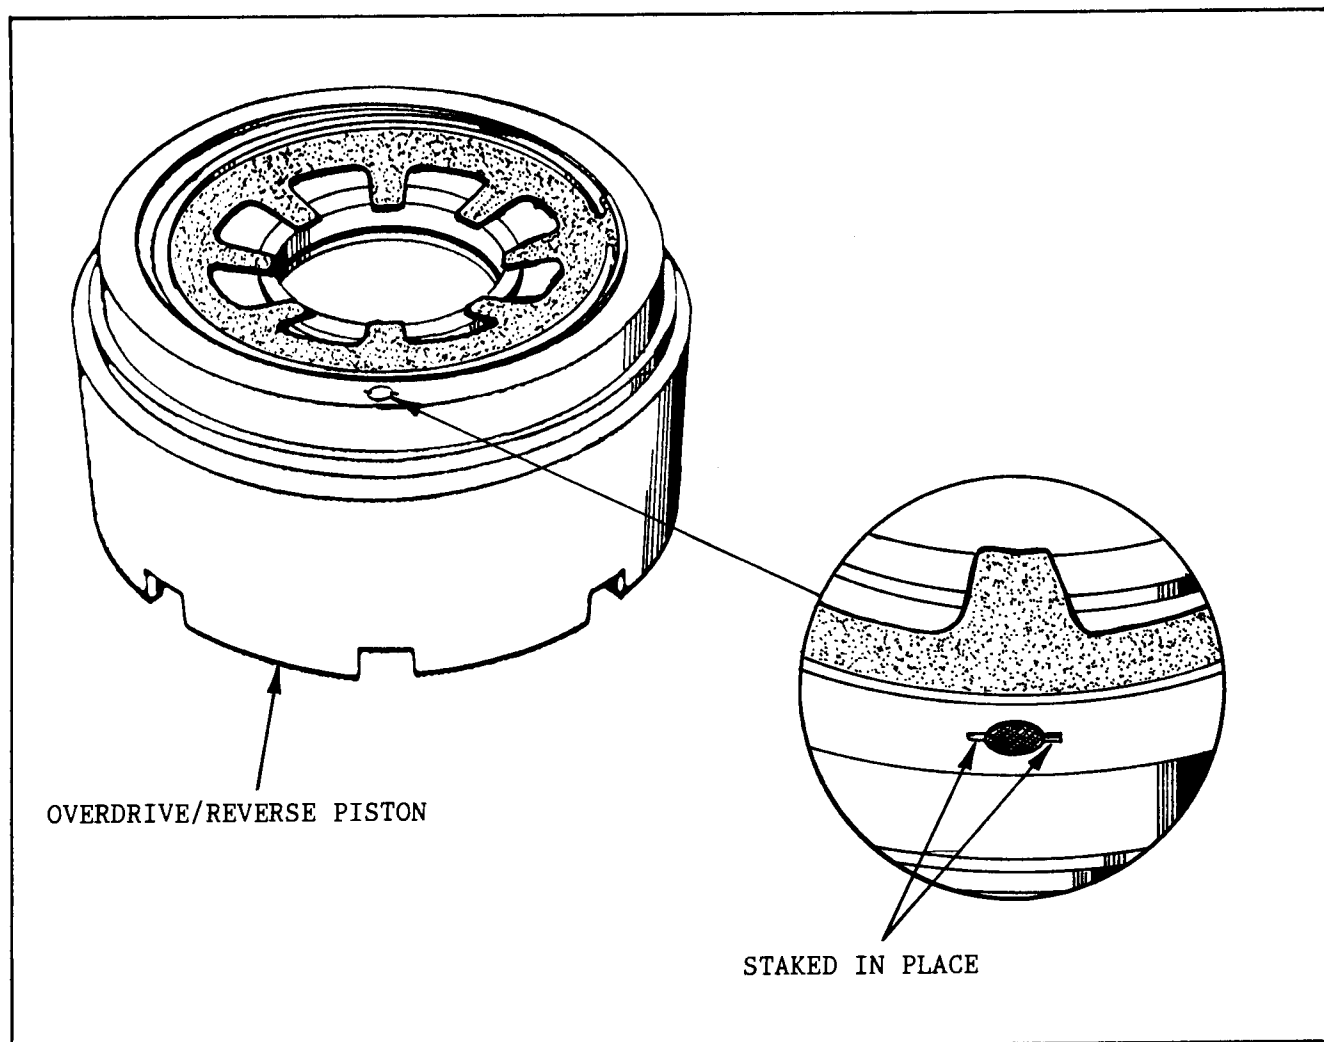
Figure 34

COMPLAINT: Premature failure of the overdrive and the reverse clutch plates, and all lip seals and "O" rings are good.

CAUSE: The cause may be an orifice and screen assembly blown out of the overdrive/reverse piston (See Figure 34).

CORRECTION: Replace the Orifice/Screen Assembly with a new one, available under OEM part number 4531903, and stake the new assembly in place (See Figure 34). They were not all staked in place at the factory.
