Technical Service Information

CHRYSLER A404

SEVERELY DELAYED 1-2 UPSHIFT AFTER REVERSE

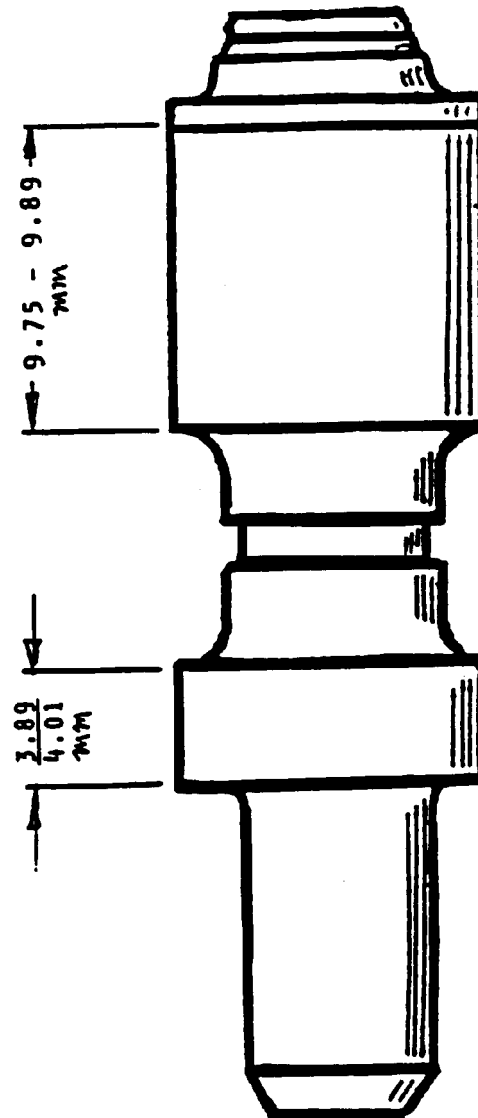
Figure 1

Customer concern of severely delayed 1-2 upshift after operating vehicle in reverse, particularly when transaxle is cold. The 1-2 upshift may not occur until vehicle has traveled as much as 1/4 of a mile and/or shift speed may be 10-12 MPH above normal shift speed range.

1. Remove Transaxle oil pan and allow to drain.
2. Remove Valve body.
3. Remove throttle valve from valve body. Check the lands for proper size on the valve as shown in figure 1. If the lands on the valve are short, replace the valve.
4. Reinstall the valve body and torque screws to 5 N.m (40 inch pounds).
5. Reinstall the transaxle oil pan and add the necessary fluid to bring to the proper fill level.
6. Road test vehicle for proper operation .
