Technical Service Information

THM 440-T4

2ND CLUTCH DURABILITY (CLIP BOOST SPRING)

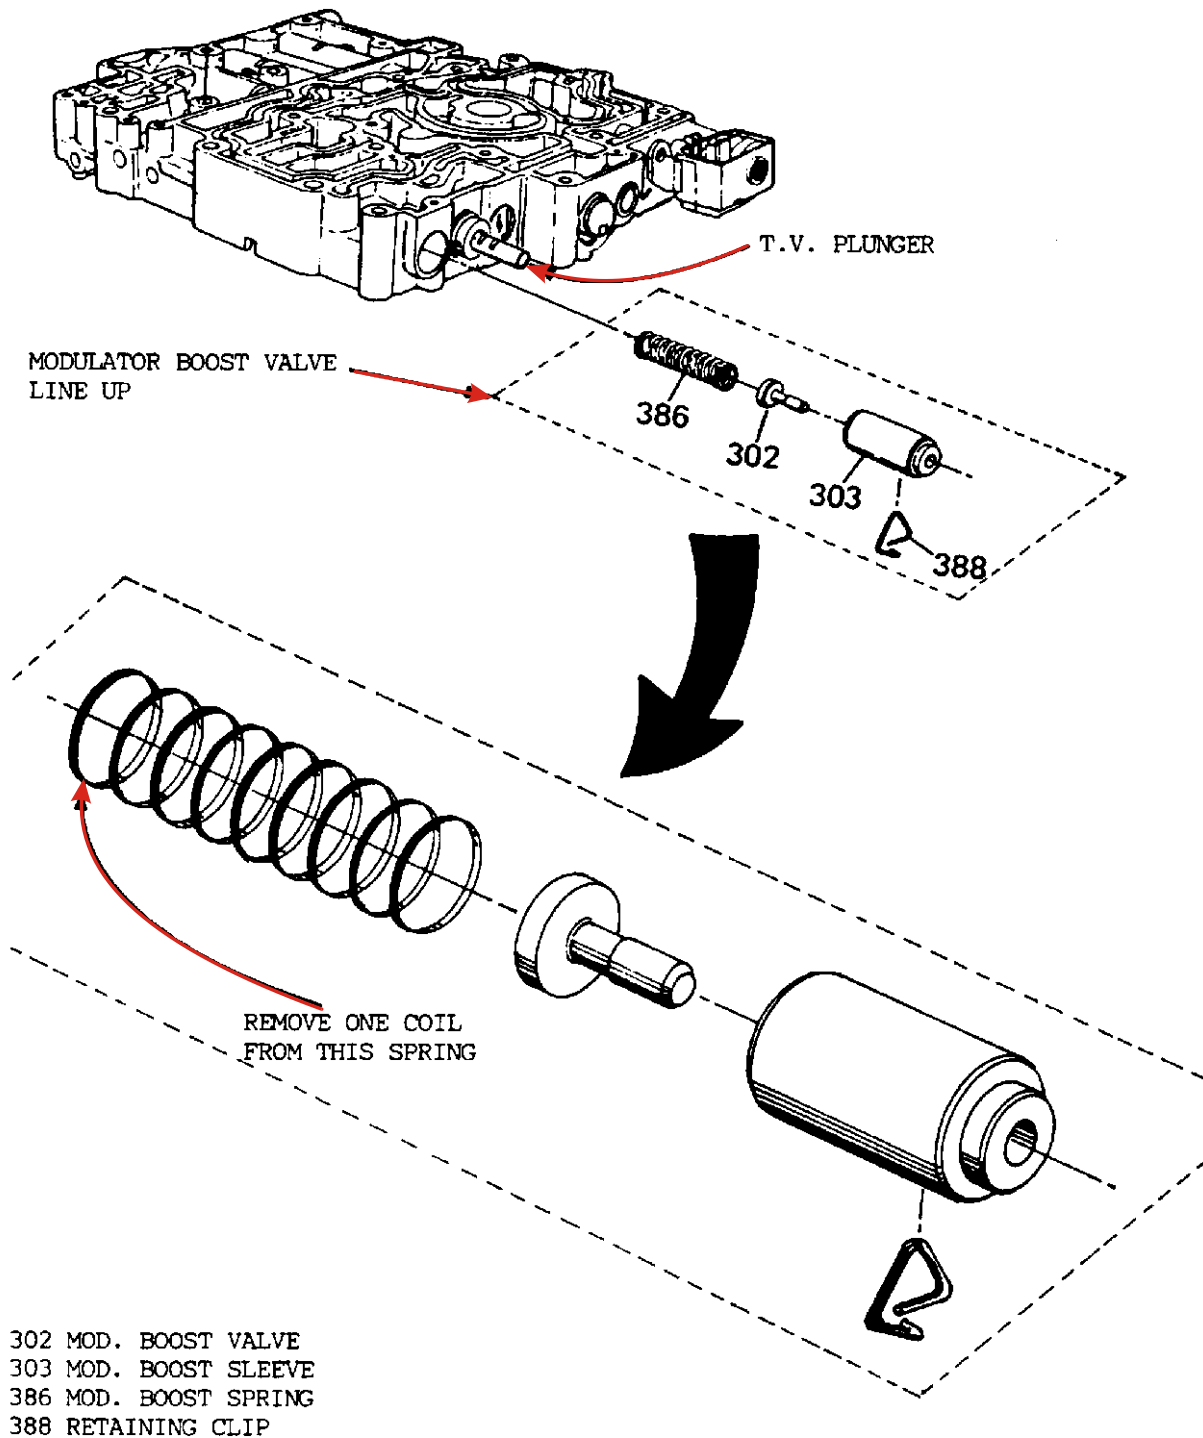
Figure 1

COMPLAINT: 2nd clutch pack with a very short life span, usually associated with a 1-2 slip, or a 1-2 slide bump.

CAUSE: The cause may be a lack of line pressure to sufficiently apply the 2nd clutch pack.

There are some valve body kits on the market that have a spring that you are told to install in this location. There are currently 3 different diameters of modulator boost valves, and 3 different spring calibrations. There is no way that 1 spring will operate "Properly" in all 3 applications.

CORRECTION: Shorten the modulator boost valve spring by 1/8", or approximately 1 coil. The modulator boost valve spring is located in the pressure regulator line up, which is directly next to the T.V. plunger in the valve body (See Figure 1). This will allow line pressure to rise at less of a throttle opening and greatly increase 2nd clutch durability. This modification should be done on all THM 440-T4 transaxles during the rebuilding process.
