Technical Service Information

THM 4T60-E ENGINE STALLS IN DRIVE ONLY DOES NOT STALL IN REVERSE

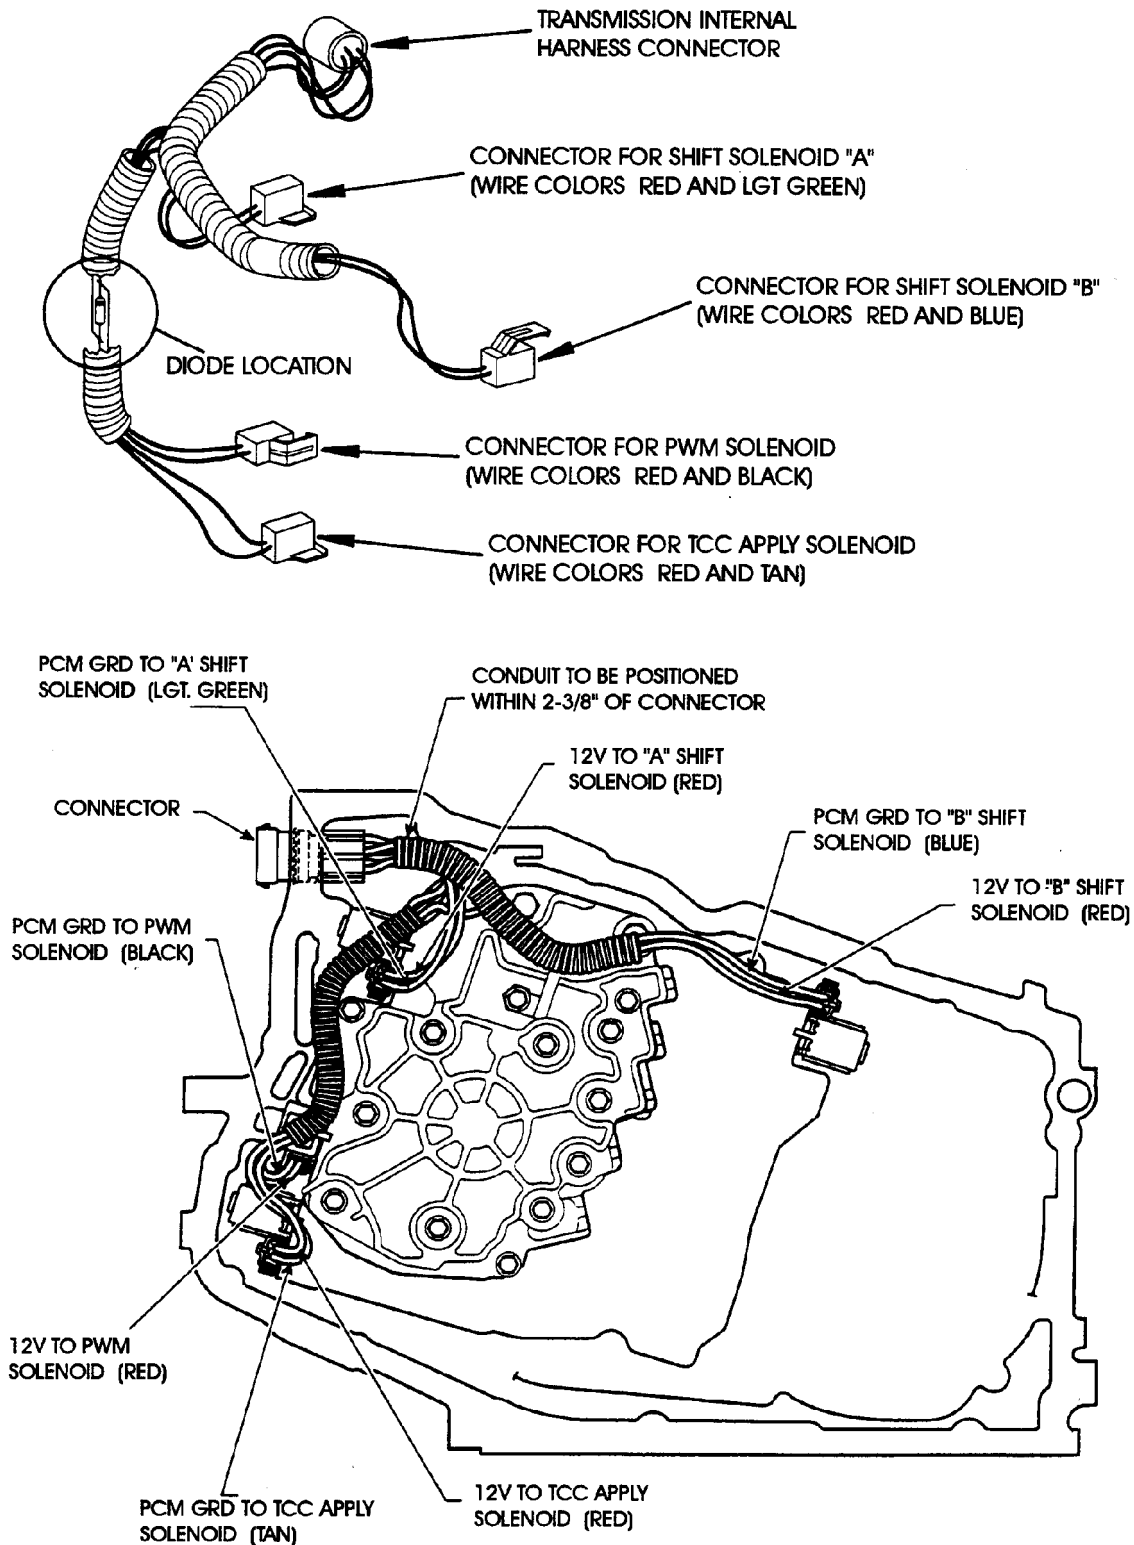
Figure 1

COMPLAINT: After rebuild, the vehicle will have a good reverse, but when the manual shift lever is placed into the Drive position, the engine will stall immediately.

CAUSE: The cause may be, the wires and connector for Shift Solenoid “B” and the TCC Apply Solenoid reversed. This can happen very easily when the wire conduit is removed from the internal wiring harness (See Figure 1). In this configuration, the transaxle will be in 4th gear, with the converter clutch applied when the selector lever is placed in Drive.

CORRECTION: Install the solenoid connectors in their proper locations. Most all of the 4T60-E transaxles, have the wire colors on the internal wire harness as shown in Figure 1. However, some models are different colors. To positively identify the wire and connector that belongs on the TCC Apply Solenoid, look for the diode in the harness (under shrink-wrap), as shown in Figure 1. The other long wires and connector will go to Shift Solenoid “B” regardless of the color of the ground wire, which could be Blue, Green, or Yellow, depending on the model.
