# Technical Service Information

## **THM 4L80-E NO REVERSE AND/OR BROKEN CASE**

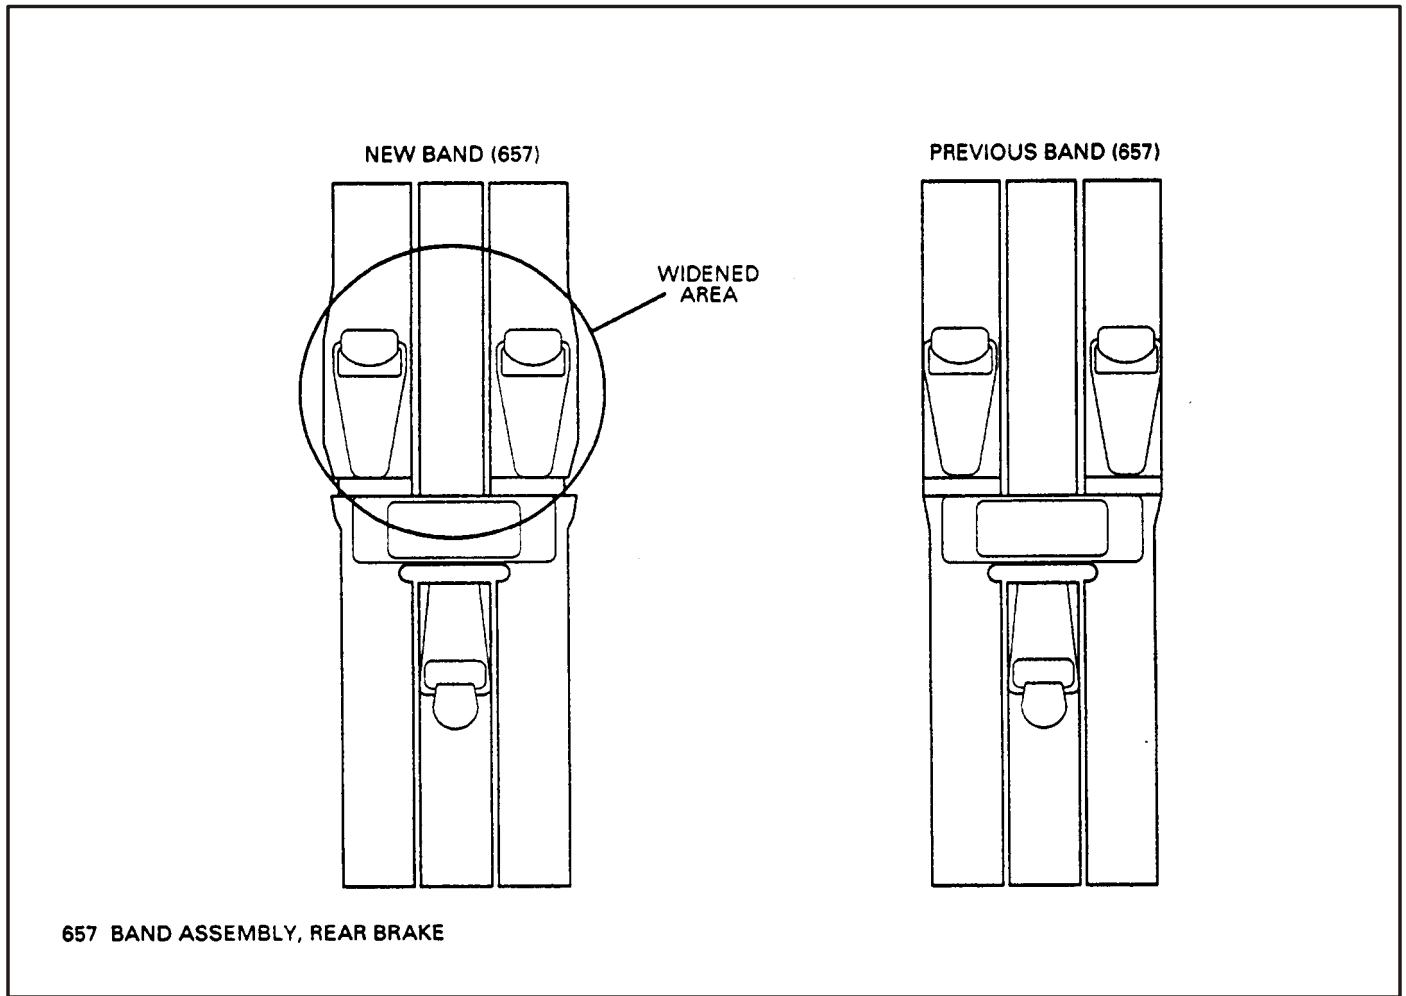
Figure 1

**COMPLAINT:** Some THM 4L80-E/4L80-E transmissions may experience a no reverse condition and/or a broken case assembly in the area of the rear band anchor pins.

**CAUSE:** This is caused by the lugs on the rear band assembly not holding on the case anchor pins, causing the reaction drum not to hold.

**CORRECTION:** Beginning on April 11, 1992 (Julian Date 101) all THM 4L80-E/4L80-EHD transmissions were built with a revised reverse band assembly which is wider in the band lug area (See Figure 1), and should be used during all rebuilds.

Reverse Band Assembly (New Design) ..... 8681620
