Technical Service Information

MITSUBISHI F4A40/50 SERIES HARSH DRIVE ENGAGEMENT OR 4-3 DOWNSHIFT AND OR HARSH OR FLARED 3RD GEAR UPSHIFT

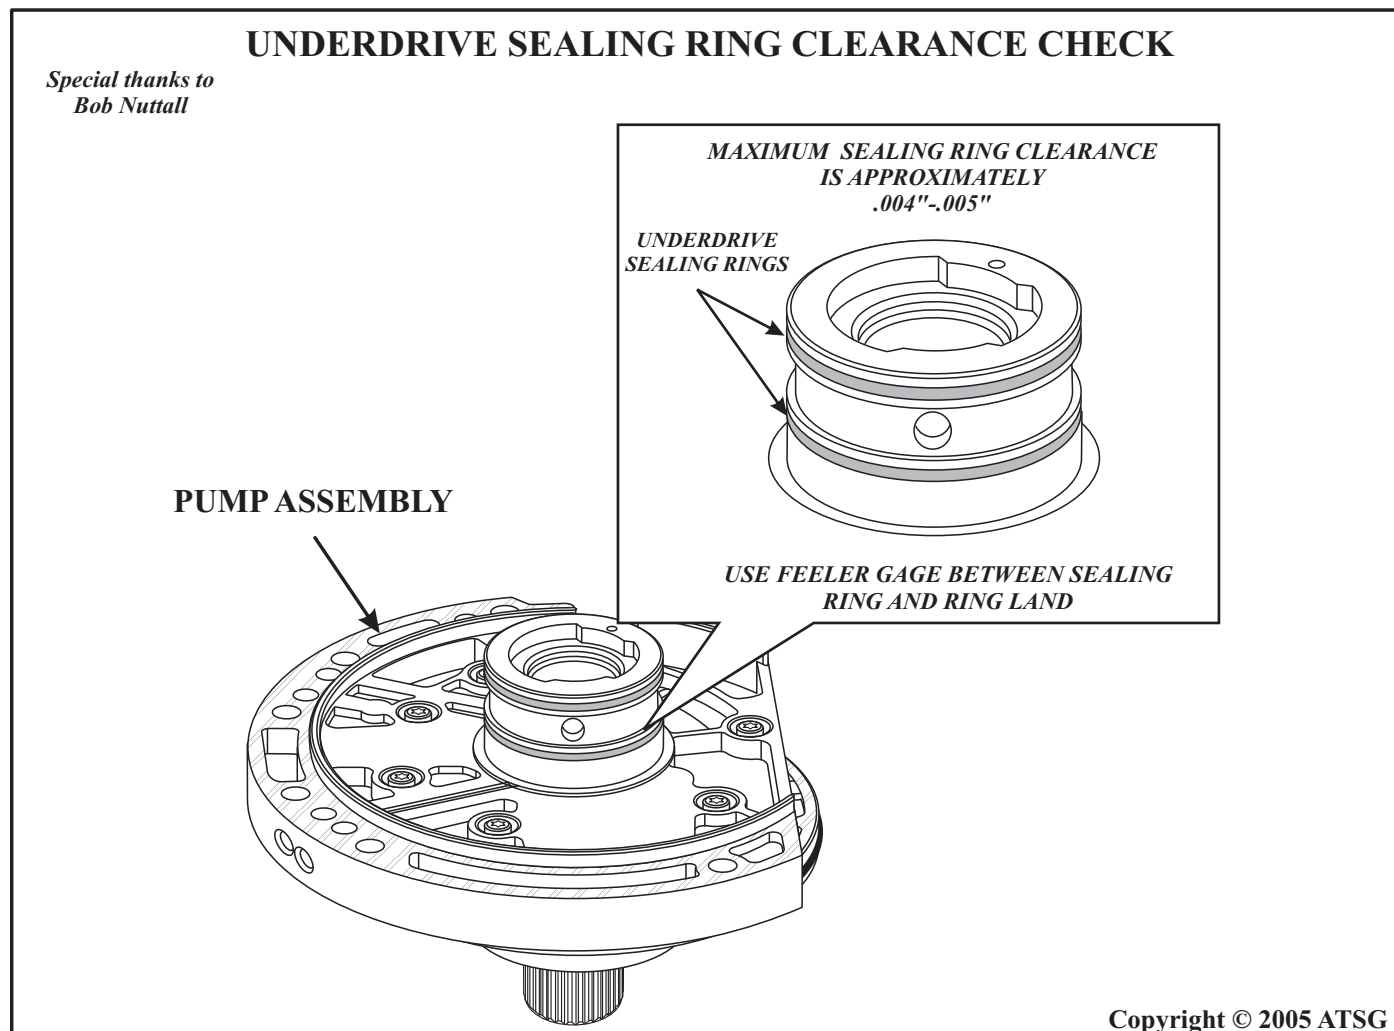
CAUSE: The cause may be, worn sealing ring lands where the Underdrive and or Overdrive Clutch sealing rings ride, creating leakage in the Underdrive or Overdrive Clutch circuit.

CORRECTION: Refer to Figure 1 to identify the Underdrive Clutch Sealing Rings. Using a feeler gage ensure that there is no more than .005" clearance between the sealing ring and the sealing ring lands. Repeat the same process for the Overdrive Clutch Sealing rings as shown in Figure 2. Replace the Pump stator or Rear Cover as necessary. **NOTE: Refer to Figure 3 and notice the "R-14" that is cast into the Pump Cover/Stator Support and Rear cover. This identifies a new design part which is made out of stronger material reducing ring land wear.**

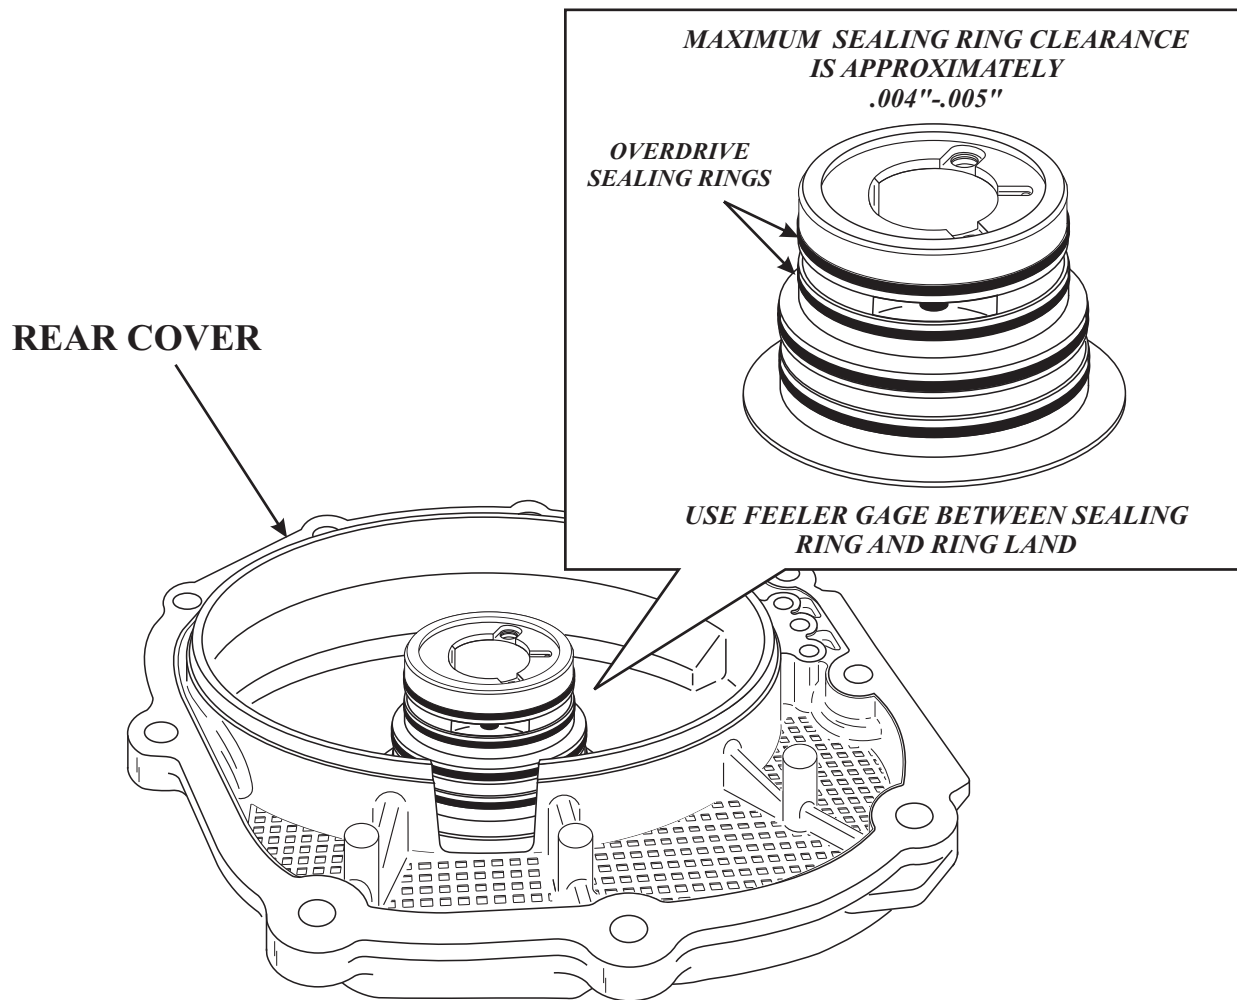
Figure 2

OVERDRIVE SEALING RING CLEARANCE CHECK

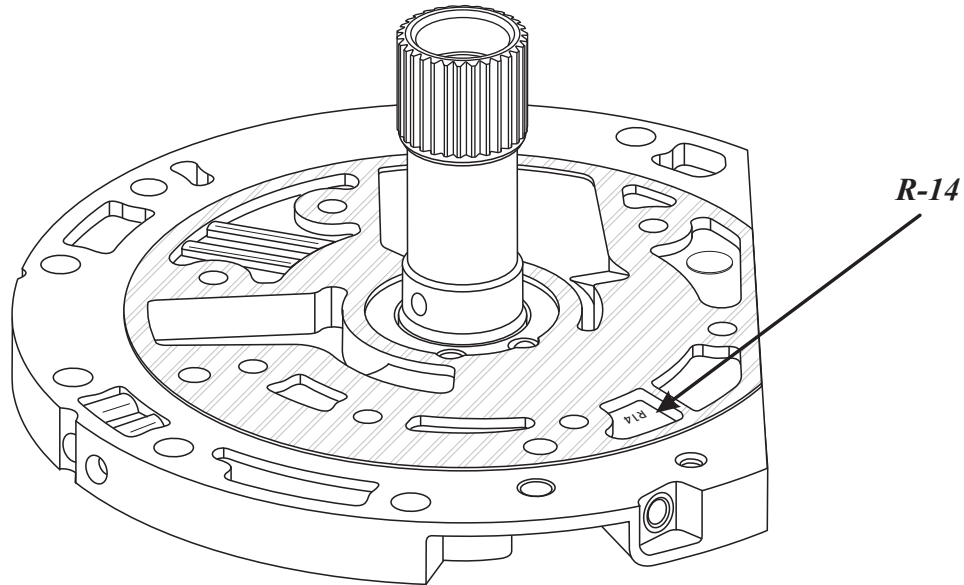
PUMP COVER/STATOR SUPPORT

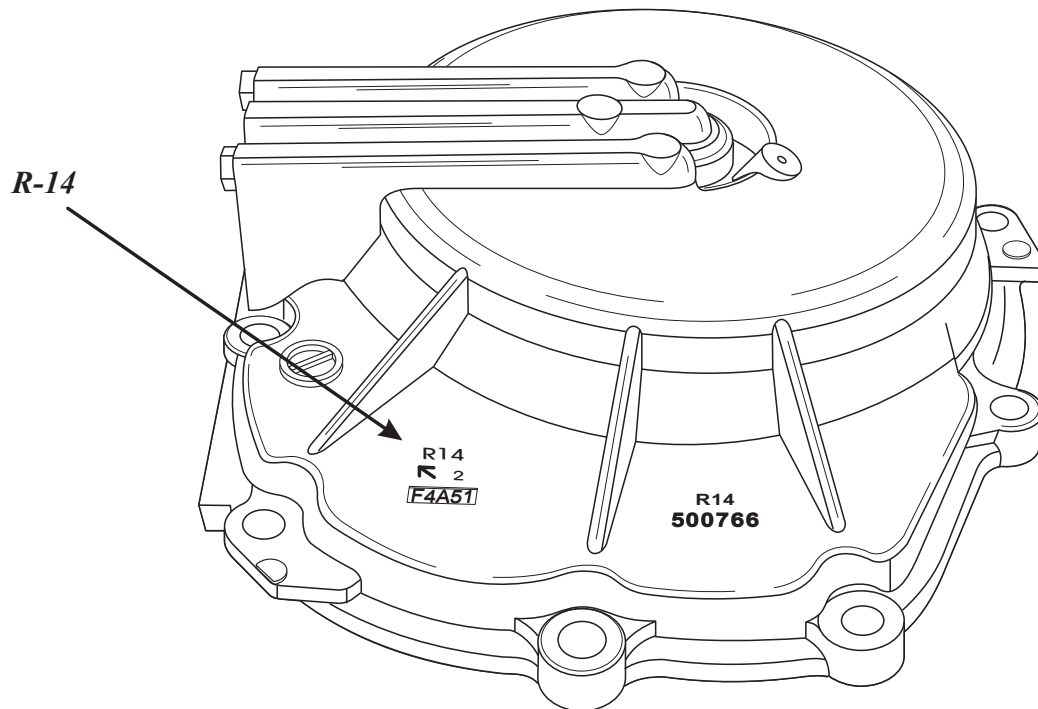
Figure 3

REAR COVER
