"VOLUME II"

INTRODUCTION

THM 440-T4 (4T60)

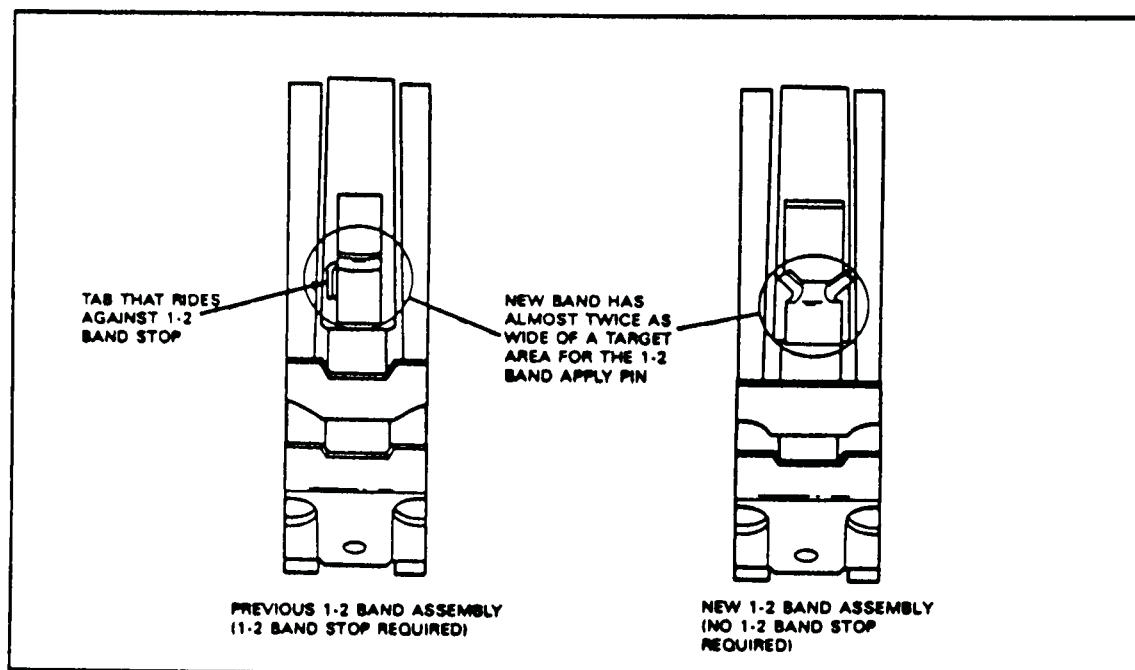
Figure 5

REASON: To eliminate the possibility of a intermittent "No Drive" condition.

- (1) 1-2 BAND ASSEMBLY - The target area on the new 1-2 band, where the band apply pin engages, has been made wider and has "Wings" added to prevent the pin from ever missing the "Target" area (See Figure 5).
- (2) 1-2 BAND STOP ASSEMBLY - The 1-2 Band Stop has been eliminated as it is no longer needed (See Figure 6).

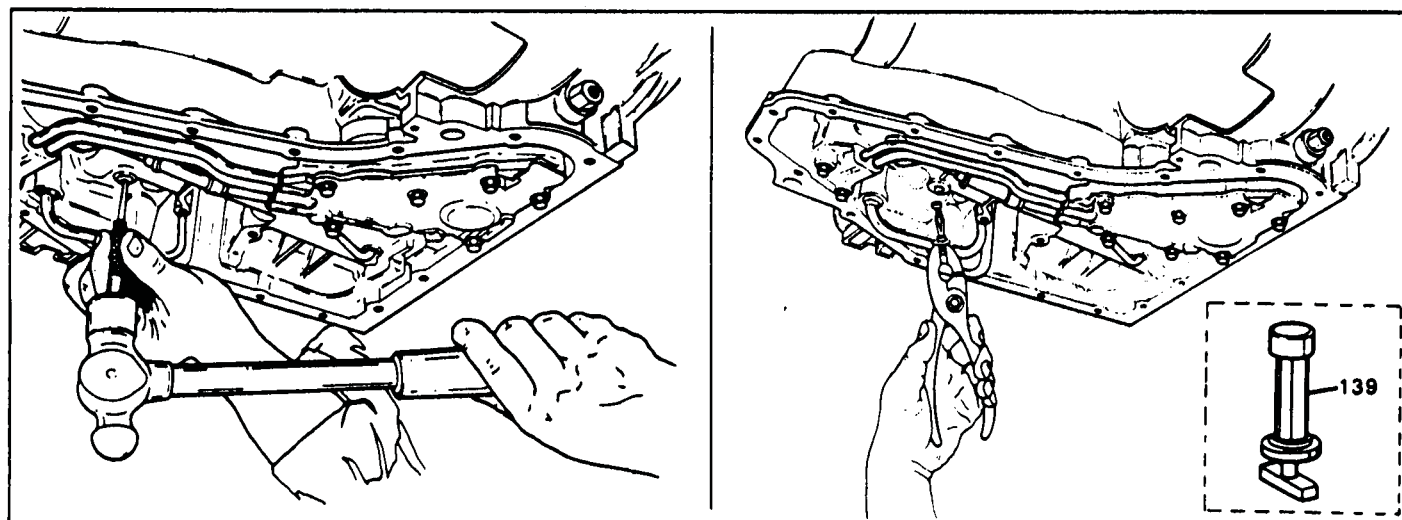
Figure 6

If the new 1-2 Band Assembly is used in a case with a 1-2 Band Stop, interference may result and band durability may be affected.

The new style 1-2 Band Assembly can be used to service ALL past models, but the 1-2 Band Stop MUST be removed and discarded (See Figure 6).

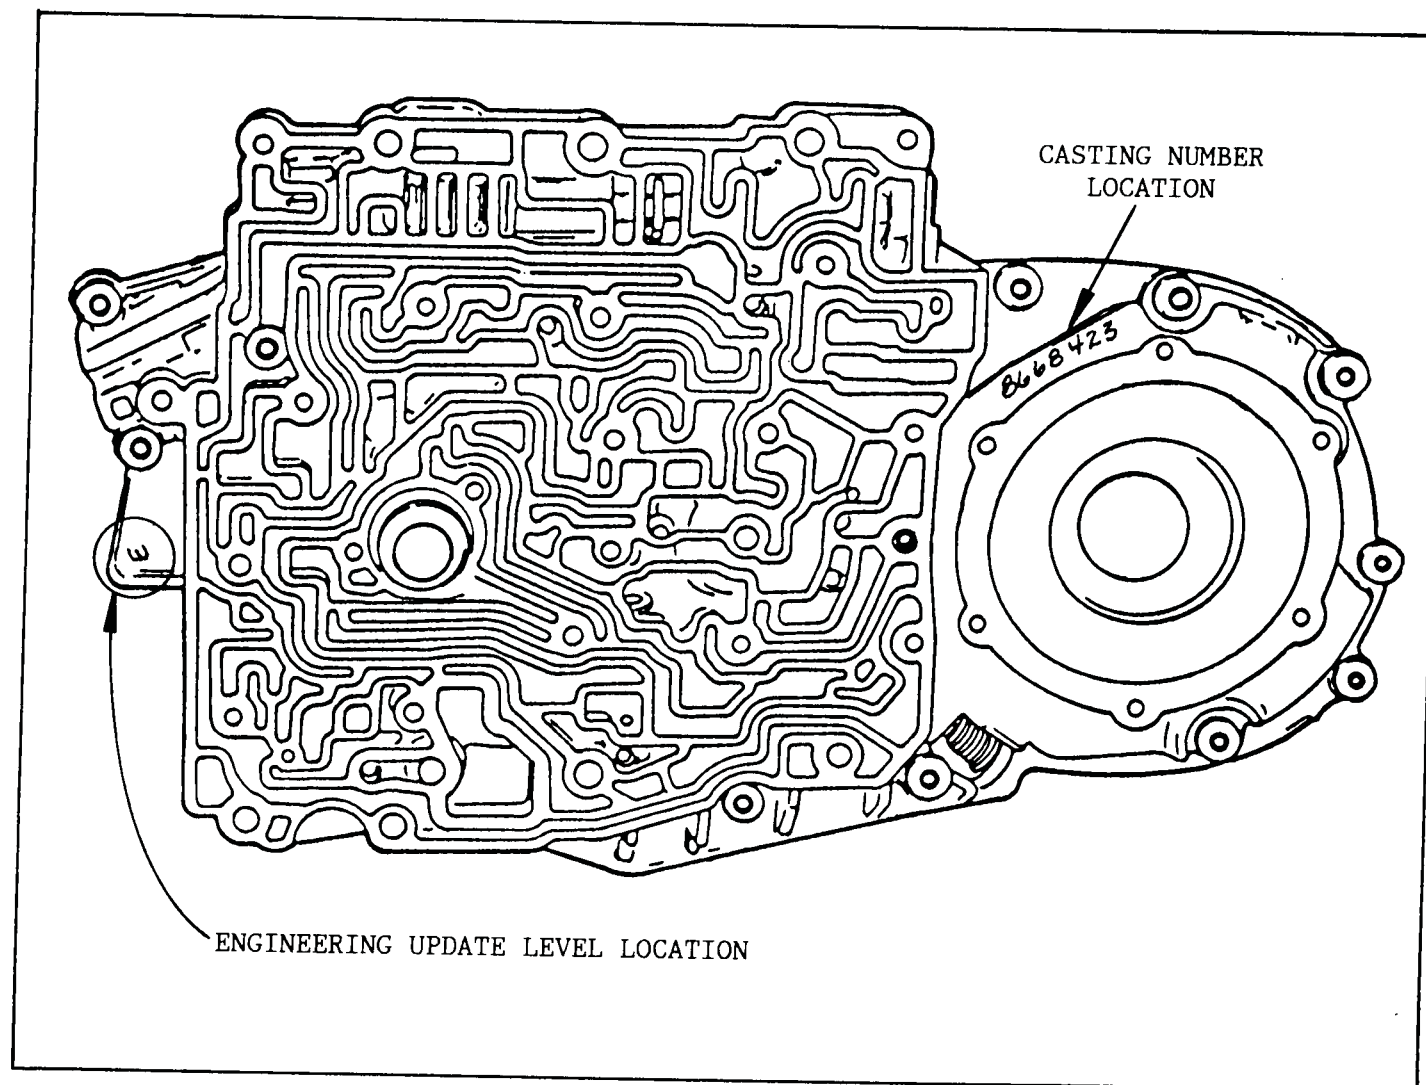
COMPLAINT: ON 1989 AND 1990 MODELS ONLY, the fourth clutch lined and steel plates burnt to the point that it has melted the channel plate in the fourth clutch area.

CAUSE: The cause may be the manual valve being positioned between the neutral and D4 position, which would allow the input clutch to be applied in 4th gear.

This was created by a change in the channel plate porting, in the manual valve area. The questionable channel plate can be identified by the casting number "8668423", with engineering update level "E". Refer to Figure 15 for locations. Casting number "8668423" with engineering update levels "A", "B", "C", and "D" are OK to use.

DO NOT USE CASTING NO. "8668423" WITH ENGINEERING UPDATE LEVEL OF "E" OR HIGHER - REFER TO FIGURE 15 FOR LOCATIONS.

CORRECTION: Install an earlier model channel plate that does not have the questionable casting number 8668423.

NEW CHANNEL PLATE - Will have porting changes for the new manual valve and new inside detent lever. The porting changes will help ensure that two ports will never be opened at once to cause burnt 4th clutch assembly. The bore for the new manual valve has been reduced by .010" to accommodate the new manual valve. This will make the previous and new parts non-interchangeable (See Figure 16).

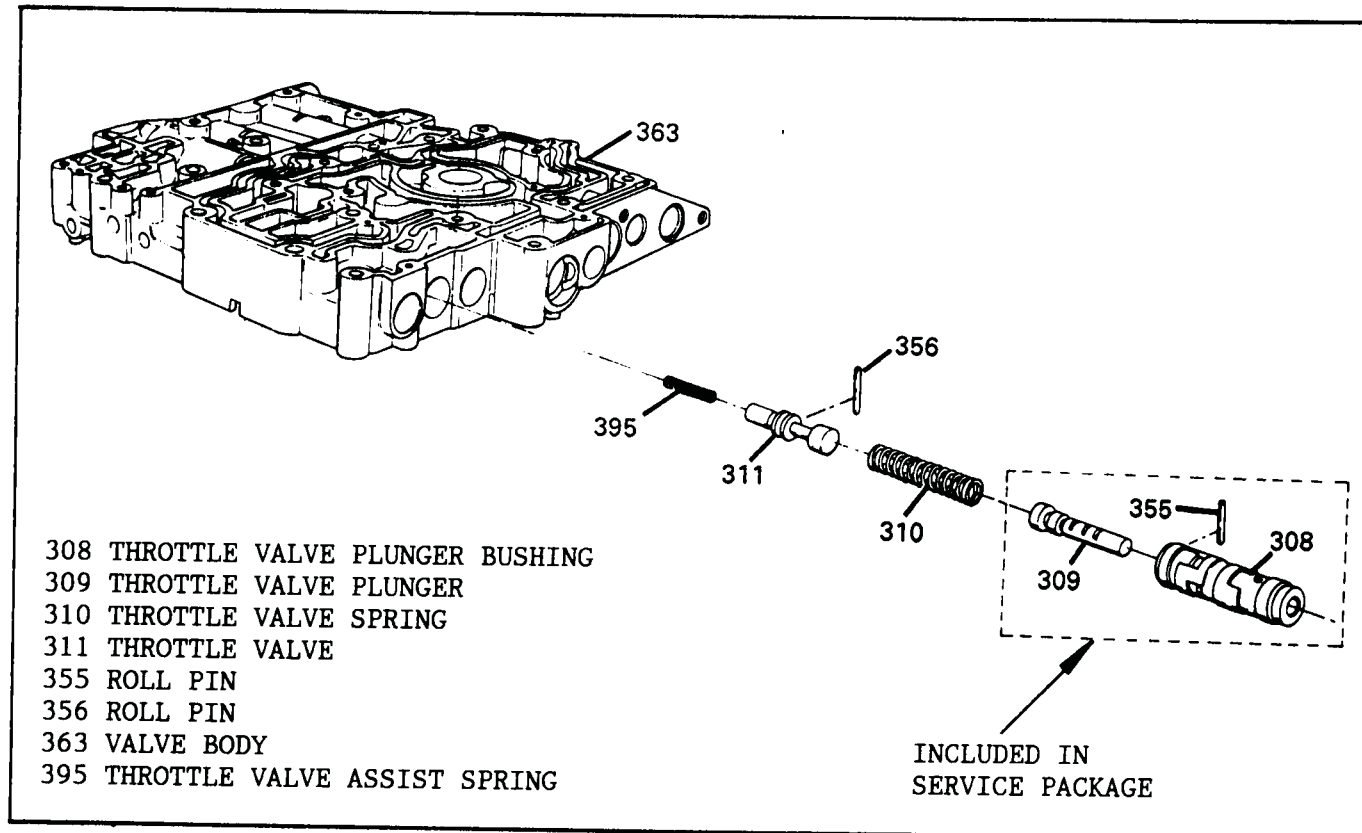
Figure 35

The T.V. Plunger and Bushing Assembly are now available from OEM in a service package, so that buying a valve body is no longer necessary when the TV plunger is broken or cracked (See Figure 35). Refer to the following OEM part numbers as it IS a model sensitive part.

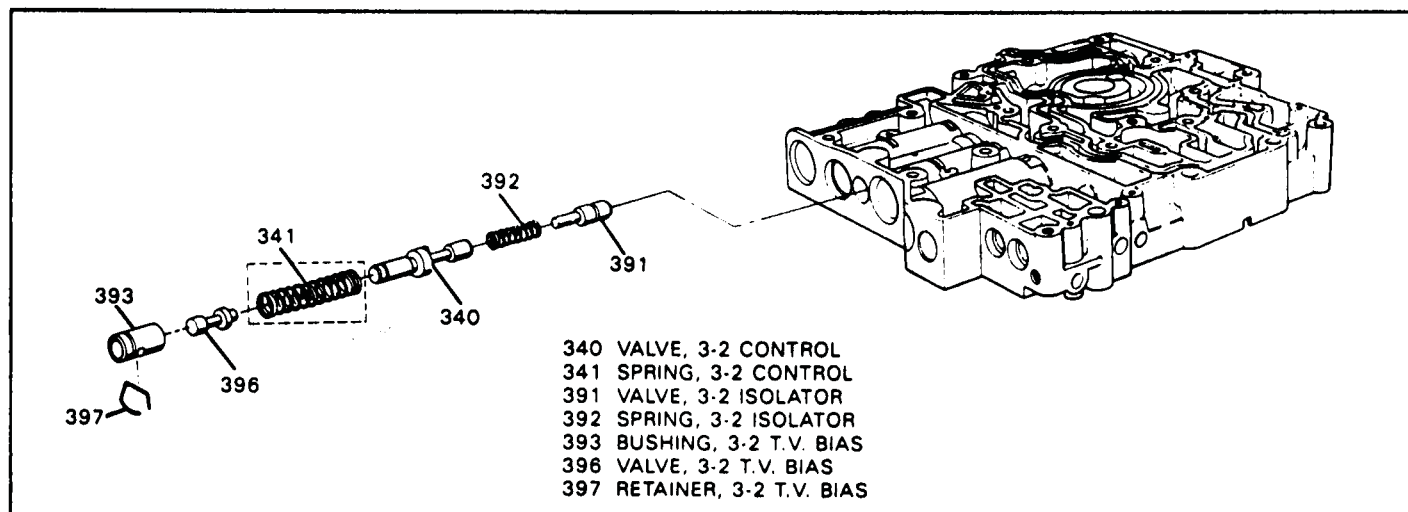
CAUSE: Improper timing for release of the third clutch and reapplication of the 1-2 band.

CORRECTION: Install a new 3-2 Control Valve Spring, now available in a service package from OEM. See "Service Information" on pages 43 and 44 for proper OEM part numbers. Refer to Figure 36 for proper installation. This IS a model sensitive part.

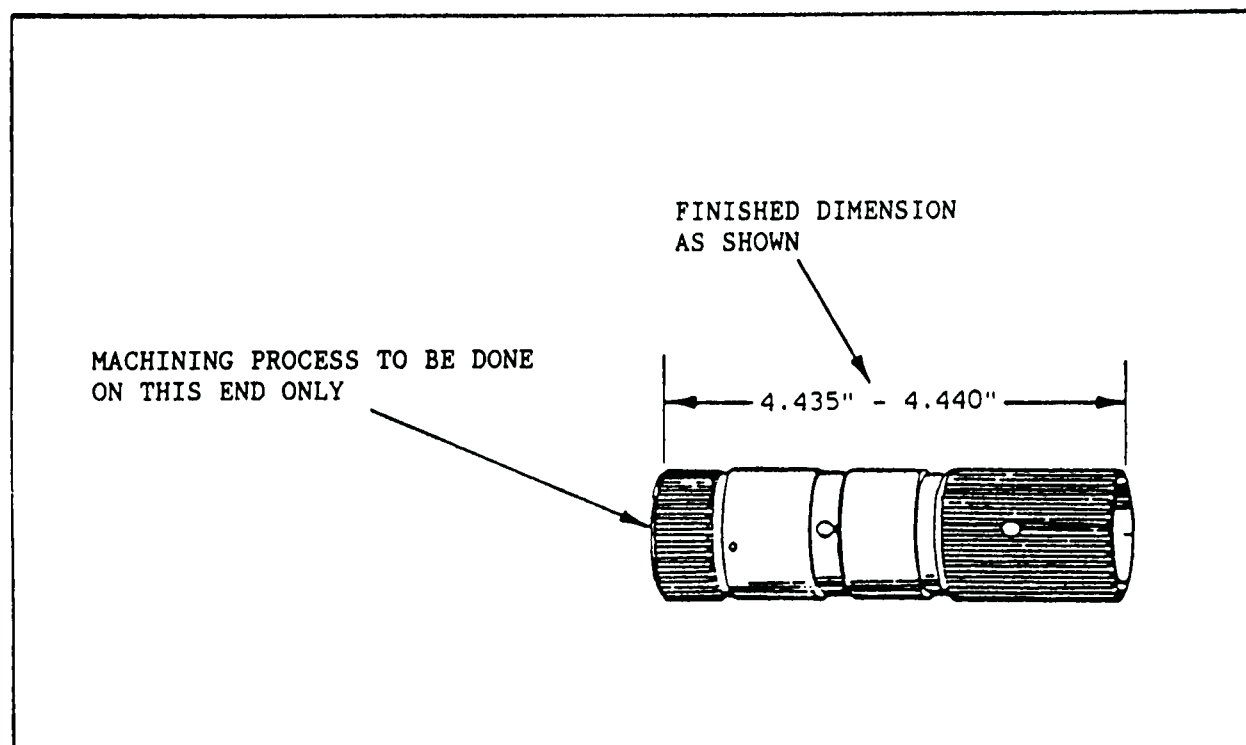
Figure 37

CAUSE: Final drive sun gear shaft is too long, and cuts or machines plastic lube dam in half.

CORRECTION: Machine or grind the final drive sun gear shaft, ON THE SHORT SPLINED END ONLY, to the dimension shown in Figure 37. Finished dimension should be 4.435" - 4.440". Non-machined final drive sun gear shaft will measure 4.480" - 4.490".

NOTE: MEASURE ALL FINAL DRIVE SUN GEAR SHAFTS TO INSURE PROPER LENGTH.

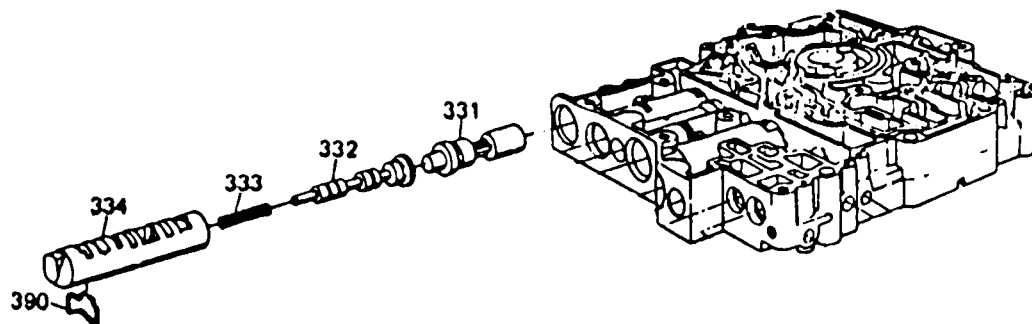
Figure 38

CAUSE: The cause may be the 1-2 shift valve sticking in the upshifted position (See Figure 38). The 1-2 shift valve is aluminum and might have a tendency to "Mushroom", caused by hitting the valve body casting in the bottom of the bore.

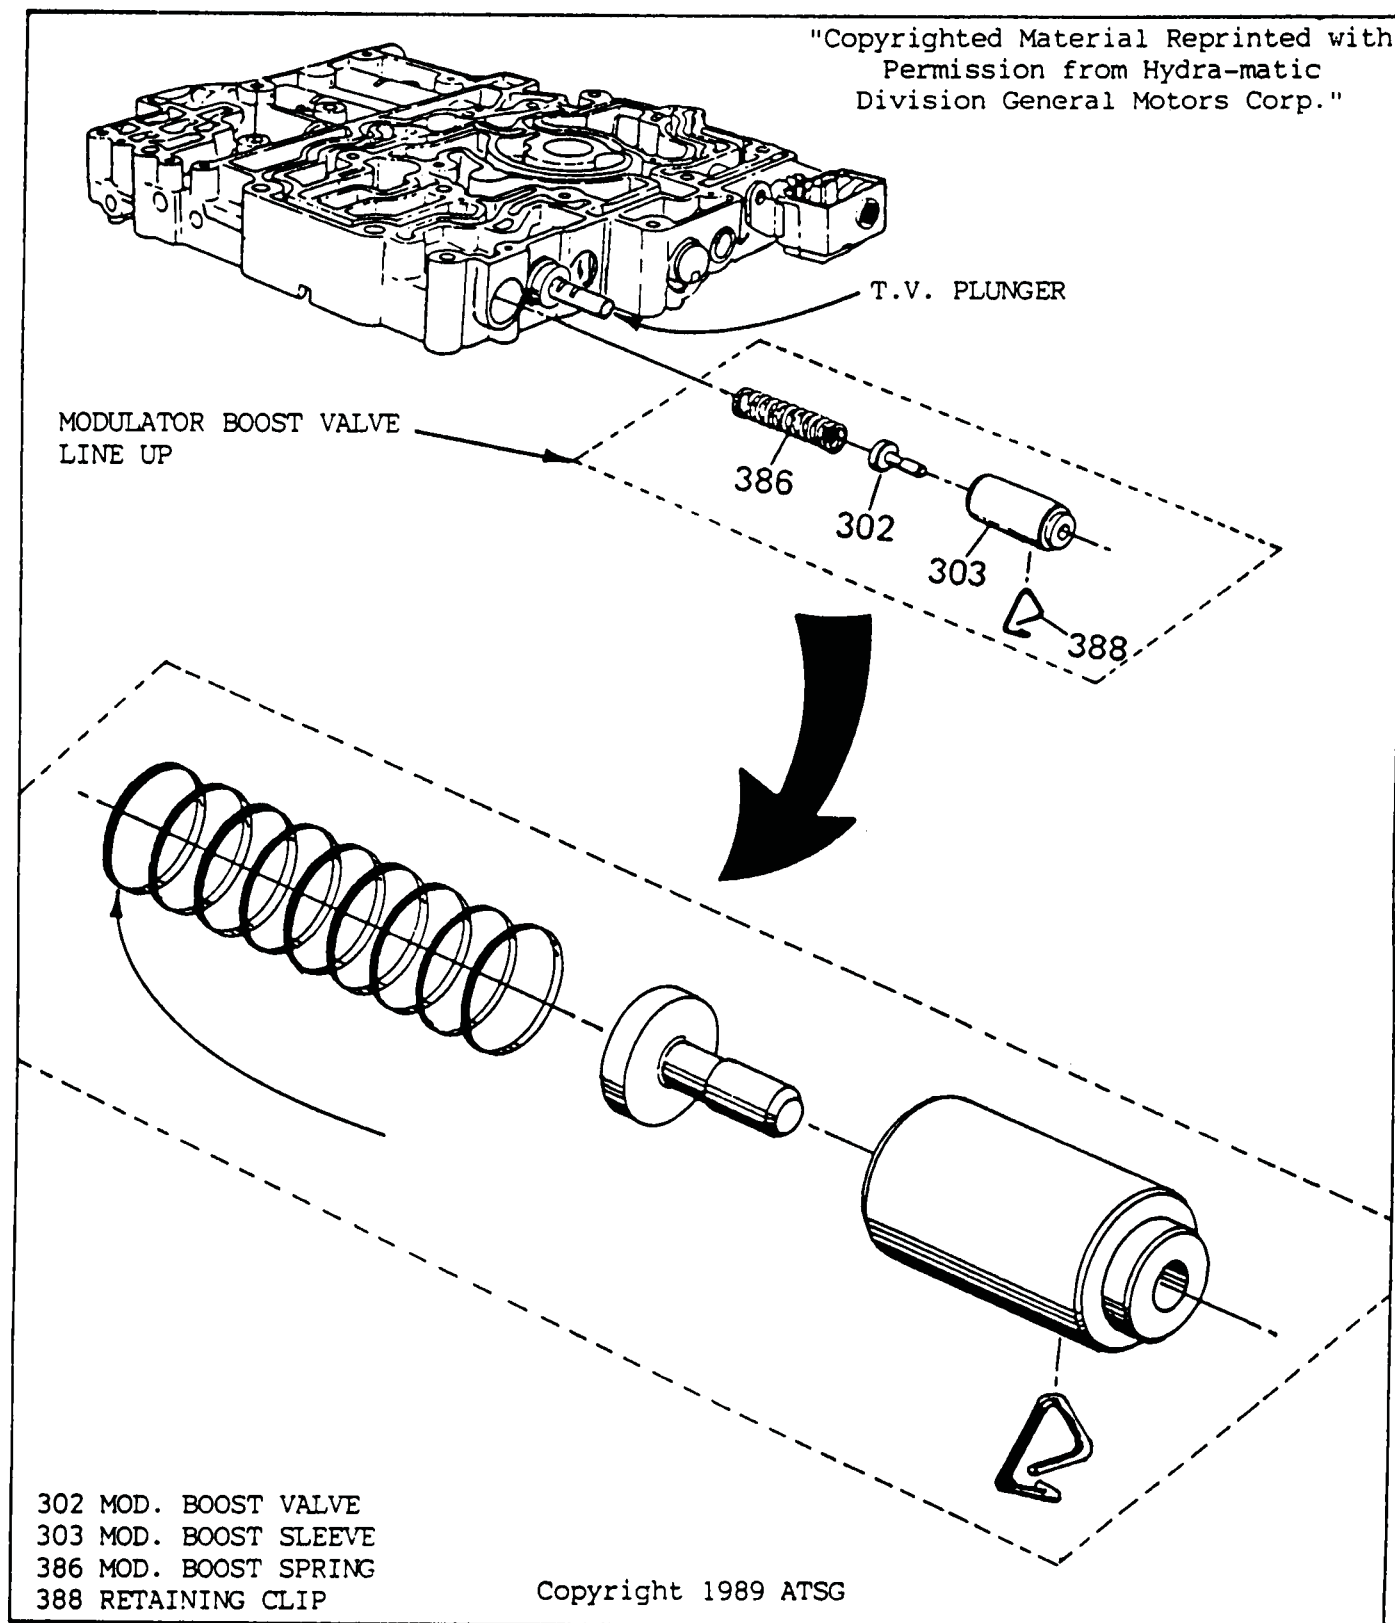
Figure 40

CAUSE: The cause may be a lack of line pressure rise to sufficiently apply the second clutch pack. We also recommend OEM "Koline" steel plates in this pack, and "Vespel" sealing rings on the driven sprocket support.
