Technical Service Information

THM 440-T4 MODULATOR VALVE "BUZZ" (CUP PLUG)

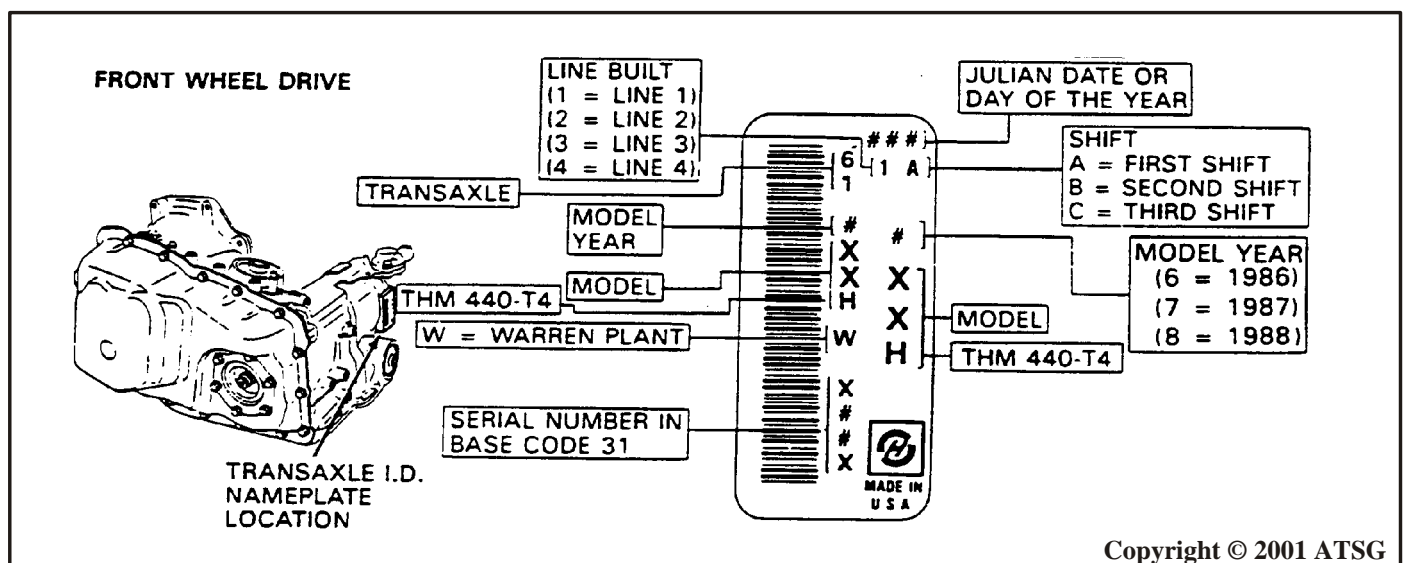
Figure 1

Bulletin Covers: (Figure 1)

Modulator valve buzz noise can be caused by a missing orificed cup plug in the modulator circuit of the channel plate for transaxles built prior to February 1, 1987 (Julian Date 032).
