FORD CD4E TURBINE SHAFT SPEED SENSOR MOUNTING SURFACE ON PUMP BODIES INCORRECT

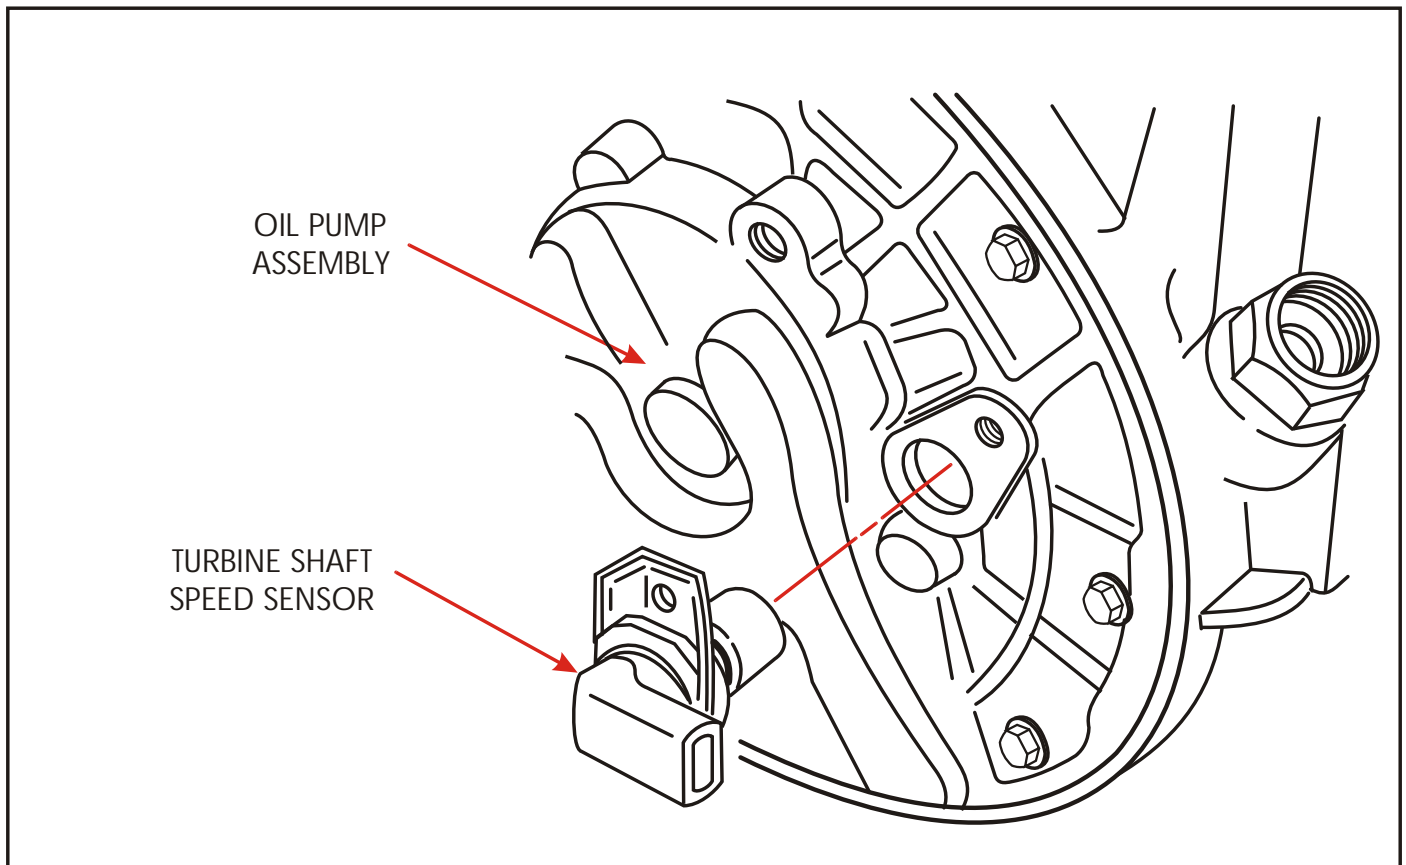
Figure 1

Some 1995 Contour, Probe and Mystique vehicles equipped with the CD4E transaxle, built from December 1994 through February 1995 with serial numbers 43350467 to 43370105 and 43410230 to 43420326 may have been assembled with incorrect turbine shaft speed sensor mounting surfaces on the pump bodies. The Turbine Shaft Speed Sensor (TSS) was modified to allow the TSS sensor to seat properly on these pump bodies. These TSS sensors were identified with a "Yellow" paint dot on the sensor itself in the location shown in Figure 2. The mis-machined pump bodies were identified with an "Orange" dot on the pump bodies in the location shown in Figure 2.

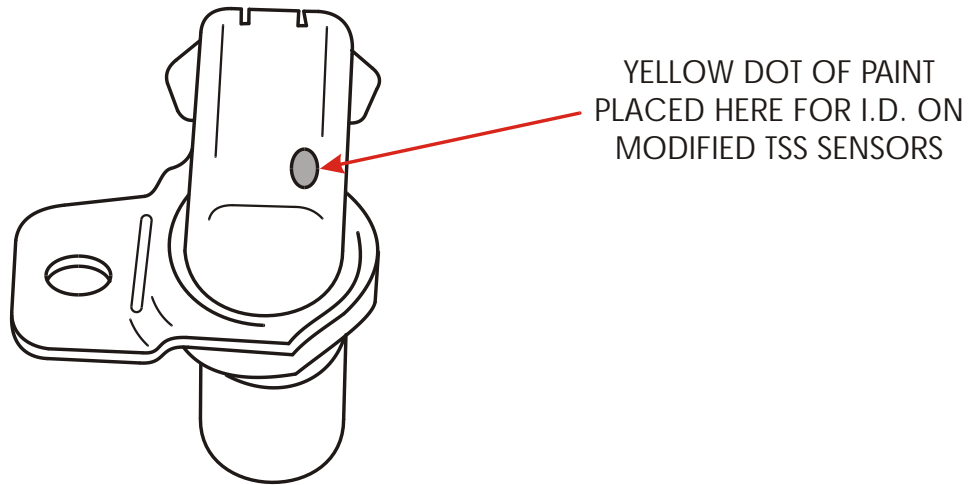
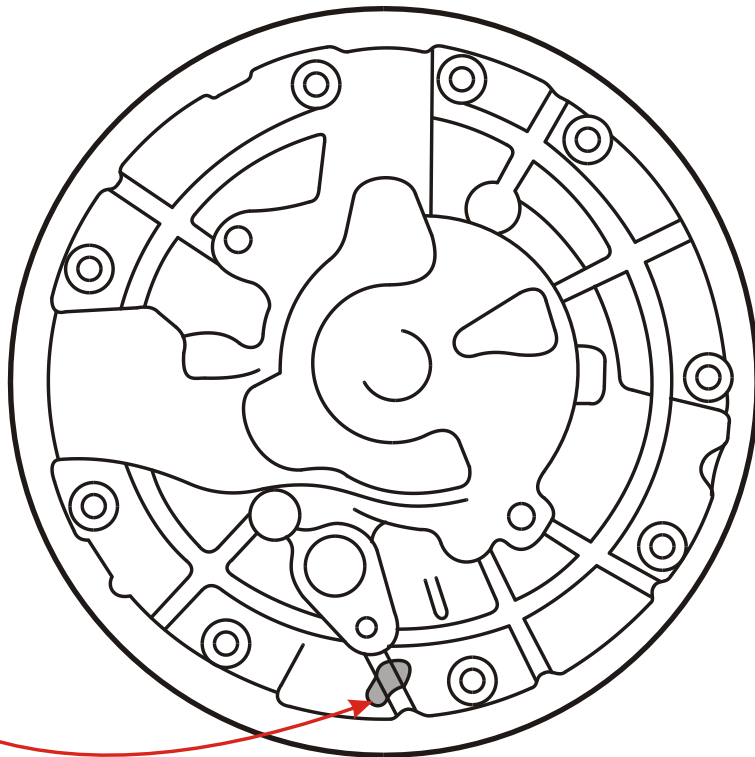
Figure 2

ORANGE DOT OF PAINT
PLACED HERE FOR I.D. ON
MIS-MACHINED PUMP BODIES

When servicing these units and TSS Sensor and/or Oil Pump assembly replacement is necessary, it will be mandatory that both pieces be replaced to prevent a clearance concern between the pump body and the Turbine Shaft Speed Sensor.
