# Technical Service Information

## TOYOTA A40 SERIES HARSH 1-2 SHIFT

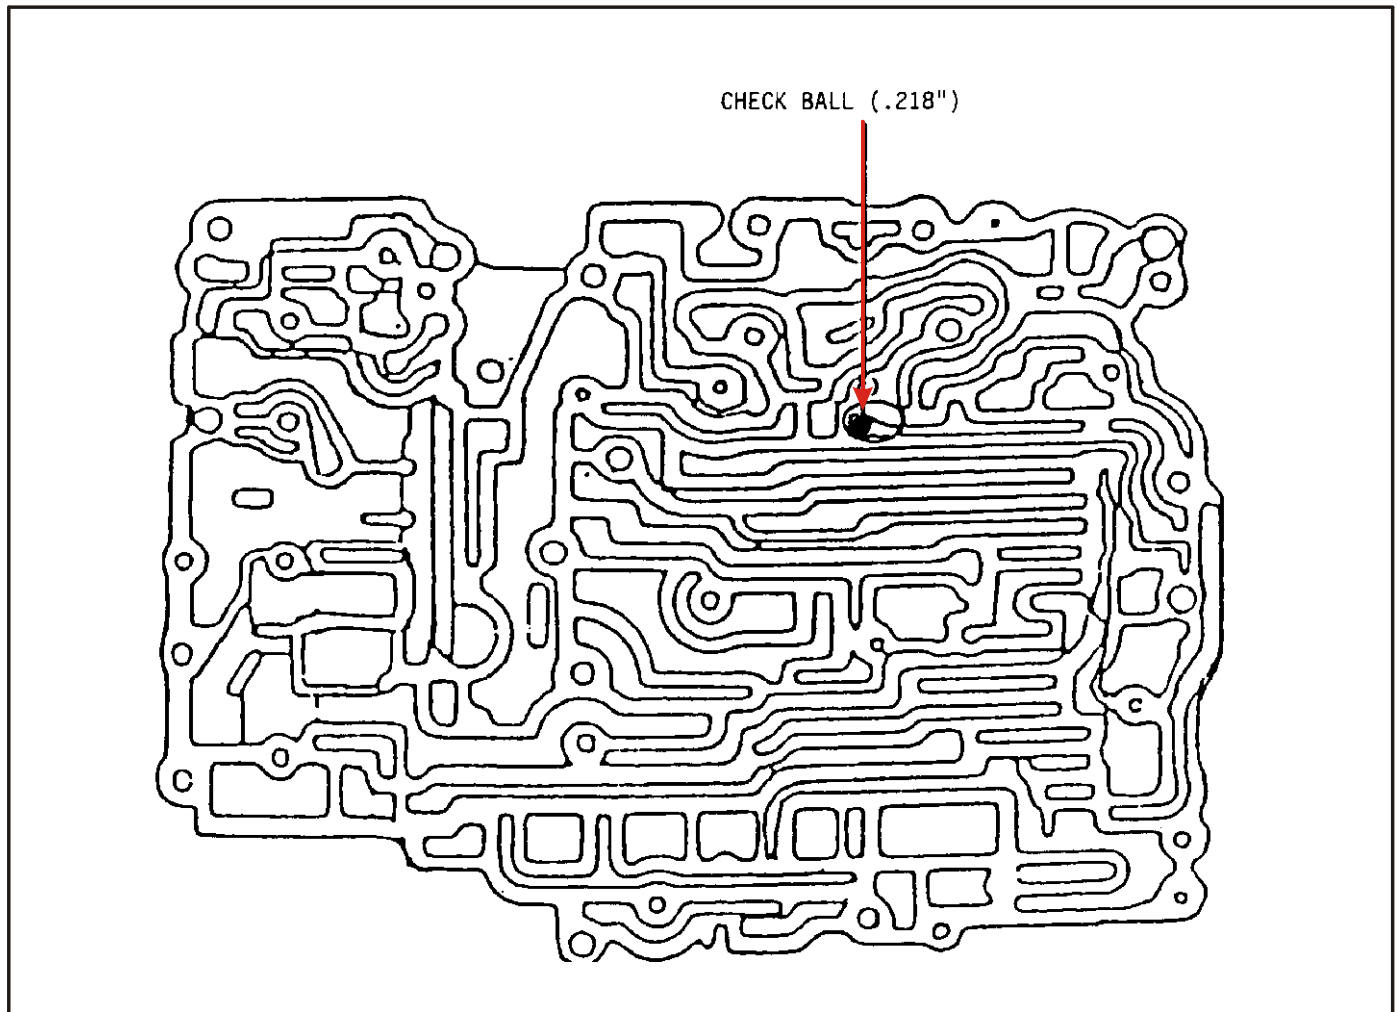
Figure 1  
AUTOMATIC TRANSMISSION SERVICE GROUP

**COMPLAINT:** Harsh 1-2 shift at all throttle positions.

**CAUSE:** Viton check ball missing, or off location.

**CORRECTION:** Install check ball in proper location (See Figure 1)
