Technical Service Information

THM 4T80-E

NEW DESIGN CENTER SUPPORT AND GASKET

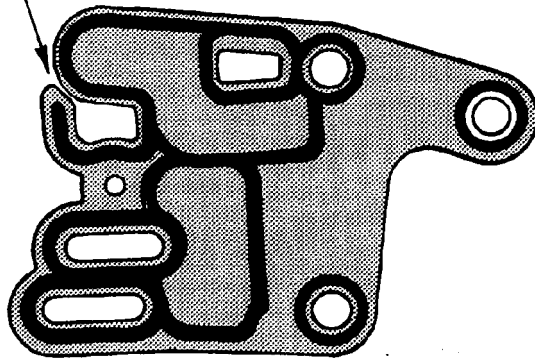
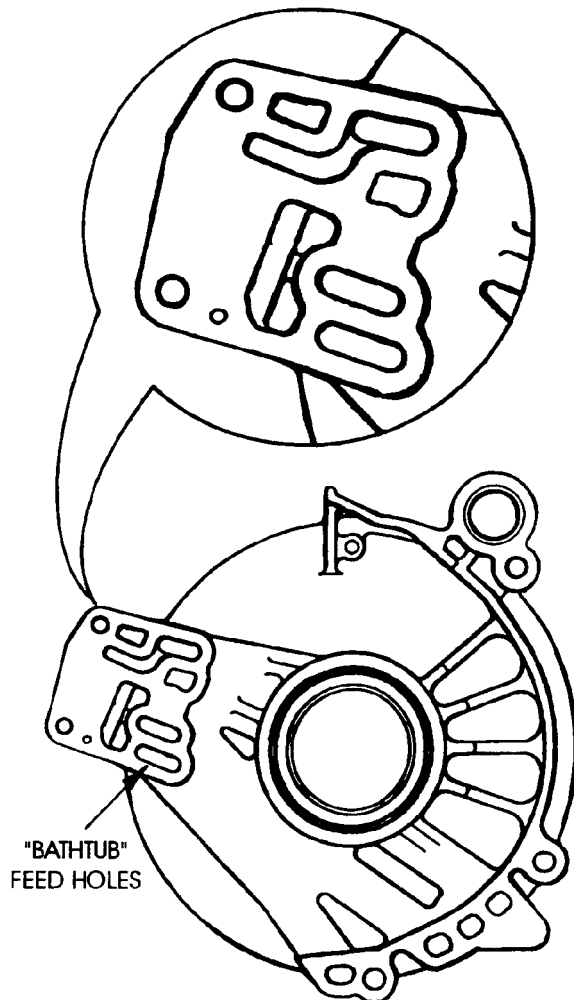
1993-1994 DESIGN LEVEL PARTS

SLOT IN
GASKET

NOTE POSITION OF BATHTUB
HOLES IN SUPPORT AND GASKET

"BATHTUB"
FEED HOLES

The Driven Sprocket Support Gaskets “WILL NOT” interchange. The 93-94 gasket must be used with the 93-94 sprocket support, and the 95-96 gasket must be used with the 95-96 sprocket support (See Figure 1).

Driven Sprocket Support Gasket (93-94 Model Only)	8683 149
Driven Sprocket Support Gasket (95-96 Model Only)	2420 1535

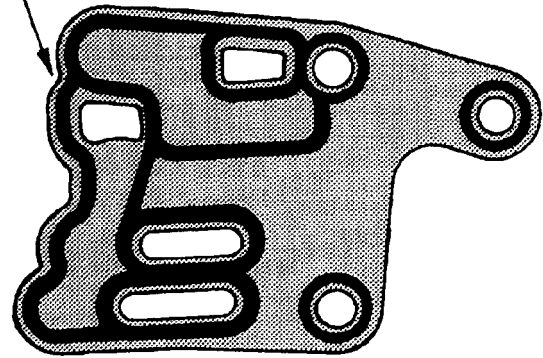
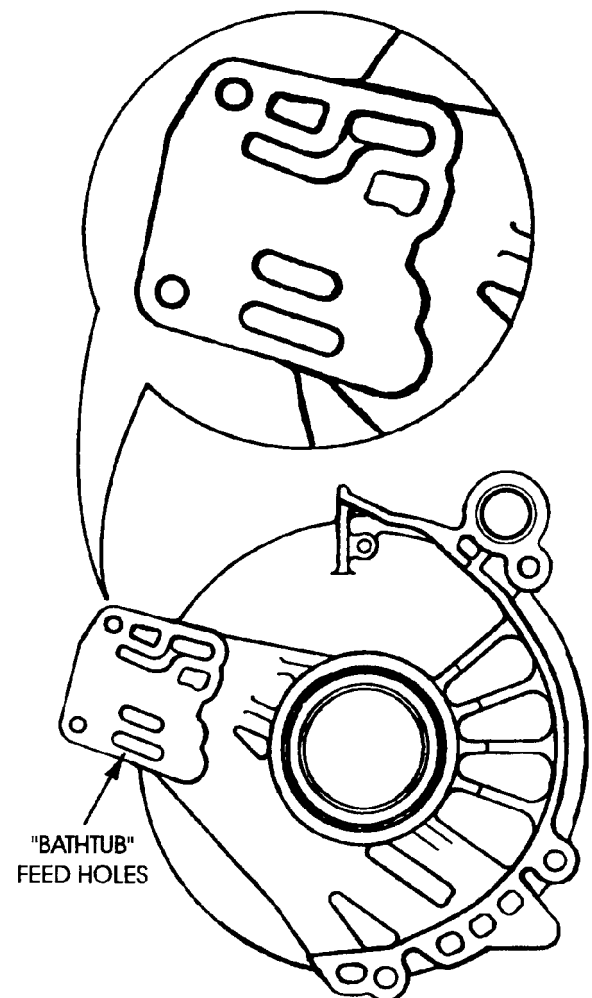
1995-1996 DESIGN LEVEL PARTS

(1) DRIVEN SPROCKET SUPPORT - New design level to accommodate 4 second clutch plates instead of the previous 3 second clutch plates. This required moving the two “Bathtub” feed holes in the Driven Sprocket Support (See Figure 1).

(2) SPROCKET SUPPORT GASKET - The two “Bathtub” feed holes in the gasket were moved to accommodate the new design sprocket support. The slot in the gasket was also removed on the new design gasket (See Figure 1).

NO SLOT IN
GASKET

NOTE "NEW" POSITION OF BATHTUB
HOLES IN SUPPORT AND GASKET

"BATHTUB"
FEED HOLES
