1996 SEMINAR INFORMATION

## "THE BEST FIX IN '96"

AUTOMATIC TRANSMISSION SERVICE GROUP  
9200 S. DADELAND BLVD. STE 720  
MIAMI, FLORIDA 33156  
(305) 670-4161

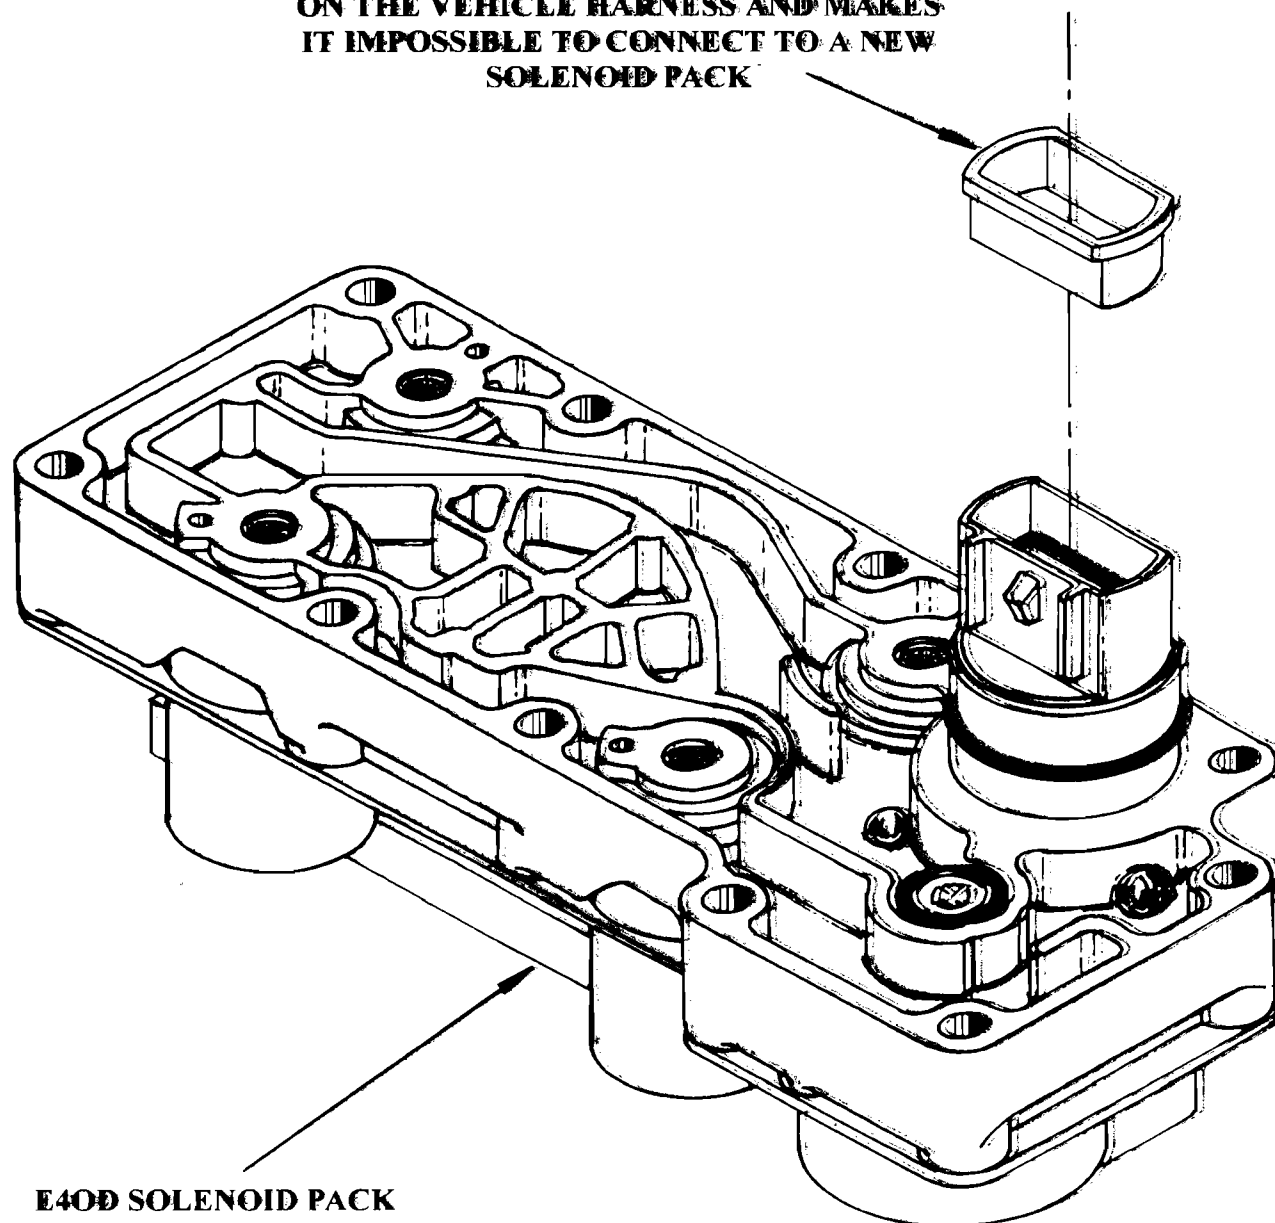
Figure 20

**1989-1994 SOLENOID PACK**

**PLASTIC SLEEVE SOMETIMES REMAINS  
ON THE VEHICLE HARNESS AND MAKES  
IT IMPOSSIBLE TO CONNECT TO A NEW  
SOLENOID PACK**

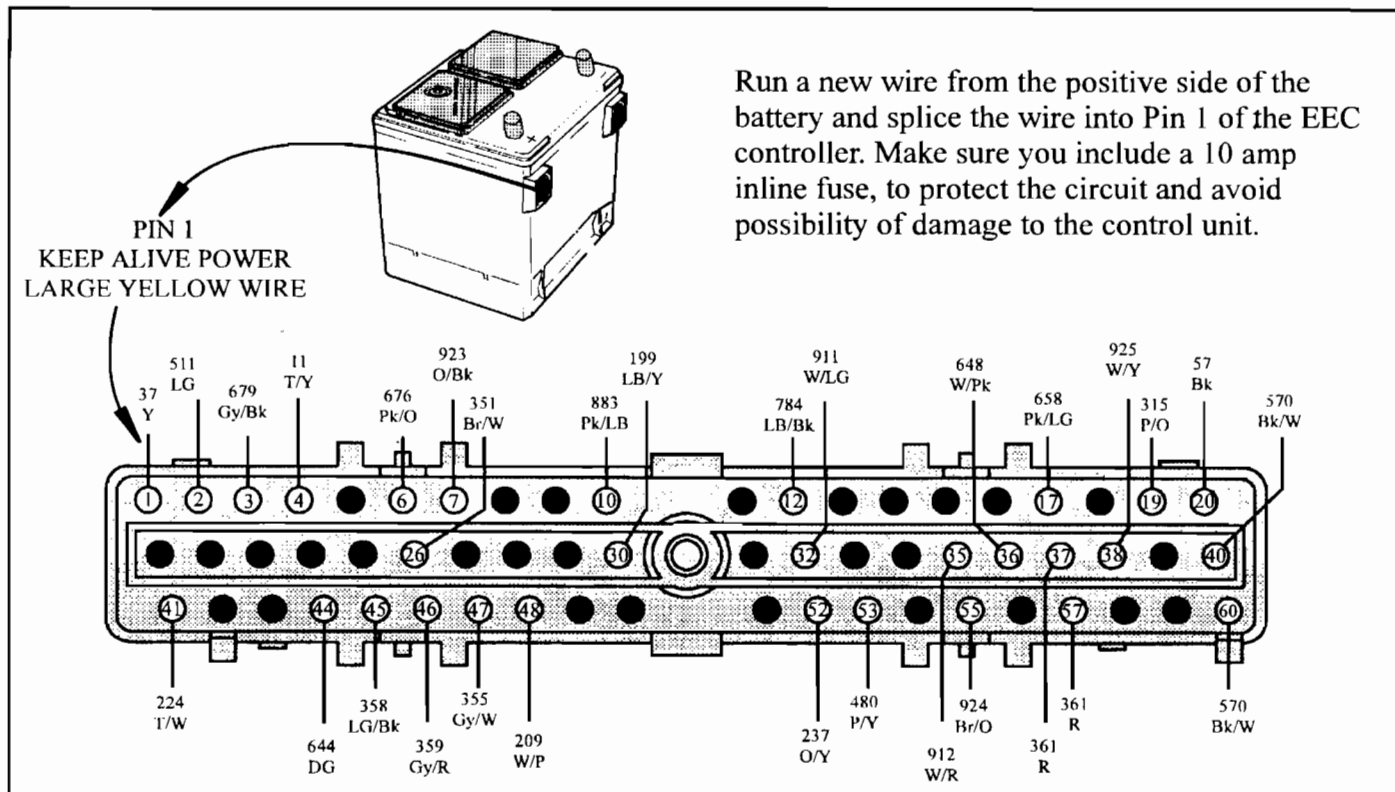
Figure 31

**CAUSE:** The cause may be, the computer losing Keep Alive Power (KAPW). Most ambulance manufacturers build the vehicles with a master power shutoff switch. When the drivers park the vehicle for any extended period of time, they turn the master switch to the "OFF" position. When the master switch is turned off, Keep Alive Power (KAPW) is lost to the TECA controller, and it goes brain dead. This allows the computer to *forget* what 1 to 1 ratio is, and it must be relearned before driving again, otherwise trouble code 62 may be set again.

**CORRECTION:** Start the vehicle, cancel overdrive, and drive the vehicle for approximately 3 miles at a speed of 45-55 MPH. After 3 miles cycle the overdrive cancel button to go into 4th gear and return to the shop. Before turning the master switch off, run a new wire with a 10 amp inline fuse from the battery positive terminal and splice into terminal No. 1 at the TECA controller, as shown in Figure 31. This will eliminate KAPW from being lost when the master power shutoff switch is turned off, and the problem should be resolved.

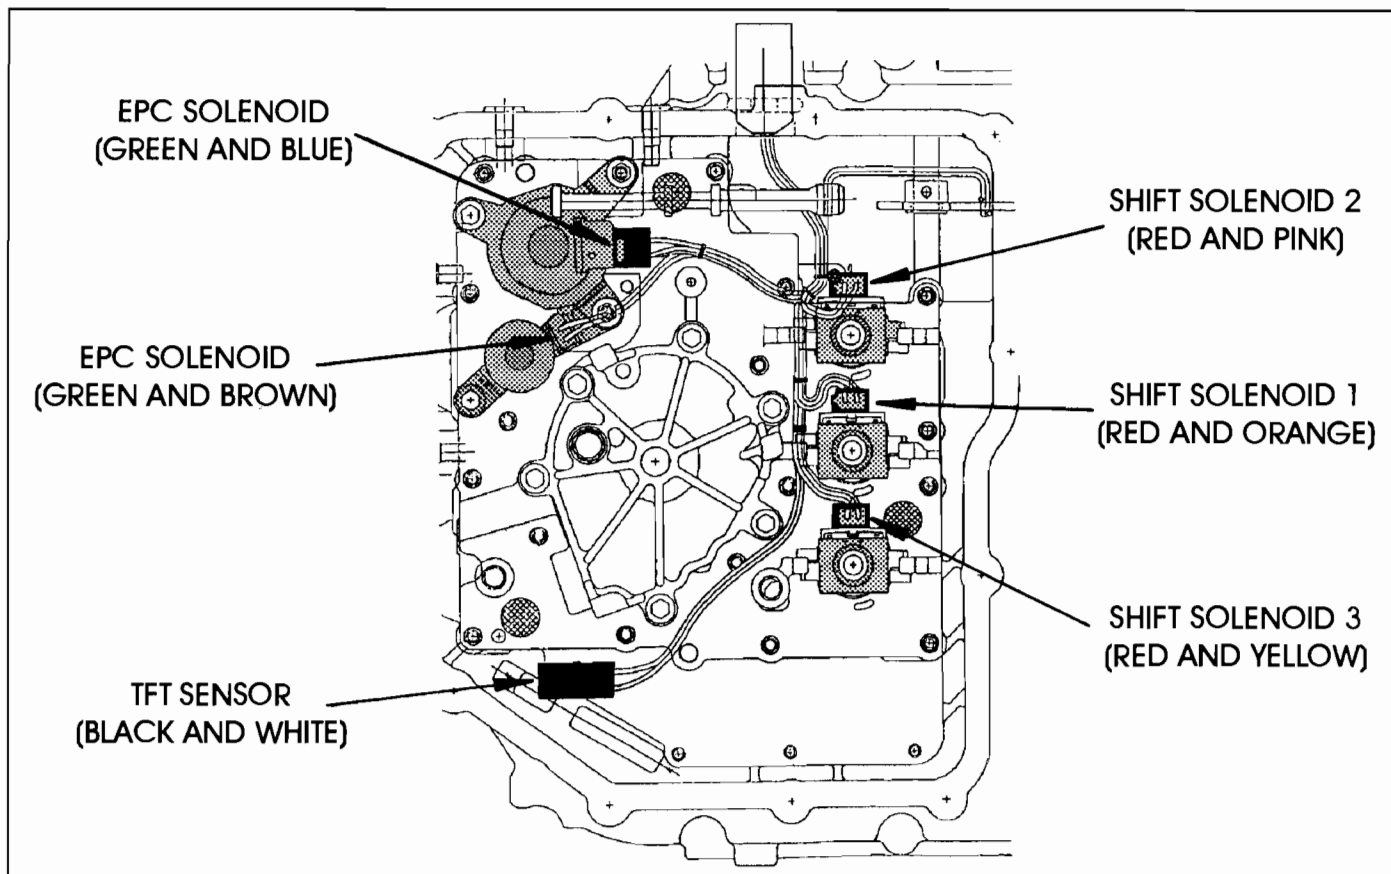
**COMPLAINT:** *After rebuild*, harsh shifts (High Line) and/or a "Clicking" or cycling noise may be heard from the side cover area, that is usually accompanied by an ON/OFF bind-up sensation that coincides with the "Clicking" noise. These symptoms may be accompanied with Diagnostic Trouble Code (DTC) 652 (MCCC Shorted or Open Circuit), DTC 624 (EPC Circuit Failure), and/or one Shift Solenoid DTC 621, 622, or 624.

**CAUSE:** The cause may be, solenoid wire connectors installed on the wrong solenoids.

**CORRECTION:** Connect the internal wiring harness connectors to their proper solenoids, using the wire colors, as shown in Figure 1 and 2. Proper connection of solenoids can also be verified externally through the case connector using the Ohms chart in Figure 2.

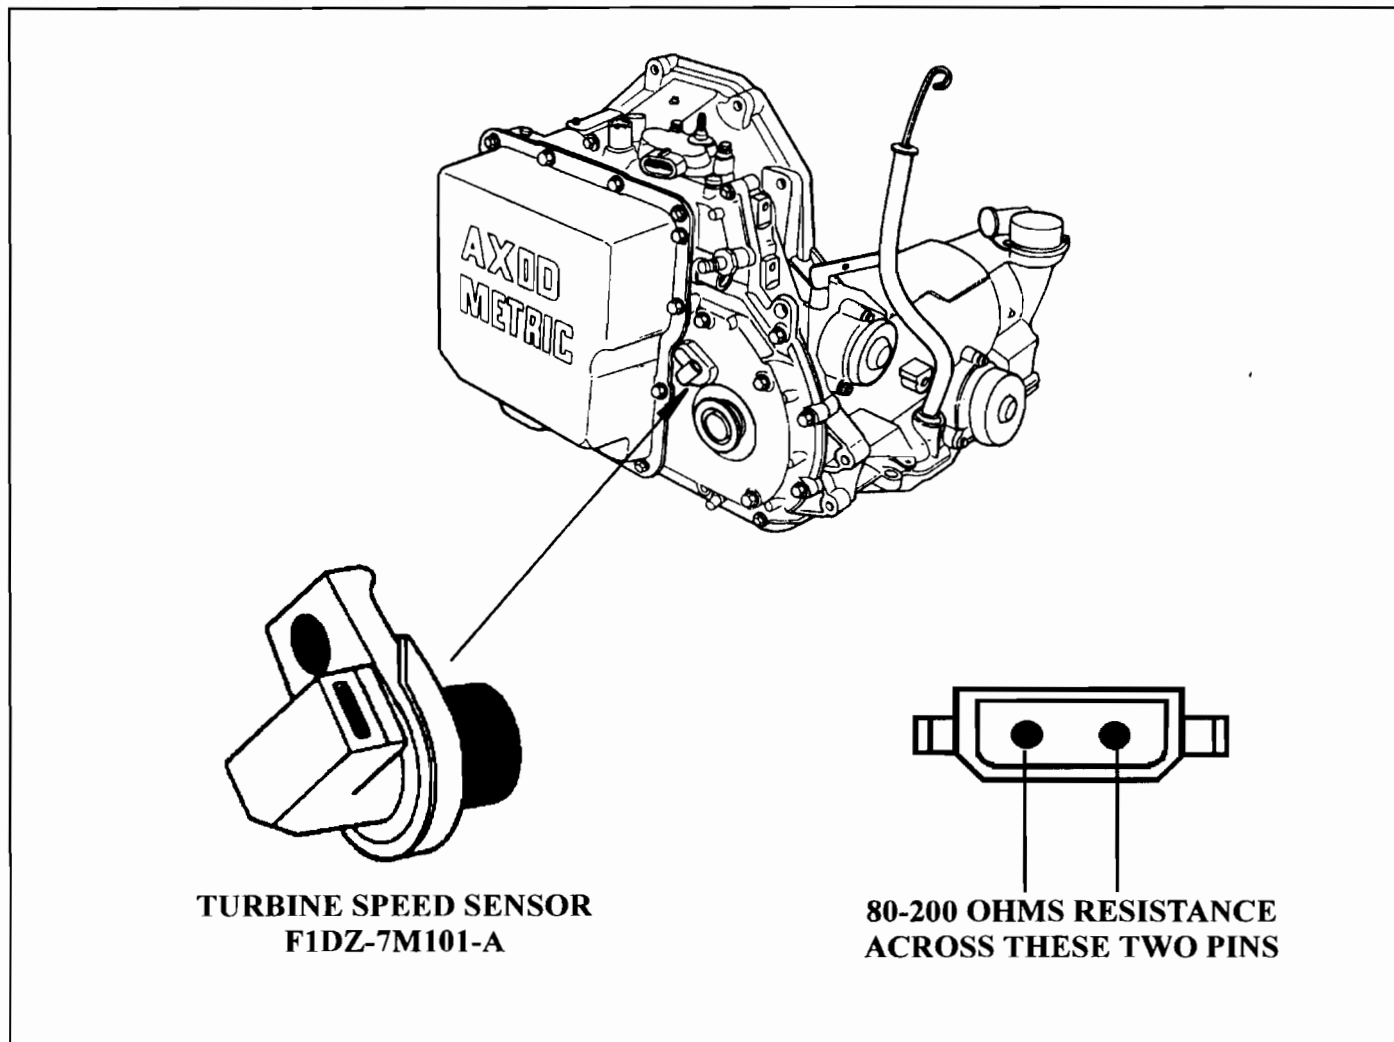
Figure 7

**CAUSE:** The cause may be, a defective Turbine Speed Sensor.

**CORRECTION:** The Turbine Speed Sensor is located on the chain cover, near the left axle seal, as shown in Figure 7. To test the TSS, disconnect the sensor harness connector, and place the leads of a DVOM across the two sensor pins. A good sensor should read 80 - 200 ohms resistance (See Figure 7). If the readings are not within the acceptable range, replace the Turbine Speed Sensor with OEM part number F1DZ-7M101-A.

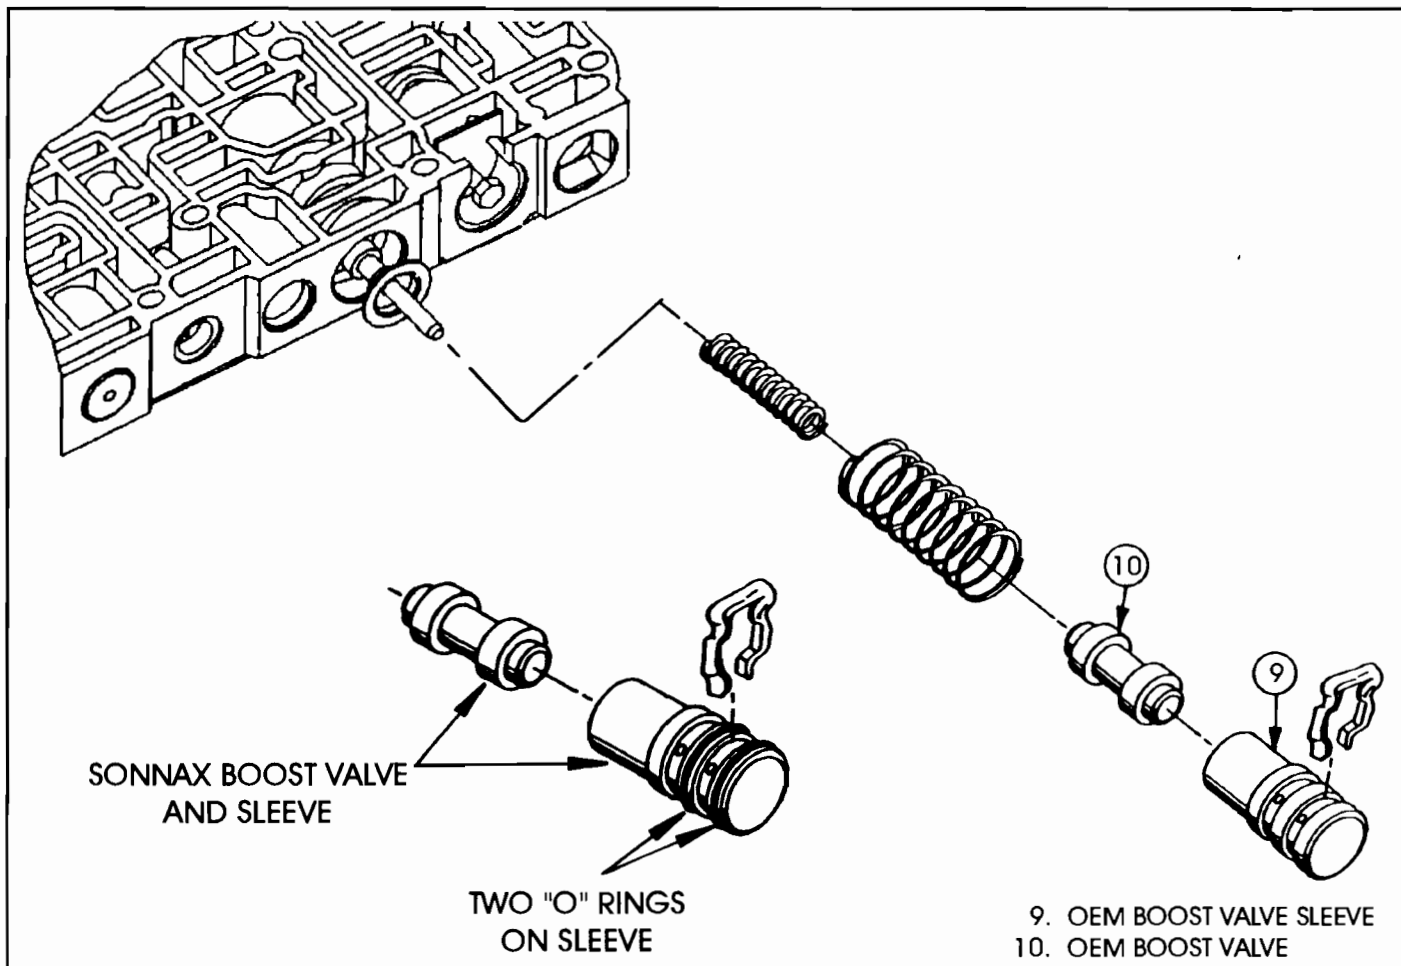
Figure 16  
*Automatic Transmission Service Group*

**COMPLAINT:** Some vehicles equipped with the AXOD or the AXODE transmission may exhibit a flair 1-2 or 2-3 upshift, 2-1 downshift clunk, non-adjustable throttle pressure, high line pressure, harsh reverse (300 PSI) and clutch and/or band failure from poor line rise.

**CAUSE:** The cause may be, the boost valve wearing the inside diameter of the boost sleeve. When this occurs, oil that enters the T.V. orifice leaks past the boost valve and exhausts through the reverse orifice. The outside diameter of the boost sleeve also allows some leakage through the valve body (See Figure 16).

**CORRECTION:** The Sonnax replacement assembly is designed to help eliminate the problems listed above, and is available under Sonnax part number 96201-01K from your transmission parts supplier. The new parts are specially coated to eliminate excessive wear and the two "O" rings provide additional protection against leakage through the valve body, as shown in Figure 16.

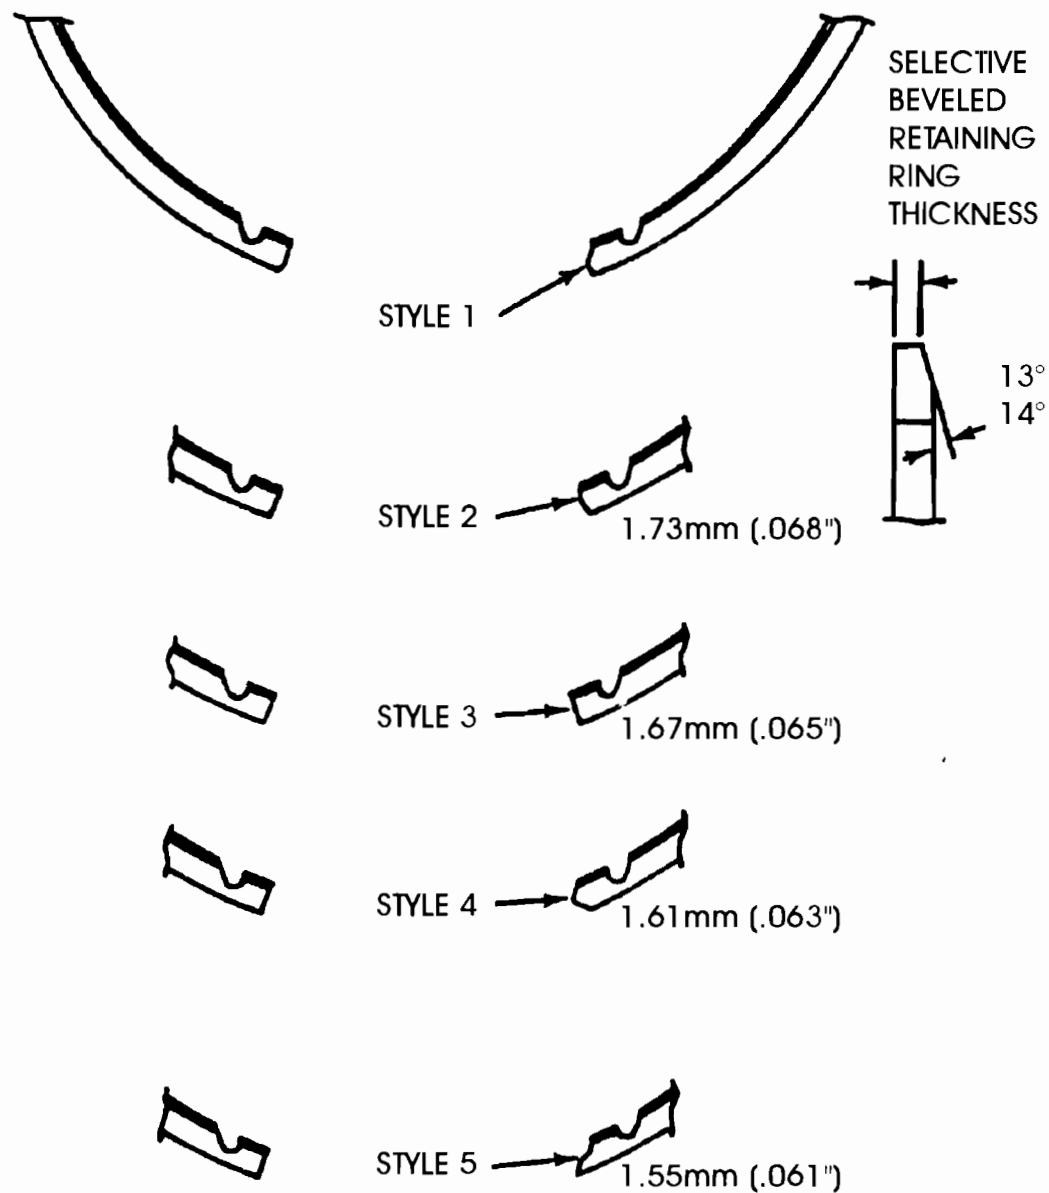
Figure 17

The AX4N transaxle is *similar* to the AXOD-E and found in *some* 1994-1995 Taurus and Sable, and found in *all* 1995 Lincoln Continal. The rear planetary support in this unit is retained with a *selective* beveled snap ring. The configuration of the end of the snap ring identifies the difference in thickness between the five selective snap rings (See Figure 17).

**AX4N ORIGINAL SELECTIVE BEVELED SNAP RING  
IDENTIFICATION AND THICKNESS**

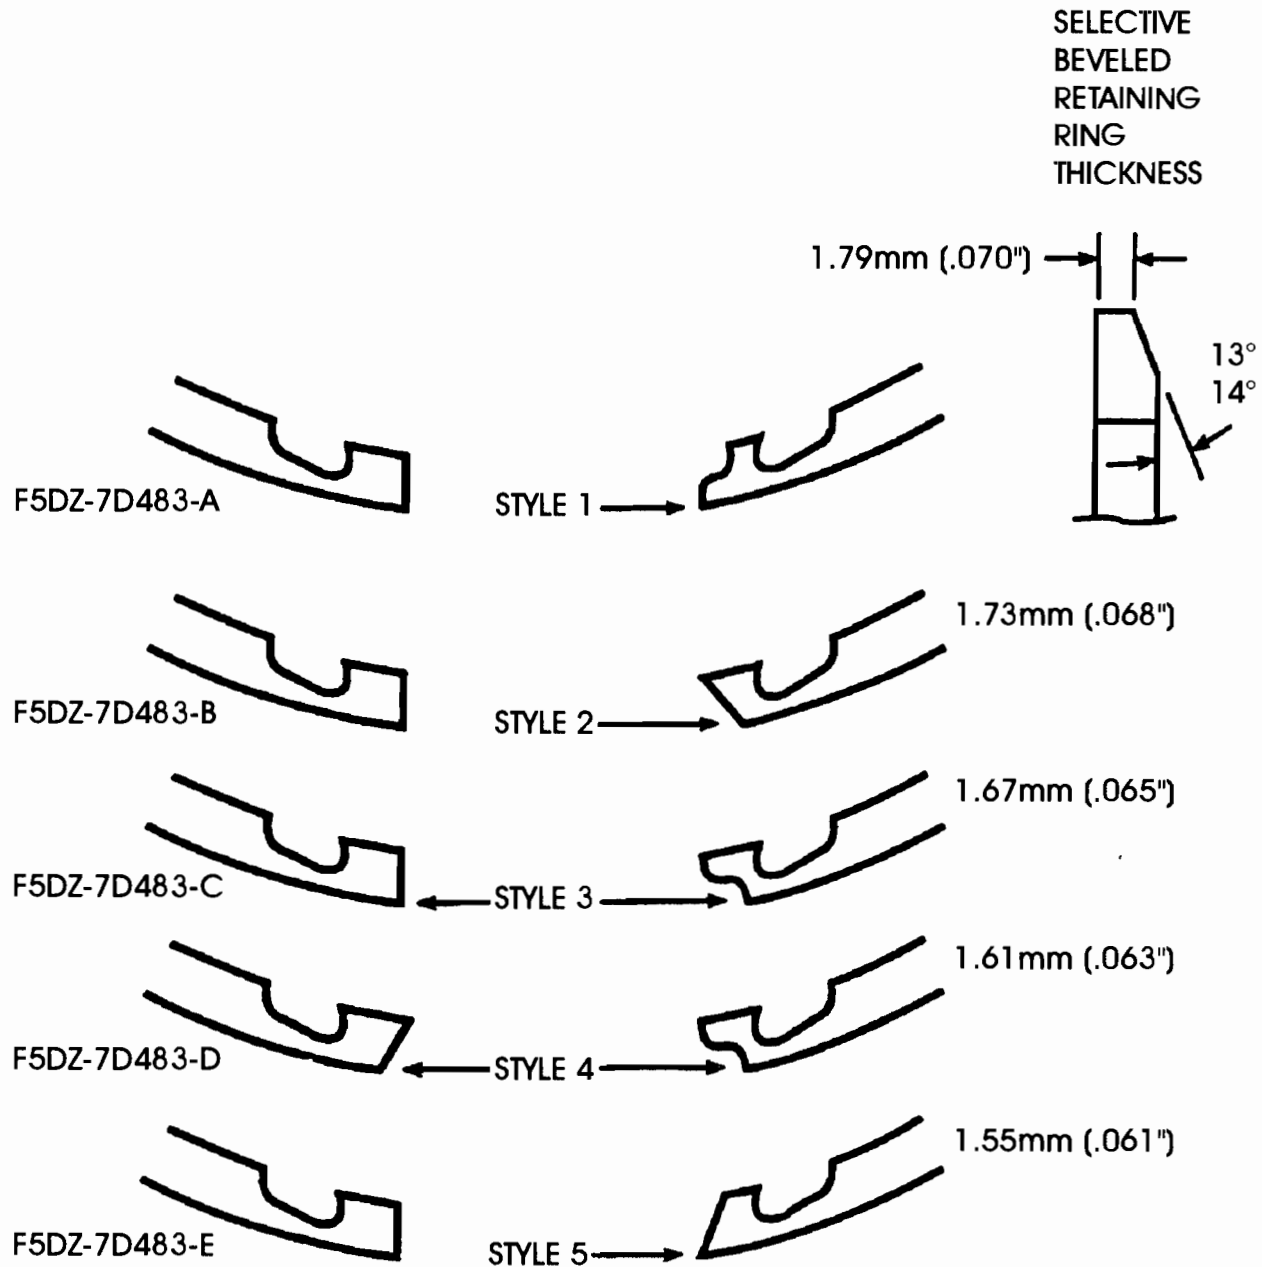
Figure 18

**AX4N SERVICE SELECTIVE BEVELED SNAP RING  
IDENTIFICATION AND THICKNESS**

4. Inspect the transaxle case and rear planetary support for possible damage caused by removing beveled snap ring with a screwdriver.
5. Obtain a new *service part* beveled snap ring, with notches (See Figure 18), with the same thickness as the original beveled snap ring, and install the new snap ring using the retaining ring pliers.

6. Perform end clearance check for the rear planetary support using the service manual. If it is not within specification, replace the selective beveled snap ring to obtain proper clearance.

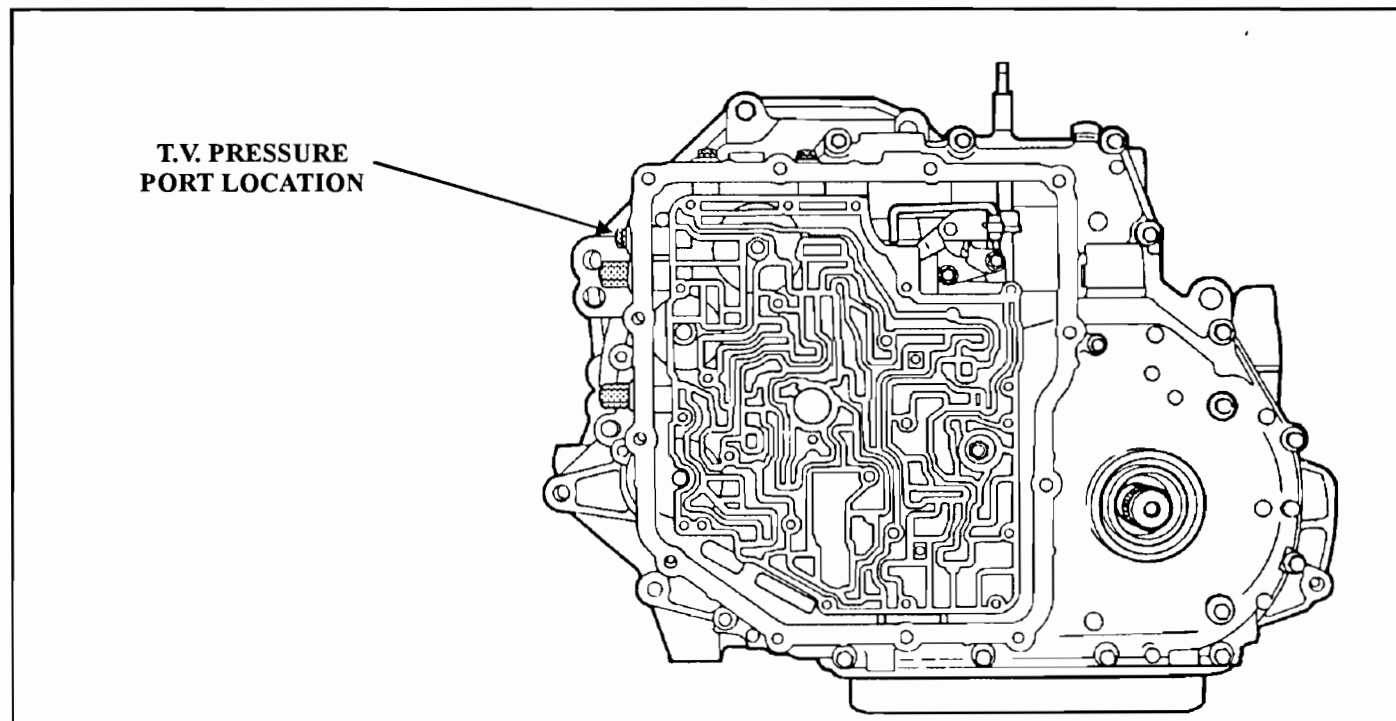
Figure 19

**CAUSE:**

The cause may be one of the following:

1. *The T.V. Cable not adjusted properly.*
2. *The T.V. Valve in the valve body stuck.*
3. *The T.V. Limit Valve in the valve body stuck.*
4. *The T.V./Line Modulator Valve in the valve body stuck or installed backwards.*
5. *The B3 Checkball located in the pump is missing, leaking, or off location.*

1. Install a 0-100 lb. pressure gauge into the T.V. pressure port, which is located on the side of transaxle as shown in Figure 19, and set the T.V. cable so that T.V. pressure reading is between 12-16 PSI.
2. Check the T.V. Valve in the valve body to ensure it is not stuck (See Figure 20).
3. Check the T.V. Limit Valve in the valve body to ensure it is not stuck, and location is shown in Figure 20.
4. Check the T.V./Line Modulator Valve in the valve body to ensure it is not stuck and is installed in the proper direction, as shown in Figure 20.
5. Ensure that the B3 Checkball located in the pump is in the proper location, as shown in Figure 21, and is the proper diameter.

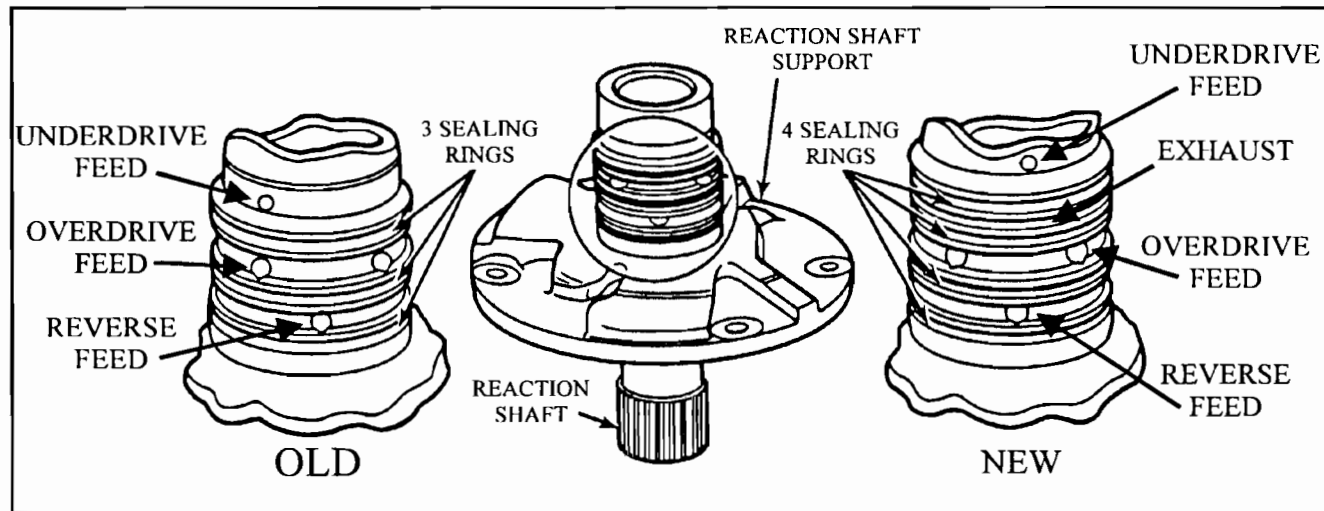
Figure 8

clutch pack or a broken snap ring jamming the clutch pack would be the obvious possibilities. The not so obvious would be cross leaks. For example, in figure 8 a view of both the early and late stators are shown. The earlier 3 ring stator would allow UD clutch oil to cross over into the OD clutch circuit in first and second gears. This would keep the OD clutch circuit partially charged with oil. The result would be low OD clutch volume readings since not much oil was required to put the OD clutches on during a 2-3 shift. This was usually accompanied with a low clutch volume reading in the UD clutch circuit as well. The reason for this is that when the transaxle made a shift into fourth gear, OD clutch oil would now cross over the ring and keep the UD clutch circuit partially charged with pressure. When the transaxle would make a 4-3 or a 4-2 downshift, not much volume of oil was required to put the UD clutch back on. This obviously was the reason why Chrysler redesigned the stator to 4 rings adding an exhaust between the two circuits.

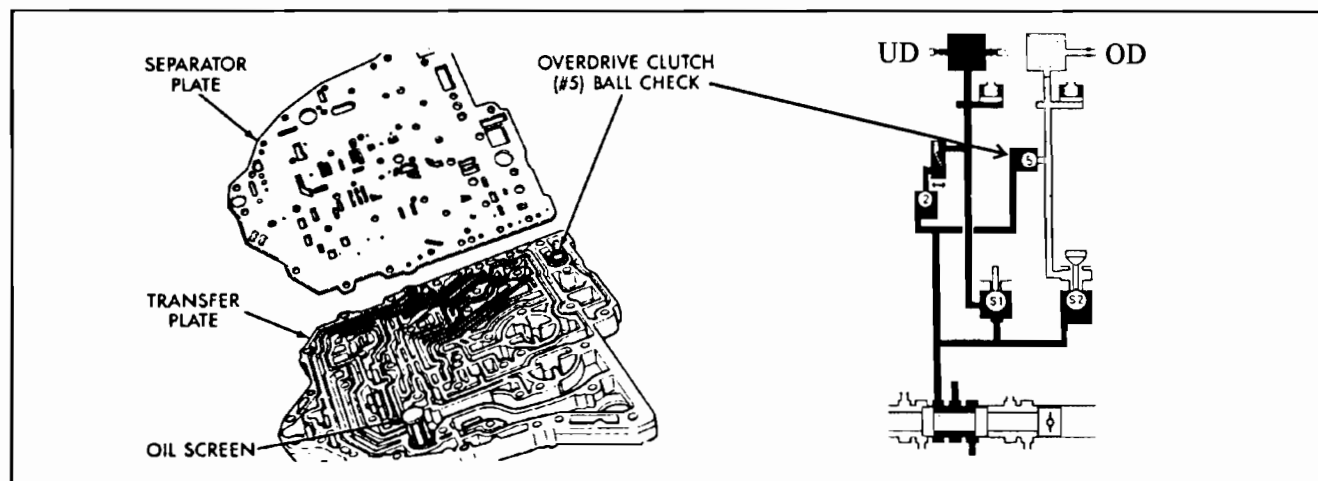
Figure 9

A low clutch volume reading in just the OD clutch circuit has been commonly caused by a defective O ring on the # 5 check ball capsule in the transfer plate as shown in figure 9. This blocks controlled line pressure from entering the OD clutch circuit. If the O ring or the capsule itself fails to hold back this pressure, the low OD clutch volume reading will vary depending upon the severity of the leak. If the leak is slight, most of the oil will exhaust past the OD solenoid and the OD clutch volume may appear to be normal. As the leak gets worse, the OD solenoid is flooded and the OD circuit becomes charged with oil causing below minimum CVI.

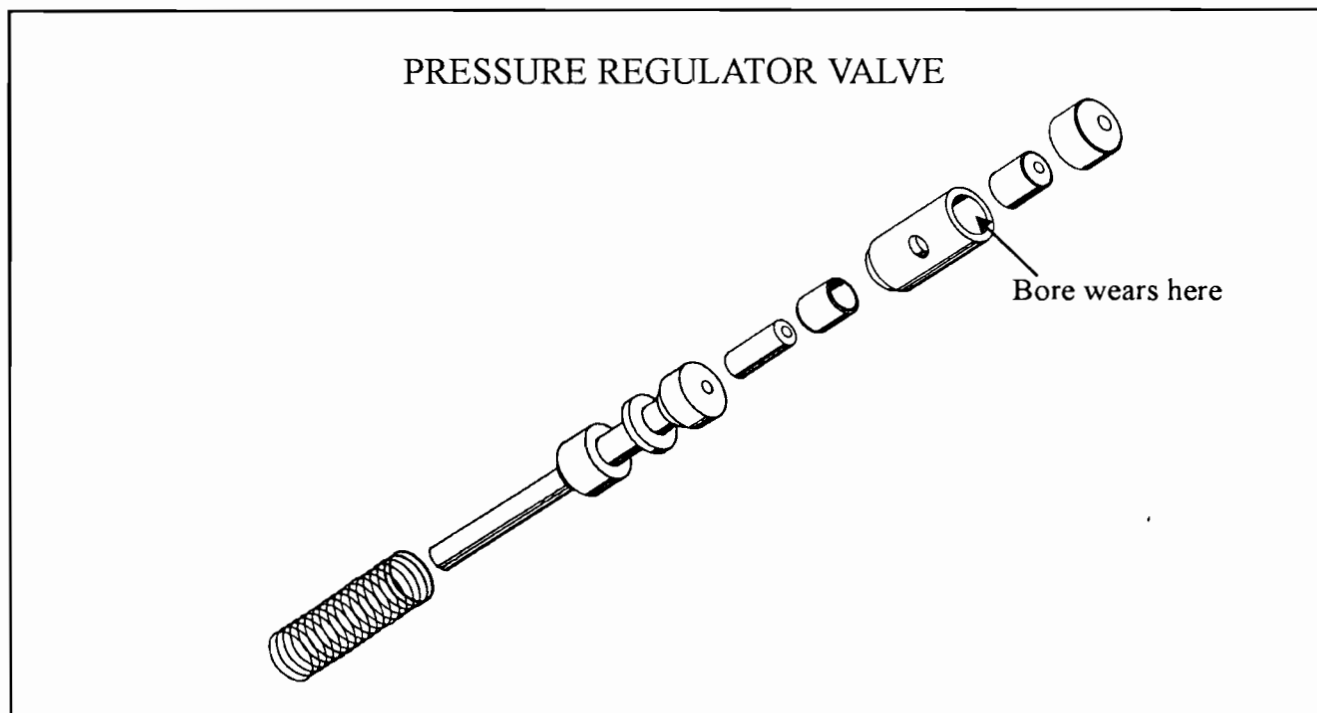
Figure 10

Another cause of low CVI that is often overlooked is high line pressure. There are three predetermined line pressure settings in an A604 transaxle. First and second gears have 120 to 145 psi. Third and fourth have 75 to 95 psi, while reverse is calibrated to have 175 to 235 psi. The controller for the transaxle has no way of knowing or checking what the actual line pressure is in the transaxle. Therefore, the controller controls the solenoid pulse rate based on these predetermined line pressure settings. If a mechanical problem occurs in the valve body causing high line pressure, the controller will be pulsing a clutch on through a solenoid based on a lower value pressure. With line pressure being much higher than what the controller thinks it is, a higher volume of oil is allowed to pass through the solenoid which results in a below minimum CVI reading. One common cause for this is either a worn sleeve in the pressure regulator valve system or a stuck pressure regulator valve (See Figure 10). These sleeves are available separately through TransGo.
