Technical Service Information

ZF6HP26

TRANSMISSION FLUID LEAK

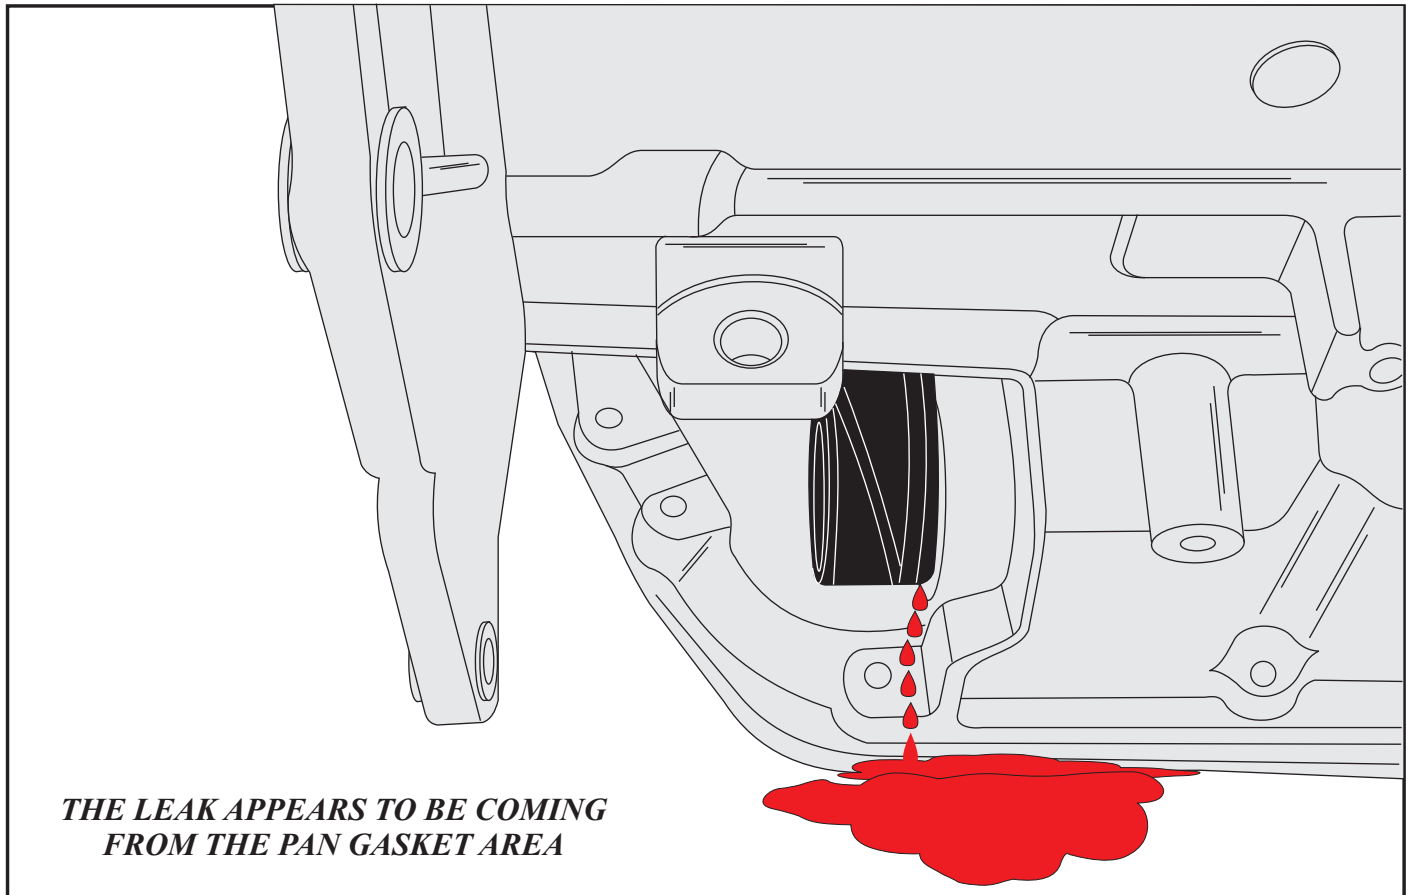
Figure 1

COMPLAINT: The transmission appears to be leaking from the pan gasket, (Refer to Figure 1).

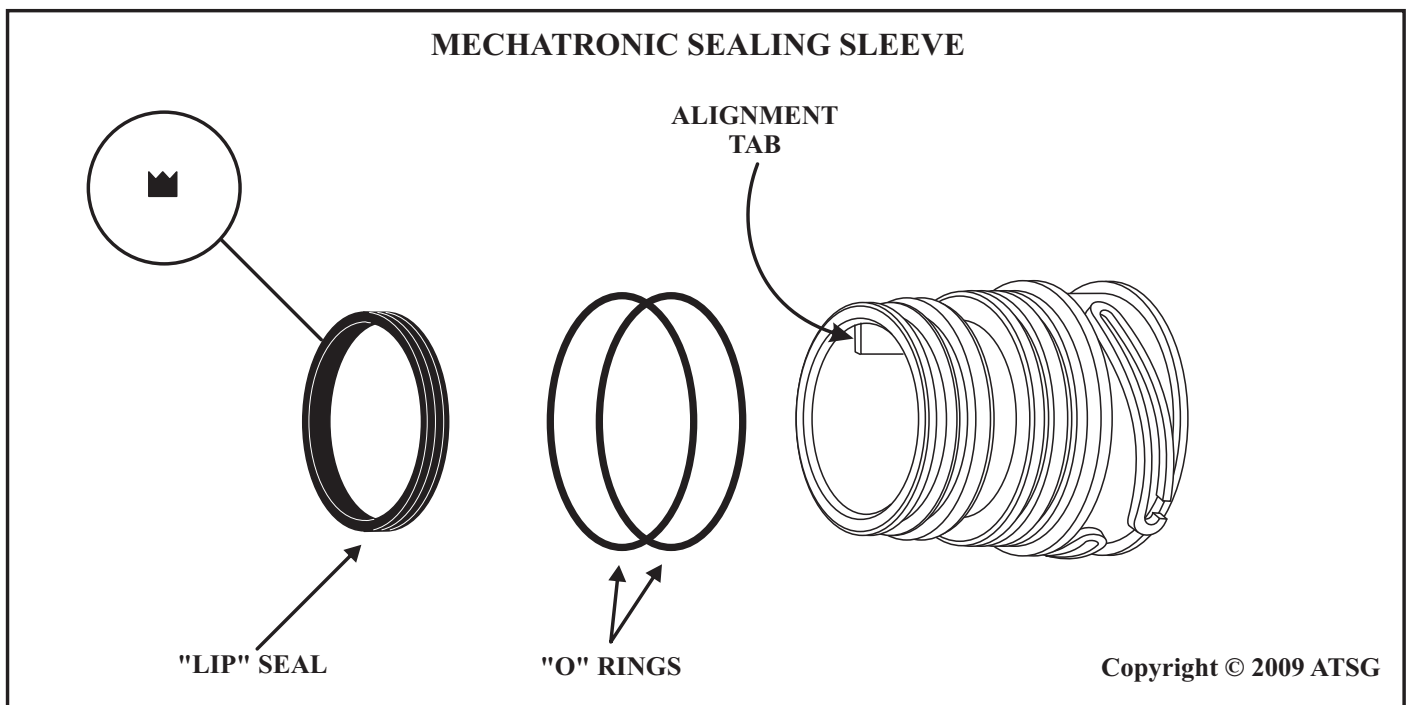
Figure 2

CAUSE: The Mechatronic Sealing Sleeve o-rings (Refer to Figure 2) is leaking and running down along the pan rail giving the appearance that the pan gasket is leaking.

CORRECTION: Replace the Mechatronic Sealing Sleeve.

Mechatronic Sealing Sleeve.....ZF Part Number 0501212190
Oil Pan/Filter Assembly For Manual Valve Body.....ZF Part Number 0501215789
