Technical Service Information

FORD / MAZDA 4F27E / FN4A-EL DTC P0741, TCC STUCK "OFF"

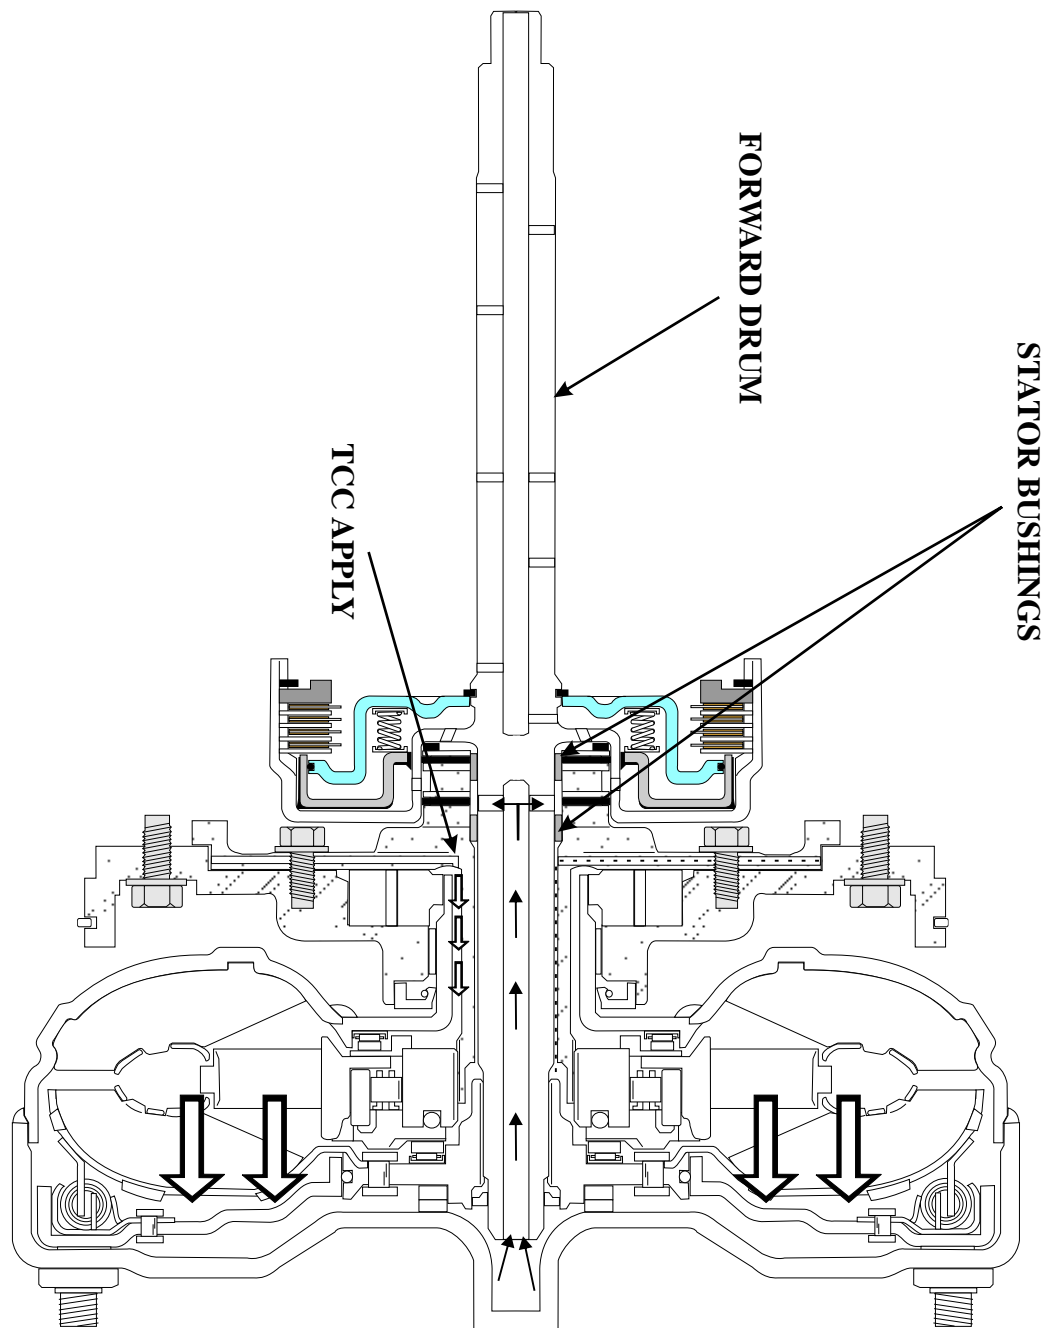
CAUSE: The cause may be, the bushings in the rear of the Pump Stator are worn causing a loss of Converter apply oil, as shown in the cut-away in Figure 1 , when the TCC is applied.
NOTE: When the stator bushings wear, Torque Converter Clutch Apply pressure will be exhausted thru the already exhausting Torque Converter Release pressure.

TORQUE CONVERTER APPLIED

NOTE: Wear in the Stator bushings may cause a loss of TCC Apply Pressure to the already exhausting TCC Release Pressure, creating TCC slip.

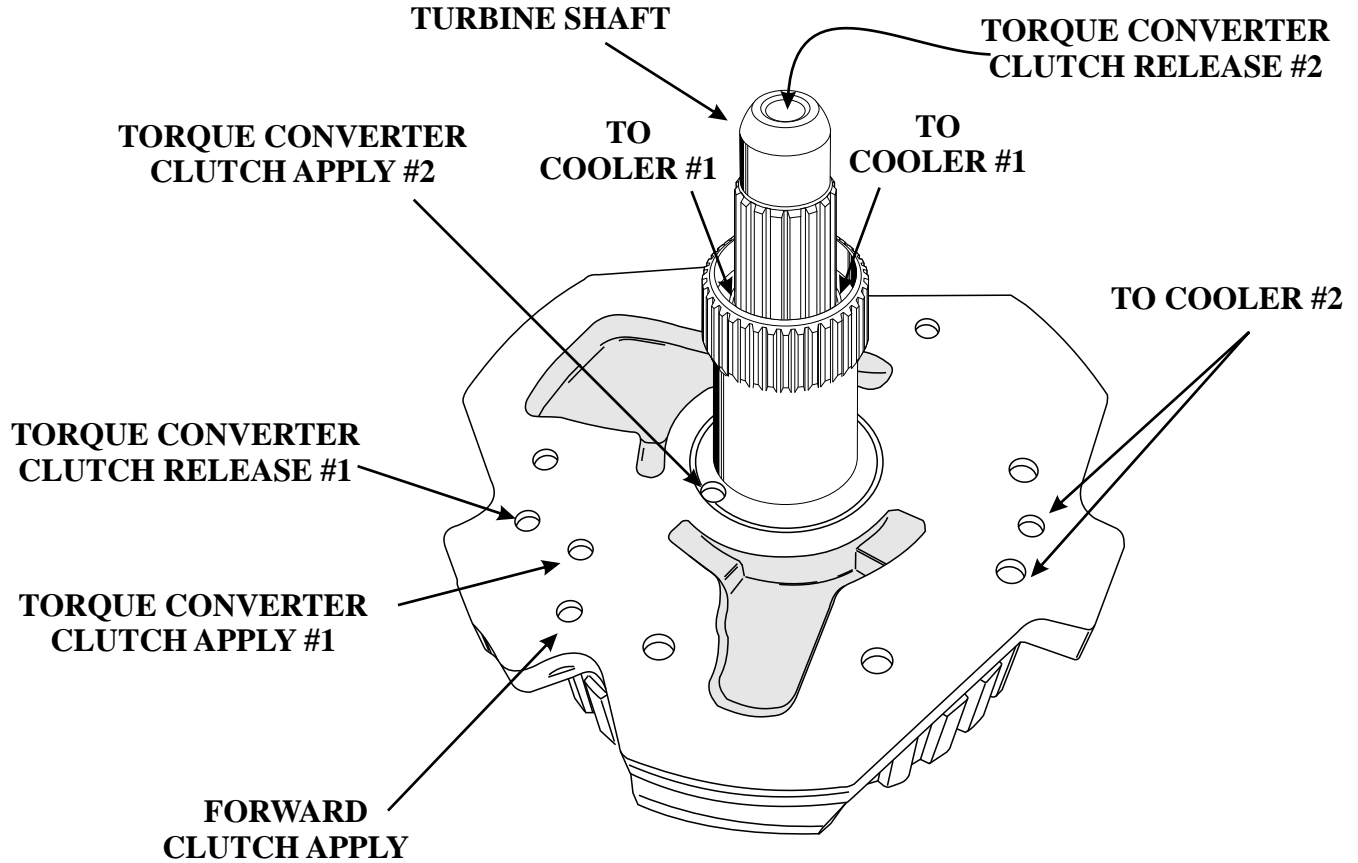
STATOR PASSAGE IDENTIFICATION

CORRECTION: Refer to Figure 2 for the identification of the Turbine shaft and Stator passages. Refer to Figure 3 to air check the Turbine Shaft to ensure that the bushings are worn. Refer to Figure 4 for the location of the Stator bushings. If stator does not pass the air check as shown in Figure 3, the stator bushings must be replaced.

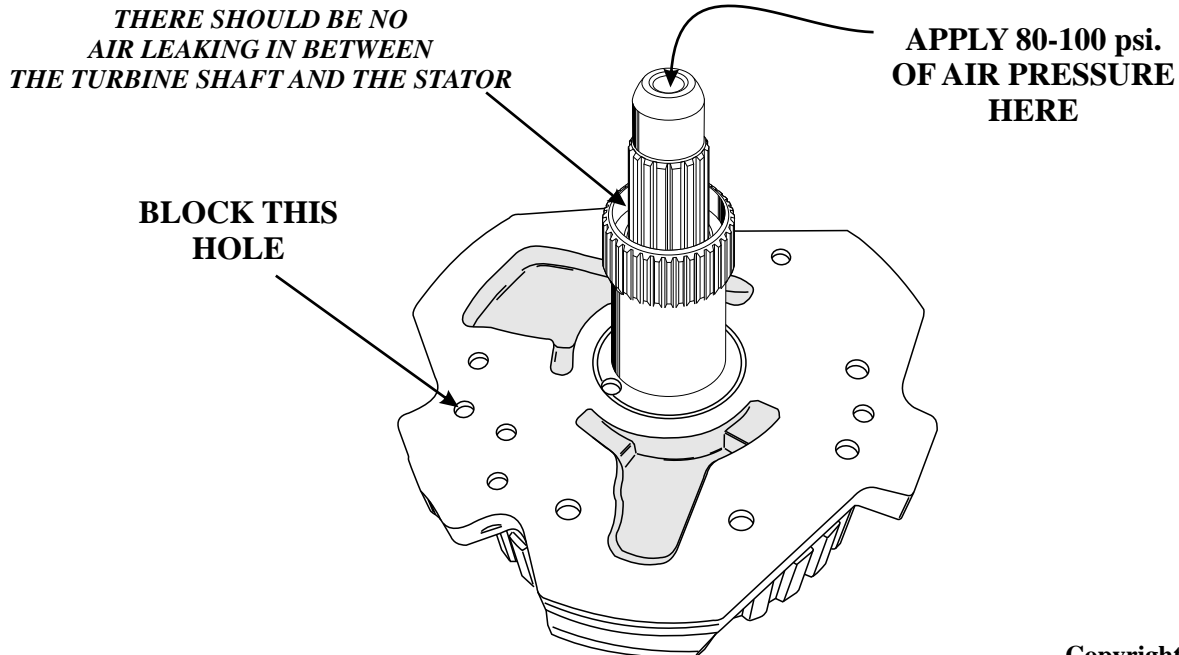
Figure 3

AIR CHECKING THE STATOR BUSHINGS

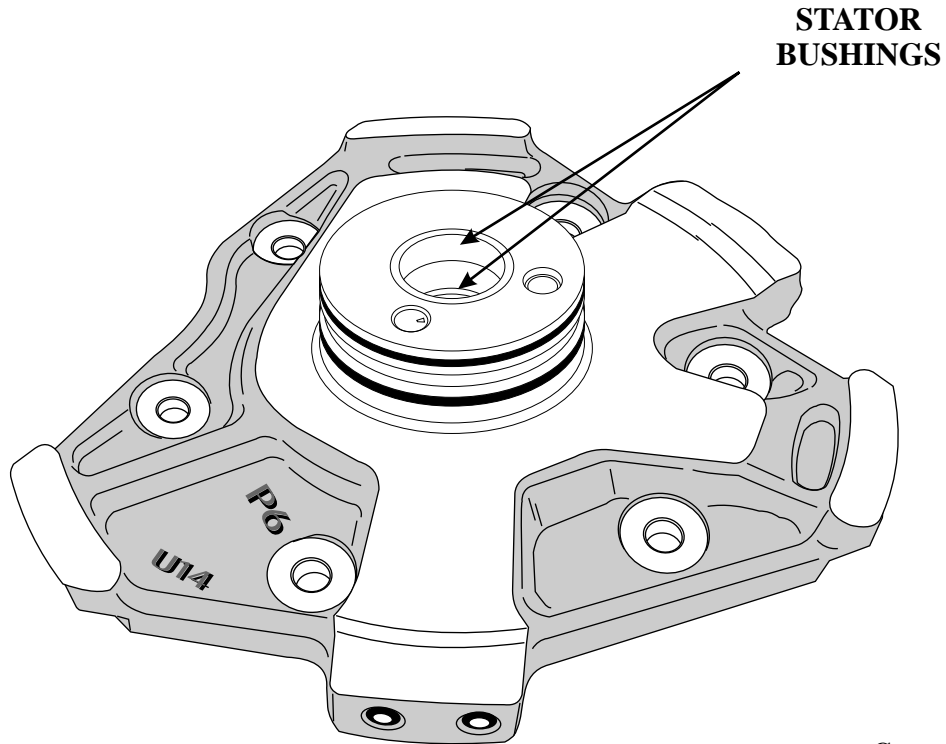
Figure 4

STATOR BUSHING LOCATIONS

PUMP ASSEMBLY (Ford Part number).....3S4Z-7A103-AA
STATOR BUSHINGS (Sonnax Part number).....46000-01K
