Technical Service Information

MAZDA GF4A-EL

FRONT SEAL BLOWOUT OR CHRONIC LEAKER

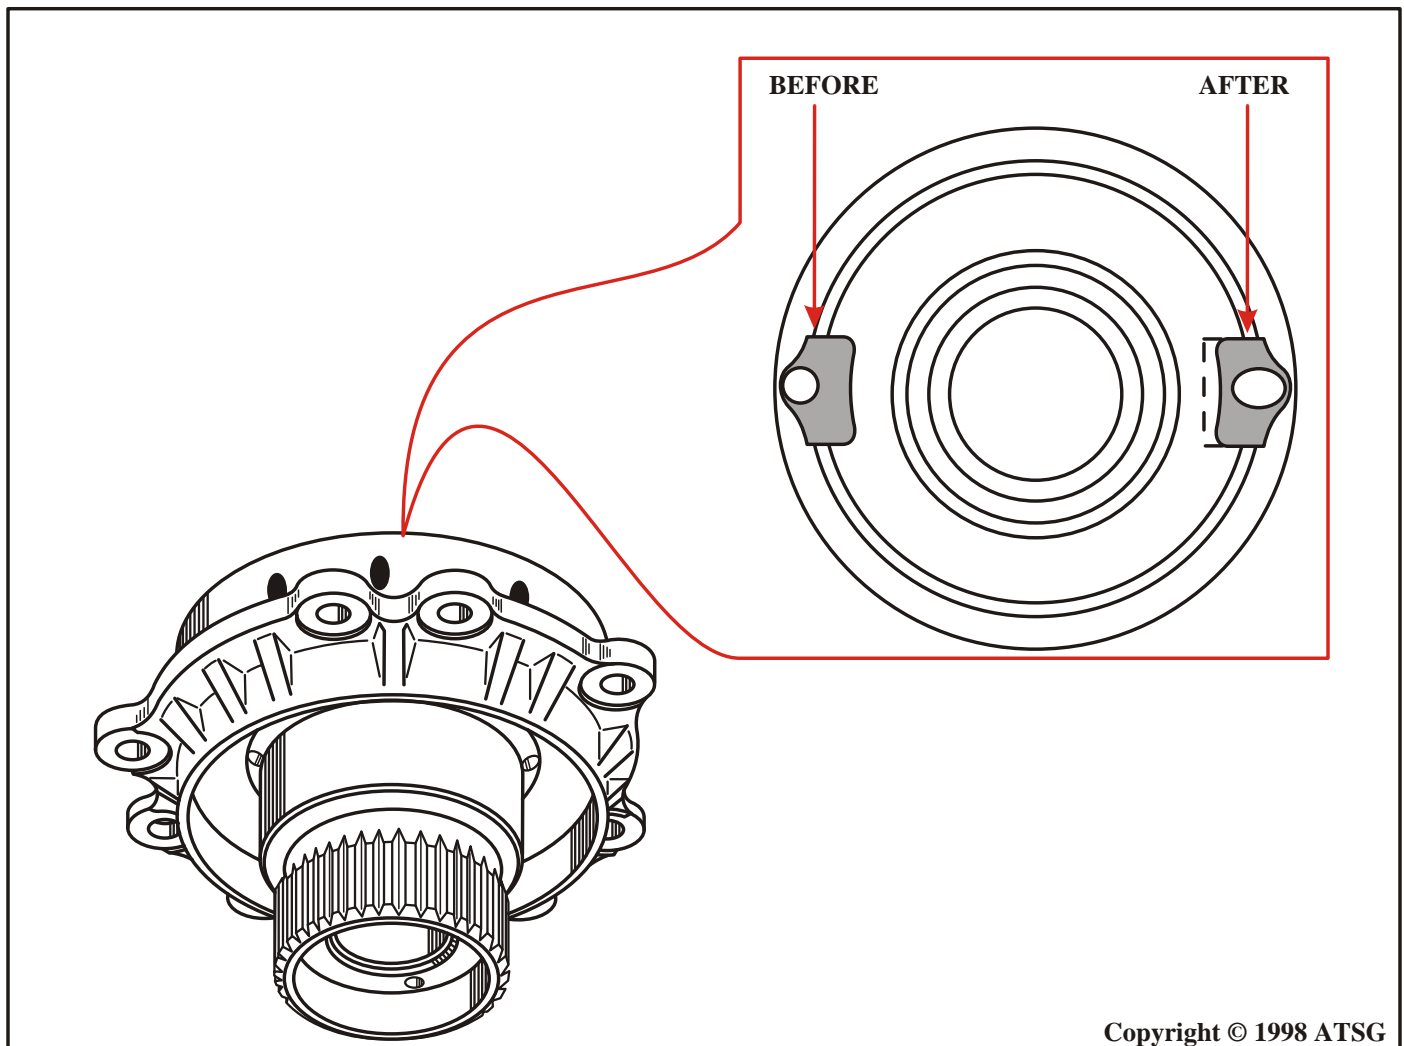
Figure 1

COMPLAINT: Continuous front seal leak or front seal forced out onto the converter hub repeatedly.

CAUSE: The cause may be, insufficient drainback passages in the pump support, or worn or misplaced bushing in the torque converter.

CORRECTION NUMBER 1: Remove the pump support and bearing race. With drill or die grinder, enlarge and deepen the factory drainback passage in the "Rear" of the pump support, as shown in Figure 1. Notice that the drainback hole and the passage to the "Dotted Line" are both enlarged.
