Technical Service Information

SUBARU JUSTY LOW RATIO ONLY; NO RATIO CHANGE

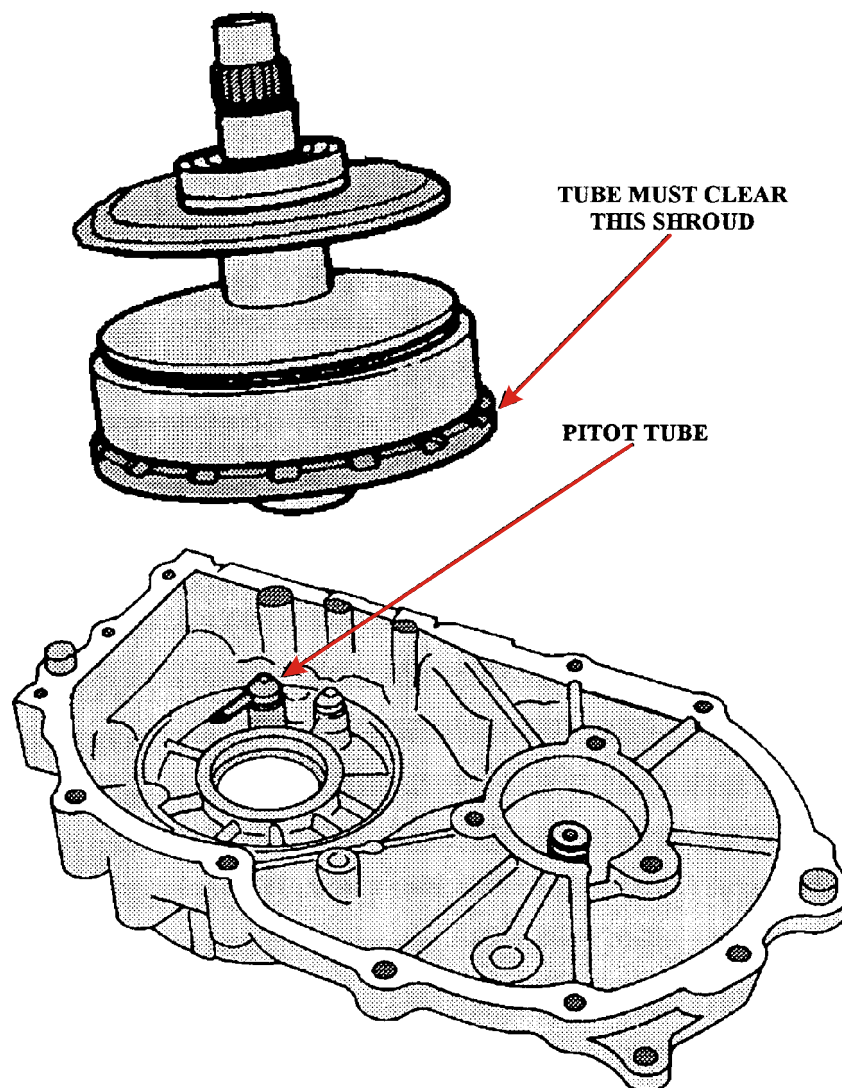
Figure 4

COMPLAINT: Transmission remains in low, will not change ratio.

CAUSE: Failure to rotate the "PITOT TUBE" out of the primary pulley before the side case and the transmission case are split will cause the "PITOT TUBE" to break or bend, causing a loss of pitot pressure which is necessary for a ratio change. (See figure 4)
