# Technical Service Information

## **CHRYSLER 45RFE NO 3RD OR 4TH GEAR**

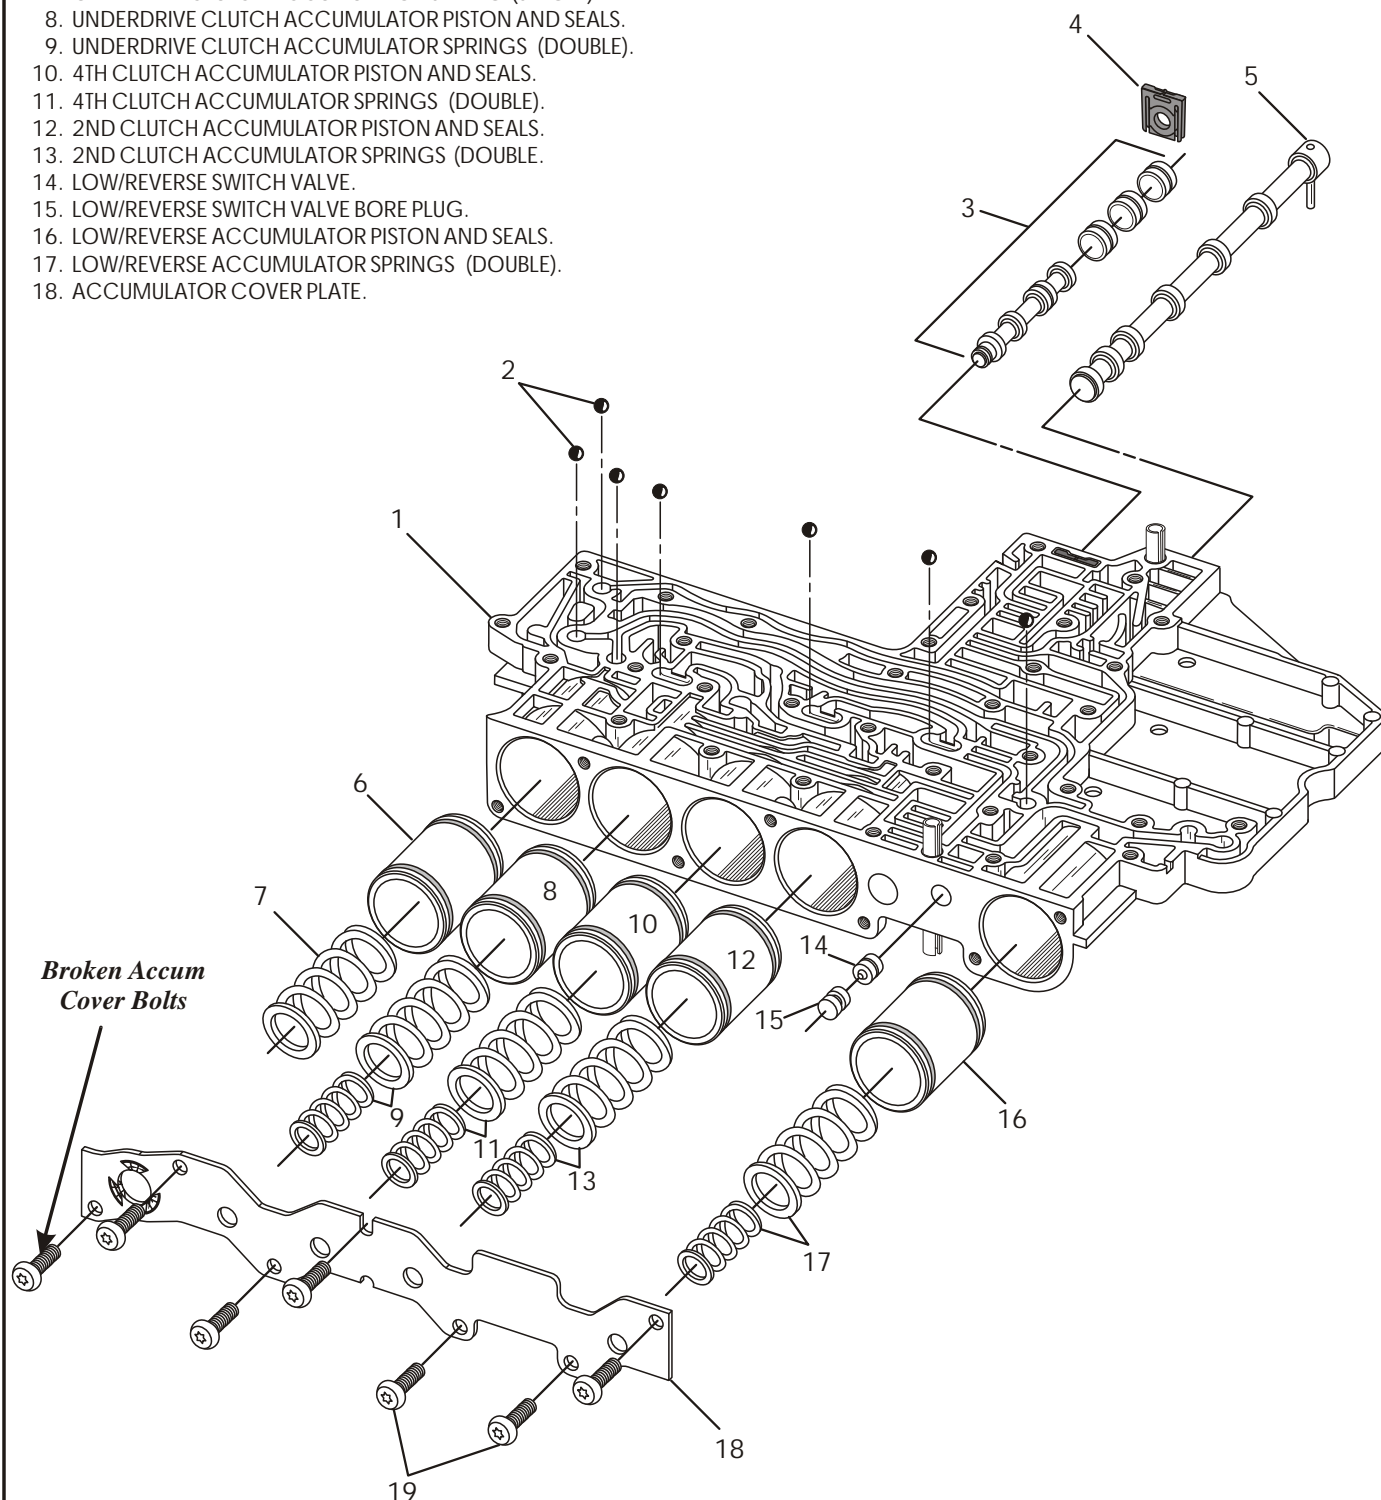
Figure 1

**CAUSE:** The cause may be, broken accumulator cover bolts allowing the overdrive accumulator piston to come out far enough to exhaust all overdrive clutch feed oil. The overdrive clutch is applied in 3rd and 4th gears. Usually, the accumulator cover plate is also very badly bent and must be straightened, as it is not available from OEM individually. We suspect the accumulator bolts were not properly torqued to begin with.

**CORRECTION:** Straighten the accumulator cover plate and install new accumulator cover plate retaining bolts, as shown in Figure 1.

*Special Note: When reinstalling the new bolts, use red Lock-Tite® on the threads.*
