Technical Service Information

ZF5HP24

“E” CLUTCH FEED PIPE DAMAGE

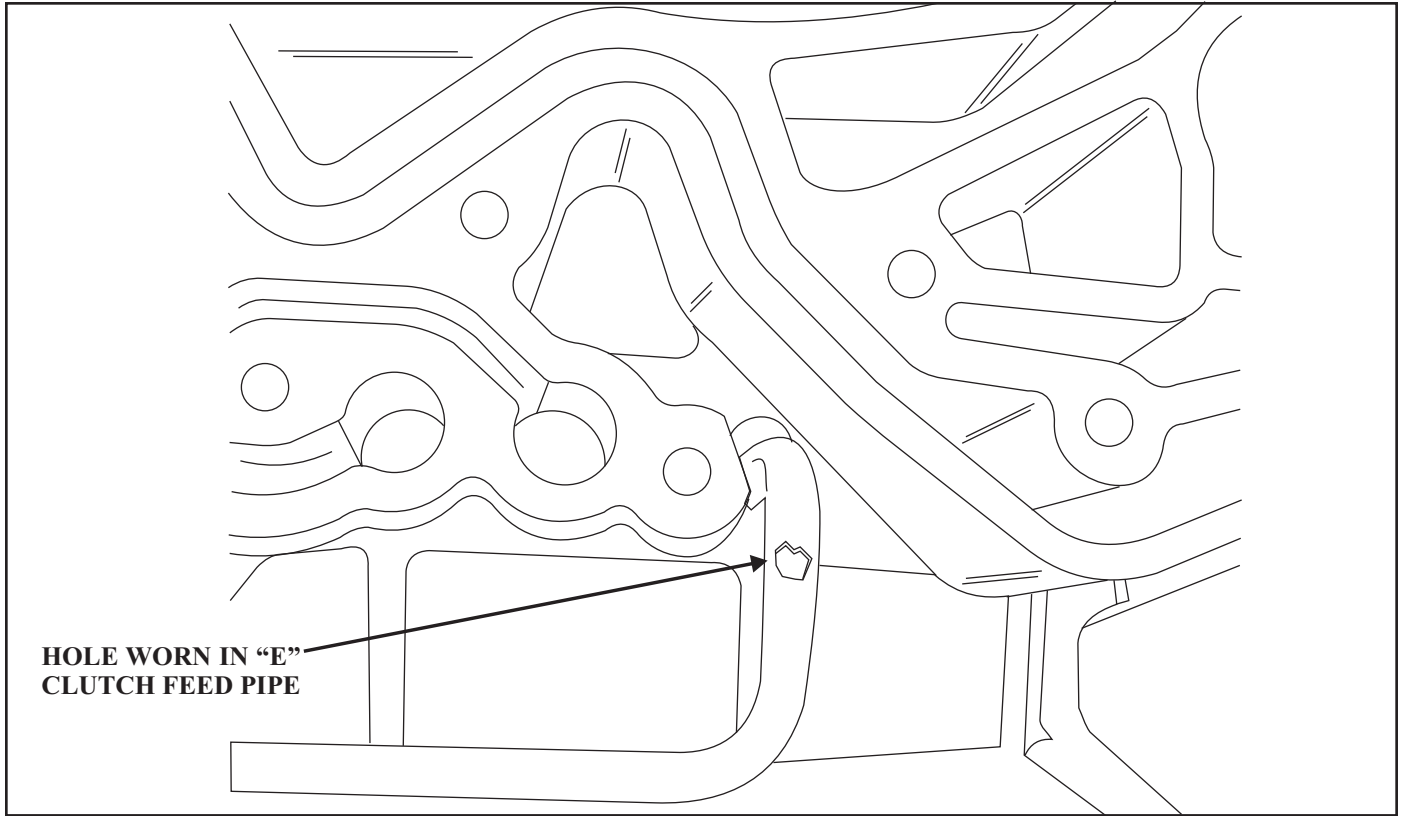
Figure 1

CAUSE: The “E” clutch feed pipe has made contact with the valve body casting and has had a hole rubbed through the pipe, (Refer to Figures 1 and 2).

It is important to insure that the feed pipe fits tightly in the case to prevent contact with the valve body. It would also help to remove some of the valve body casting, in the ribbed area, to insure enough clearance between the pipe and the valve body.
