MAZDA/FORD GF4A-EL/GF4EAT HARSH UPSHIFTS

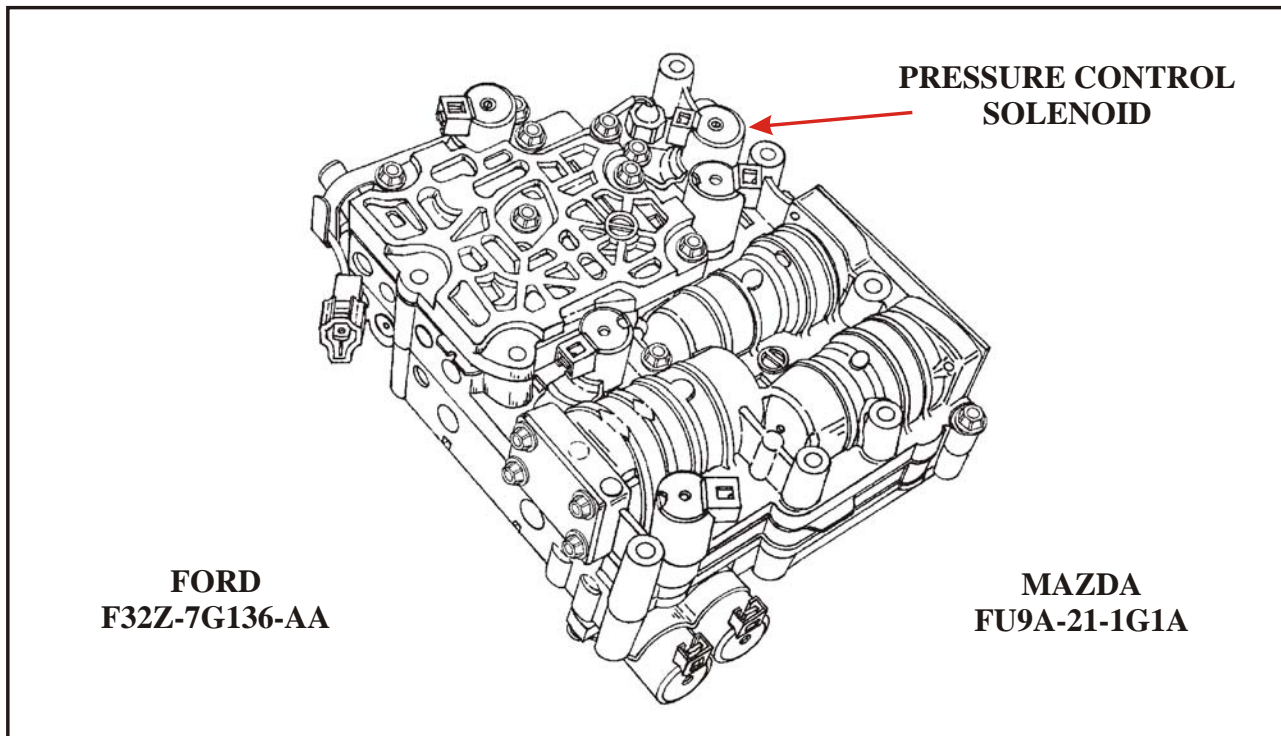
COMPLAINT: 1993 & up, vehicles equipped with GF4A-EL transaxles, built before 1/3/95, may exhibit a harsh 1-2 upshift or harsh upshift complaints before or after overhaul. Line pressure appears to be normal or slightly higher than normal when checking in the "D" range. "Normal" line pressure readings are as follows, 60-78psi. at idle and 161-172 psi. at stall.

CAUSE: The cause may be, higher than normal control pressure passing through the main control spacer plate.

CORRECTION: Replace the Pressure Control Solenoid as shown in Figure 1 with Ford part number F32Z-7G136-AA or Mazda part number FU9A-21-1G1A. Inspect the Pressure Regulator Valve and the Pressure Regulator Valve bore for wear or scoring. Inspect the Boost Valve and Boost Valve Sleeve for wear or scoring. Ensure that there is no *"side to side"* wobble of the Pressure Regulator Valve, when it is in its bore. See Figure 2. Enlarge the Pressure Regulator *"balance"* orifice in the rear control spacer plate to .056" as shown in Figure 3.

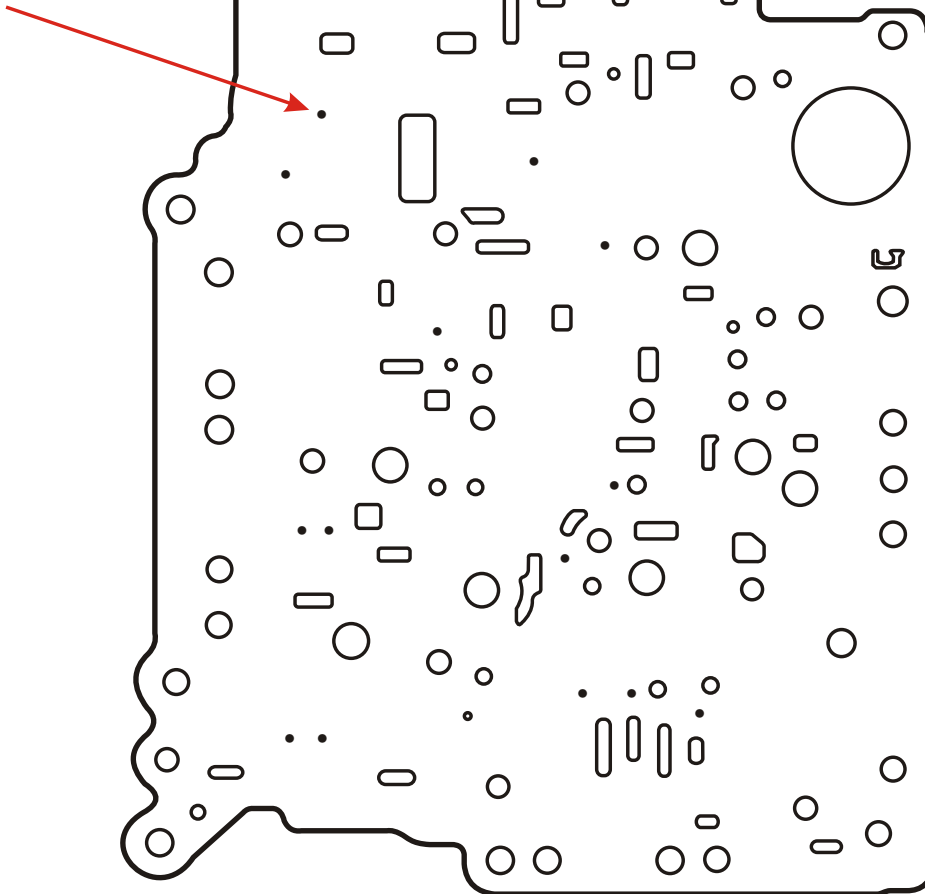
Figure 3

REAR CONTROL SPACER PLATE

ENLARGE THIS
ORIFICE TO .056"
