# Technical Service Information

## **FORD A4LD CONTINUOUS FRONT SEAL LEAKS, PREMATURE CONVERTER HUB WEAR, PREMATURE PUMP GEAR DAMAGE, ON 2.8L, 2.9L AND 4.0L ENGINES ONLY**

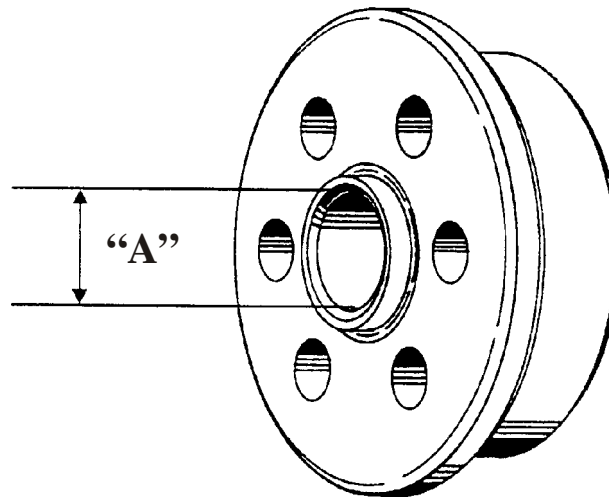
### **CRANKSHAFT TO FLYWHEEL SPACER OEM PART NUMBER D4ZZ-6434-A**

- COMPLAINT:** After rebuild, continuous leaks from the front pump seal area, possibly premature bushing wear and/or wear on the torque converter hub seal area, and in extreme cases may exhibit premature front pump gear breakage. The complaint may be any or all of the above, depending on the extent of the wear.
- CAUSE:** The cause may be a “Crankshaft to Flywheel Spacer” worn in the area that supports the torque converter pilot hub, allowing a mis-alignment of the torque converter to pump, on models equipped with 2.8L, 2.9L and 4.0L engines only.
- CORRECTION:** Inspect the “Crankshaft to Flywheel Spacer” for any abnormal wear and replace as necessary. Refer to Dimension “A” in Figure 1 to measure the spacer. Dimension “A” on a new spacer is .750”, and the OEM part number is D4ZZ-6434-A.
- SERVICE INFORMATION:**

**DIMENSION “A” SHOULD BE .750” ON A NEW SPACER**

Crankshaft to Flywheel Spacer ..... D4ZZ-6434-A
