Technical Service Information

FORD A4LD TIE-UP IN THE PARK POSITION

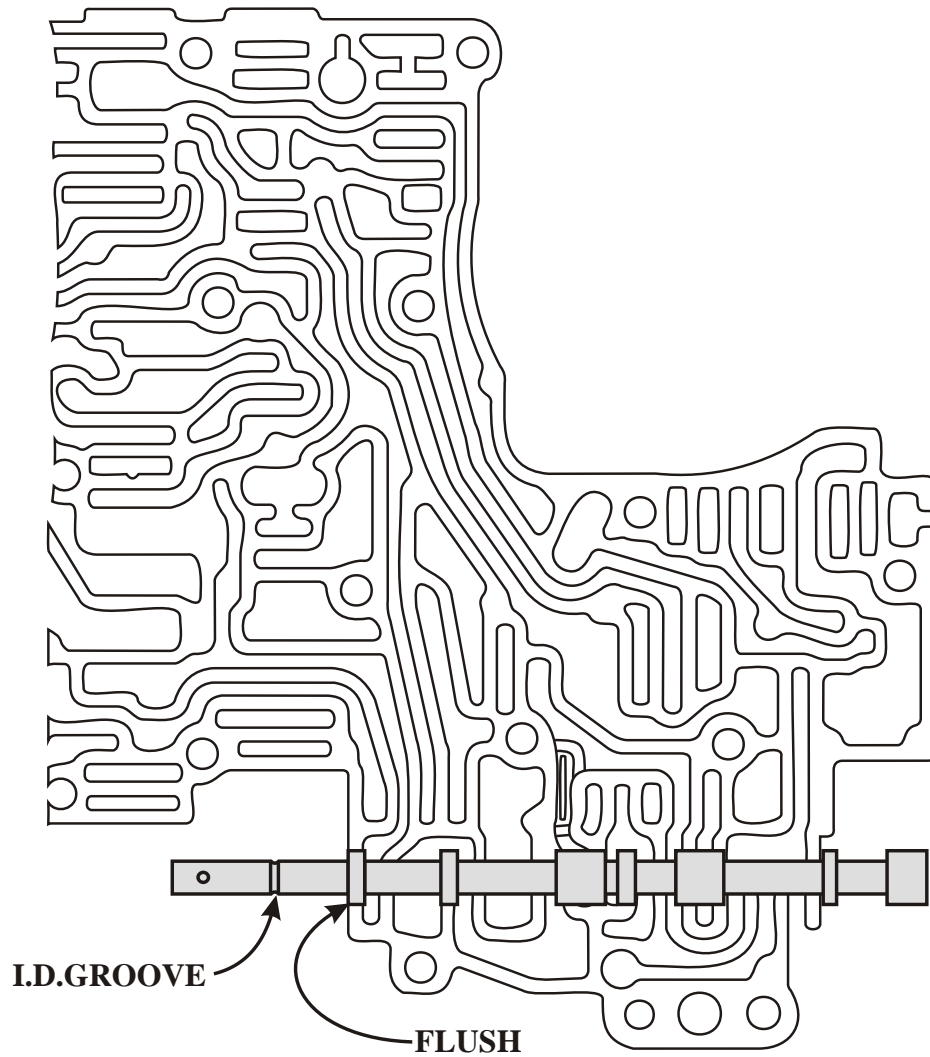
Figure 1

CAUSE: The cause may be, an improperly adjusted manual valve. The .075" puck supplied in some gasket sets and in some valve body kits WILL NOT WORK ON ALL MODELS. On SOME valve bodies, using the "Puck" to adjust the manual valve, will allow the manual valve to move past the Park position and apply the forward clutch.

WITH THE MANUAL LEVER IN THE “D2” POSITION THE FIRST LAND ON THE MANUAL VALVE SHOULD BE FLUSH WITH THE VALVE BODY CASTING

1. Measure the link hole in the manual valve to ensure that it is .157" in diameter, and has not elongated due to wear. It is also recommended to use the latest manual valve, with the I.D. Groove near the link hole, and available under OEM number E8TZ-7C389-A. (See Figure 1).
2. With the valve body installed on the transmission, place the manual lever into the "D2" position.
3. With the manual lever in the "D2" position, the first land on the manual valve should be flush with the valve body casting, as shown in Figure 1. However, approximately .010" below flush to .020" above flush with the valve body casting is totally acceptable.
4. Bend the manual valve link as necessary to achieve the dimensions listed above.
