# Technical Service Information

## CHRYSLER A404 SECOND GEAR STARTS (GRIND FLATS)

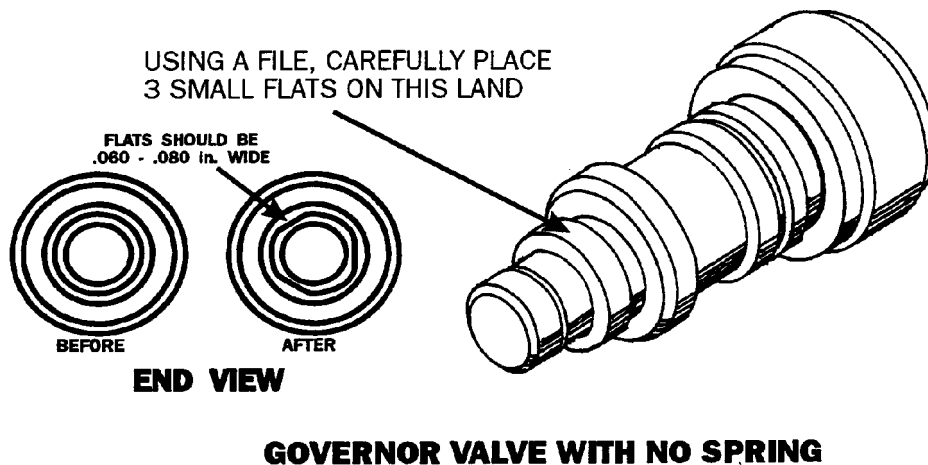
Figure 1

**COMPLAINT:** 2nd gear starts after overhaul.

**CAUSE:** If all other possibilities have been eliminated, the cause may be cross leaks causing governor pressure at a stand still.

**CORRECTION:** Carefully grind 3 small flats on the second land of the free floating governor valve (without spring) to provide an exhaust. see figure 1.
