# Technical Service Information

## SUBARU 4-AT

### DELAYED OR NO FORWARD ENGAGEMENT

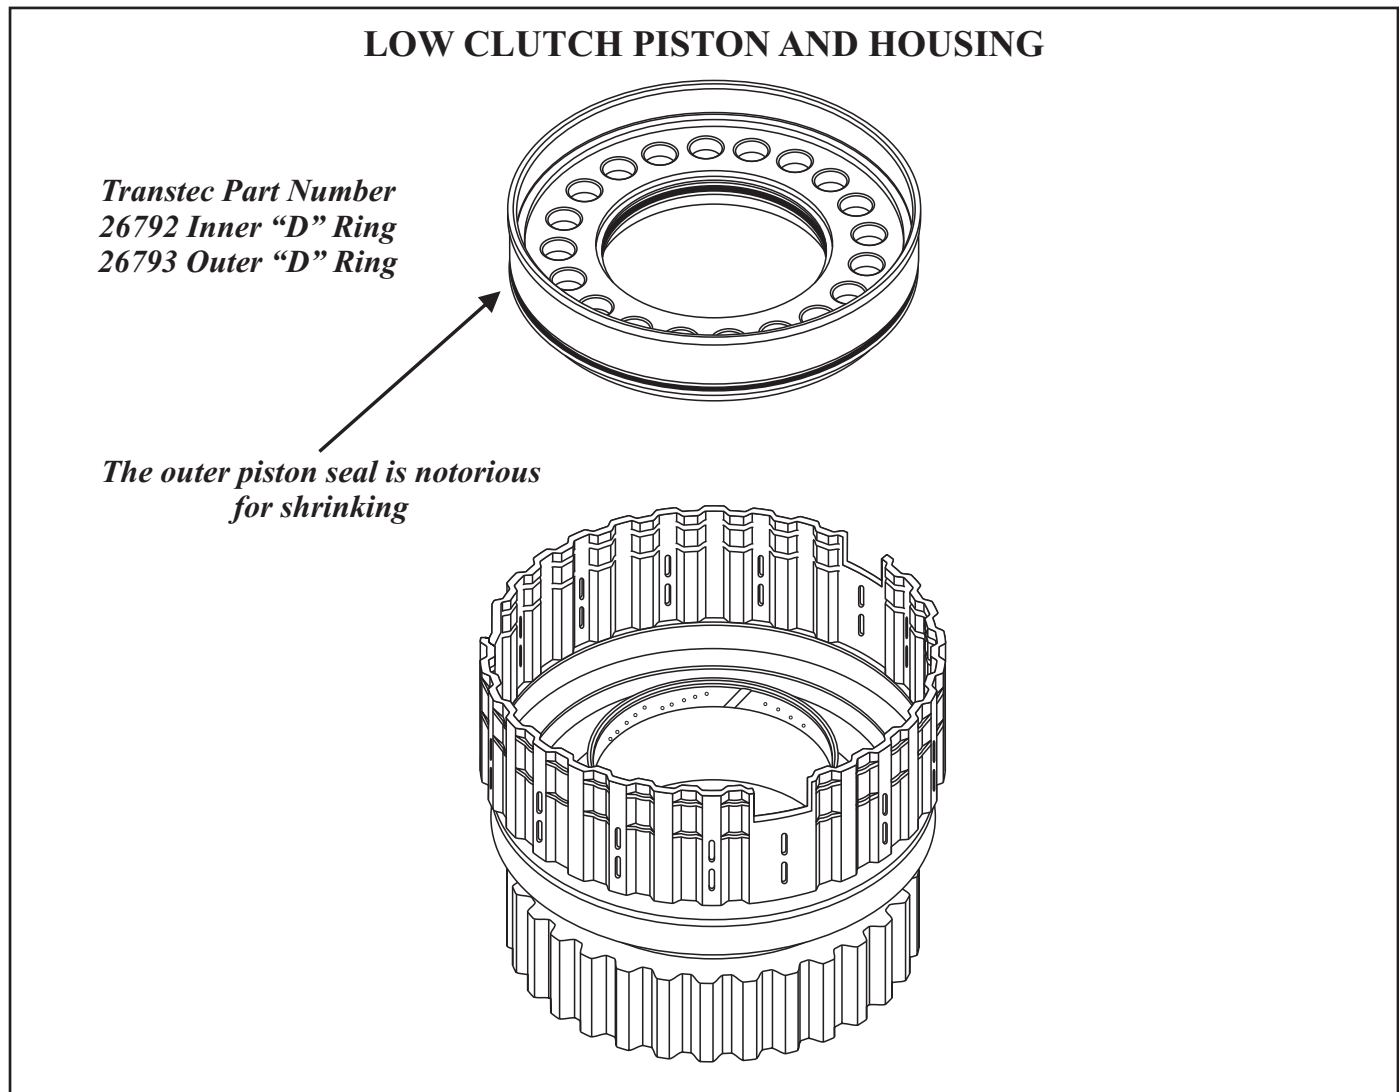
**COMPLAINT:** 1998 or later Subaru vehicles equipped with the new design 4-AT 4 speed automatic transaxle, may exhibit a complaint of delayed engagement in forward, or a no forward condition.

**CAUSE:** This condition may be caused by the outer piston seal of the Low clutch drum shrinking to the point it will no longer seal effectively. Refer to Figure 1 for identification of the Low drum and piston.

**CORRECTION:** Replace the piston seals on the Low clutch piston.

As of the printing of this information, most aftermarket suppliers have changed the material of the Low Clutch Piston seals to Viton, which are at this point working very well.
