Technical Service Information

TOYOTA 540-E 540-H NO REVERSE NO ENGINE BRAKING

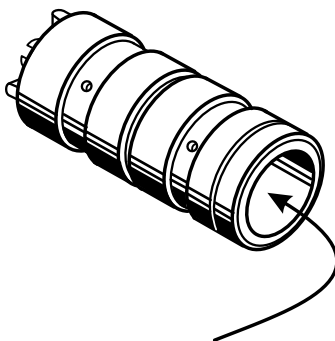
Figure 1

CAUSE: The cause may be, the inner o-ring in the Overdrive Direct Clutch Piston is blown out causing a leak in the O.D. Direct Clutch circuit. The reason for the piston seal blow out may be excessive wear in the Pressure Regulator Boost sleeve, causing high pressure in the Reverse circuit, bowing the piston in the center and blowing the piston seal out. **NOTE:** *ATSG has also had complaints with some after market filters having defective cork gaskets causing numerous holes in the spacer plate to be plugged causing very high pressure and the same failure.*

540-E BOOST SLEEVE

**INSPECT SLEEVE FOR WEAR
INSIDE OF SLEEVE**

CORRECTION: To correct this condition, replace the boost sleeve with a replacement from Toyota or Sonnax, See Figures 1 and 3. Renew the piston seals in the O.D. Direct drum as shown in Figure 2. Verify that the piston is not warped by checking with a straight edge, also shown in Figure 2.

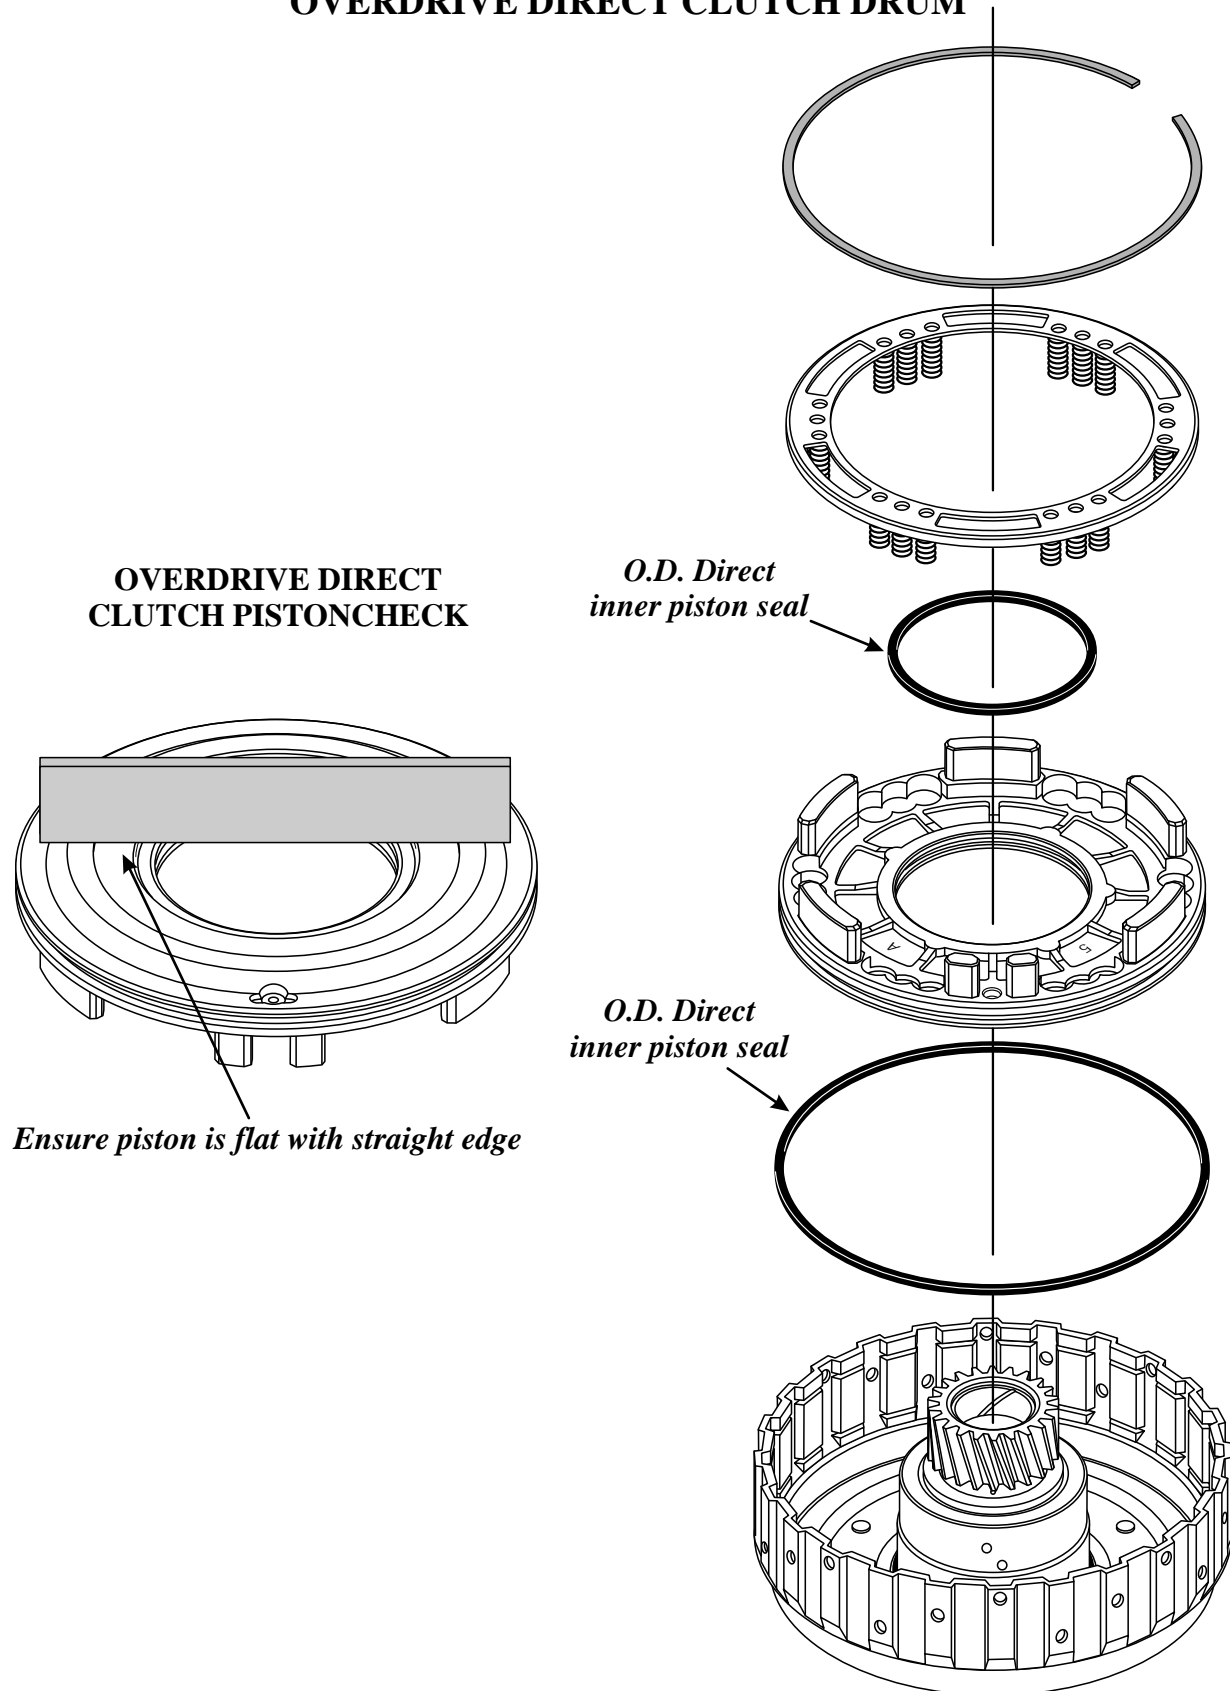
Figure 2

OVERDRIVE DIRECT CLUTCH DRUM

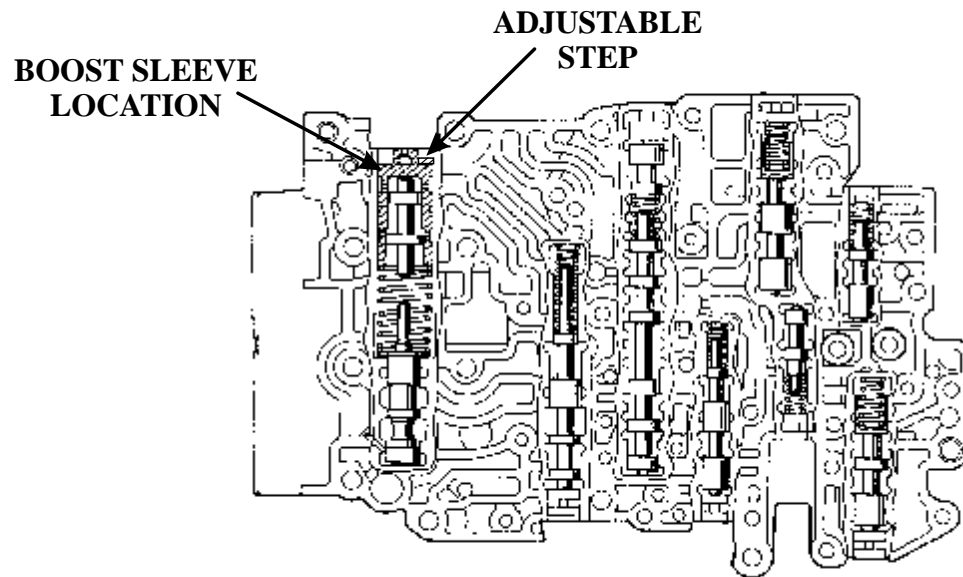
Figure 3

540-E LOWER VALVE BODY

NOTE: THE BOOST SLEEVE ON 540-E HAS AN ADJUSTABLE STEP. ENSURE THAT THE RETAINER IS IN THE SAME LOCATION AS BEFORE.
