Technical Service Information

2000 & LATER DODGE TRUCKS & VANS

46RE INTERNAL LINKAGE AND SAFETY NEUTRAL SWITCH CHANGES

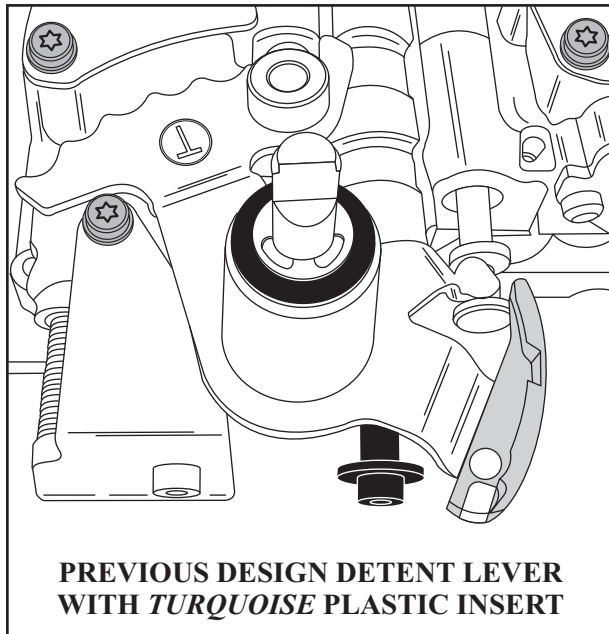
Figure 1

CAUSE: The safety neutral switch and the valve body detent lever changed for the 2000 model year. The switch is longer and the detent lever dimensionally changed to accommodate the new switch. Figures 1 and 2 show the dimensional differences between the previous and current design detent levers. Figures 3 and 4 illustrate the correct and incorrect assembly using the short switch. Figure 5 shows the correct assembly using the long switch.

CORRECTION: The detent lever with the *turquoise* plastic insert goes with the *short* safety neutral switch. The detent lever with the *red* plastic insert goes with the *long* safety neutral switch.
