# Technical Service Information

## THM 440-T4 LUBE DAM BROKEN

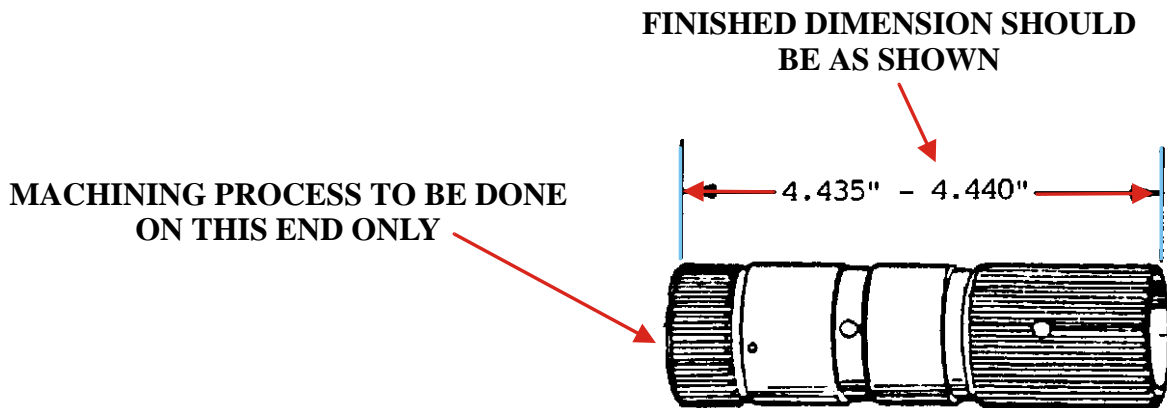
Figure 1

**CAUSE:** Final drive sun gear shaft is too long, and cuts plastic lube dam in half.

**CORRECTION:** Machine final drive sun gear shaft, ON THE SHORT SPLINED END ONLY, to the dimension shown in Figure 1. Finished dimension should be 4.435" - 4.440". Non-machined final drive sun gear shaft will measure 4.480" - 4.490". Measure all final drive sun gear shafts to insure proper length.

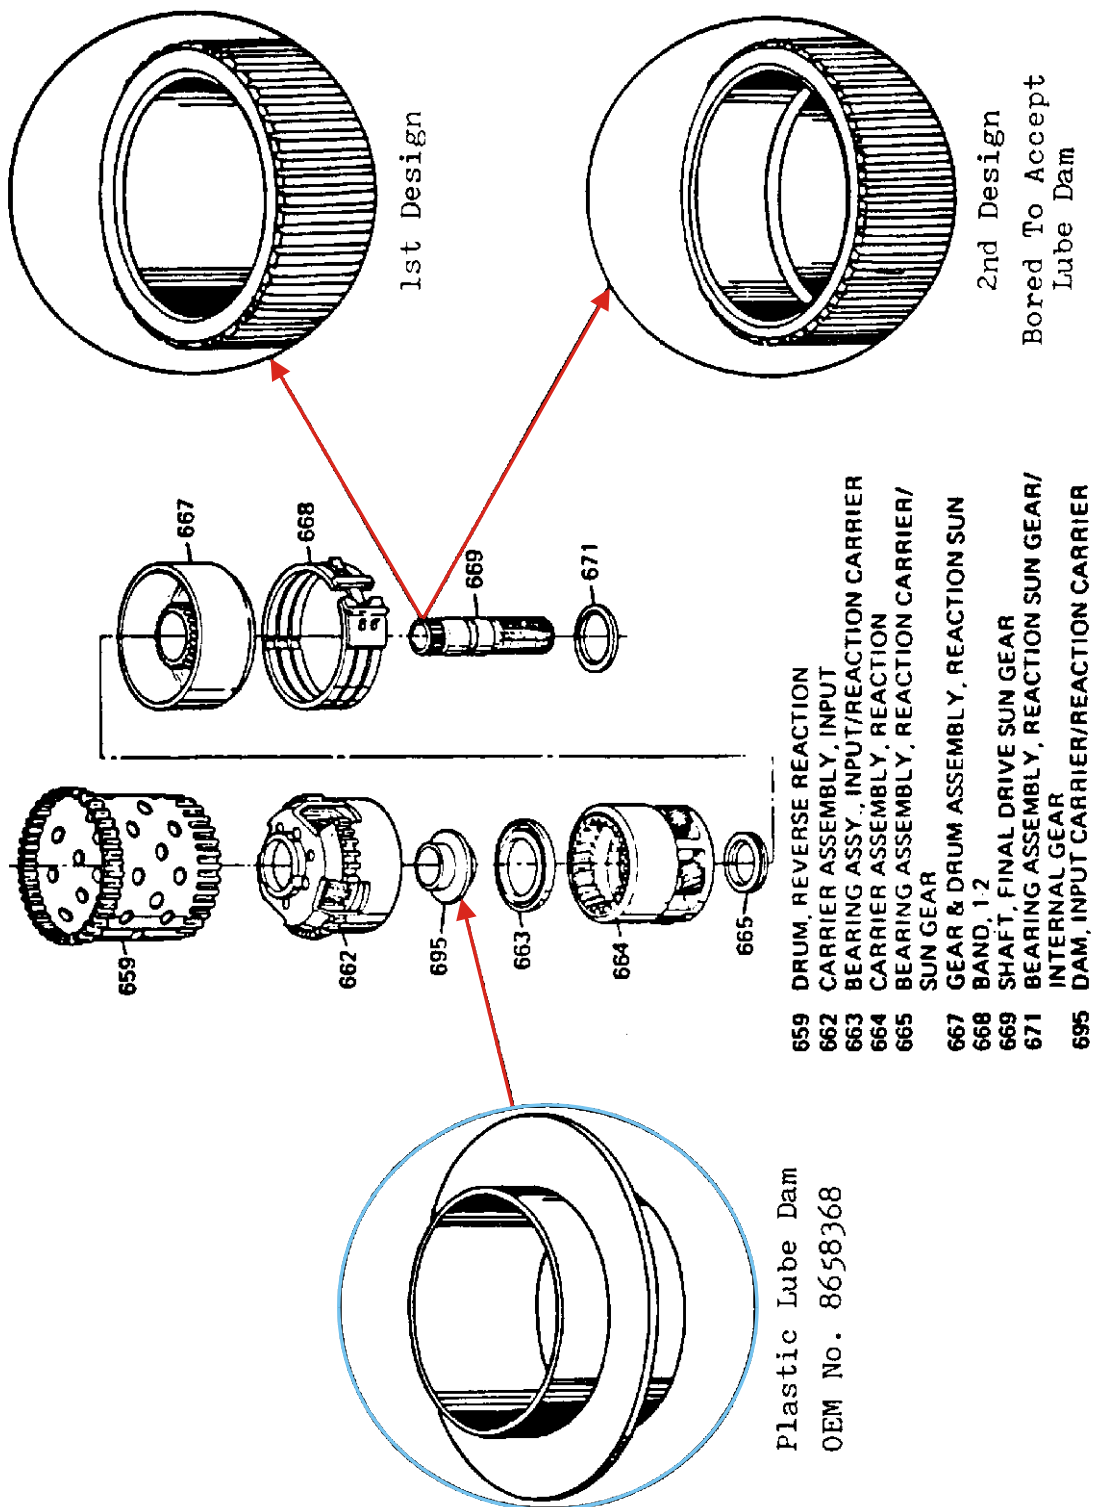
Figure 2

**COMPLAINT:** Plastic lube dam located between the carriers (See Figure 2) in two pieces, appearing as if it had been machined.
