Technical Service Information

FORD AODE/4R70W CONVERTER CLUTCH SHUDDER

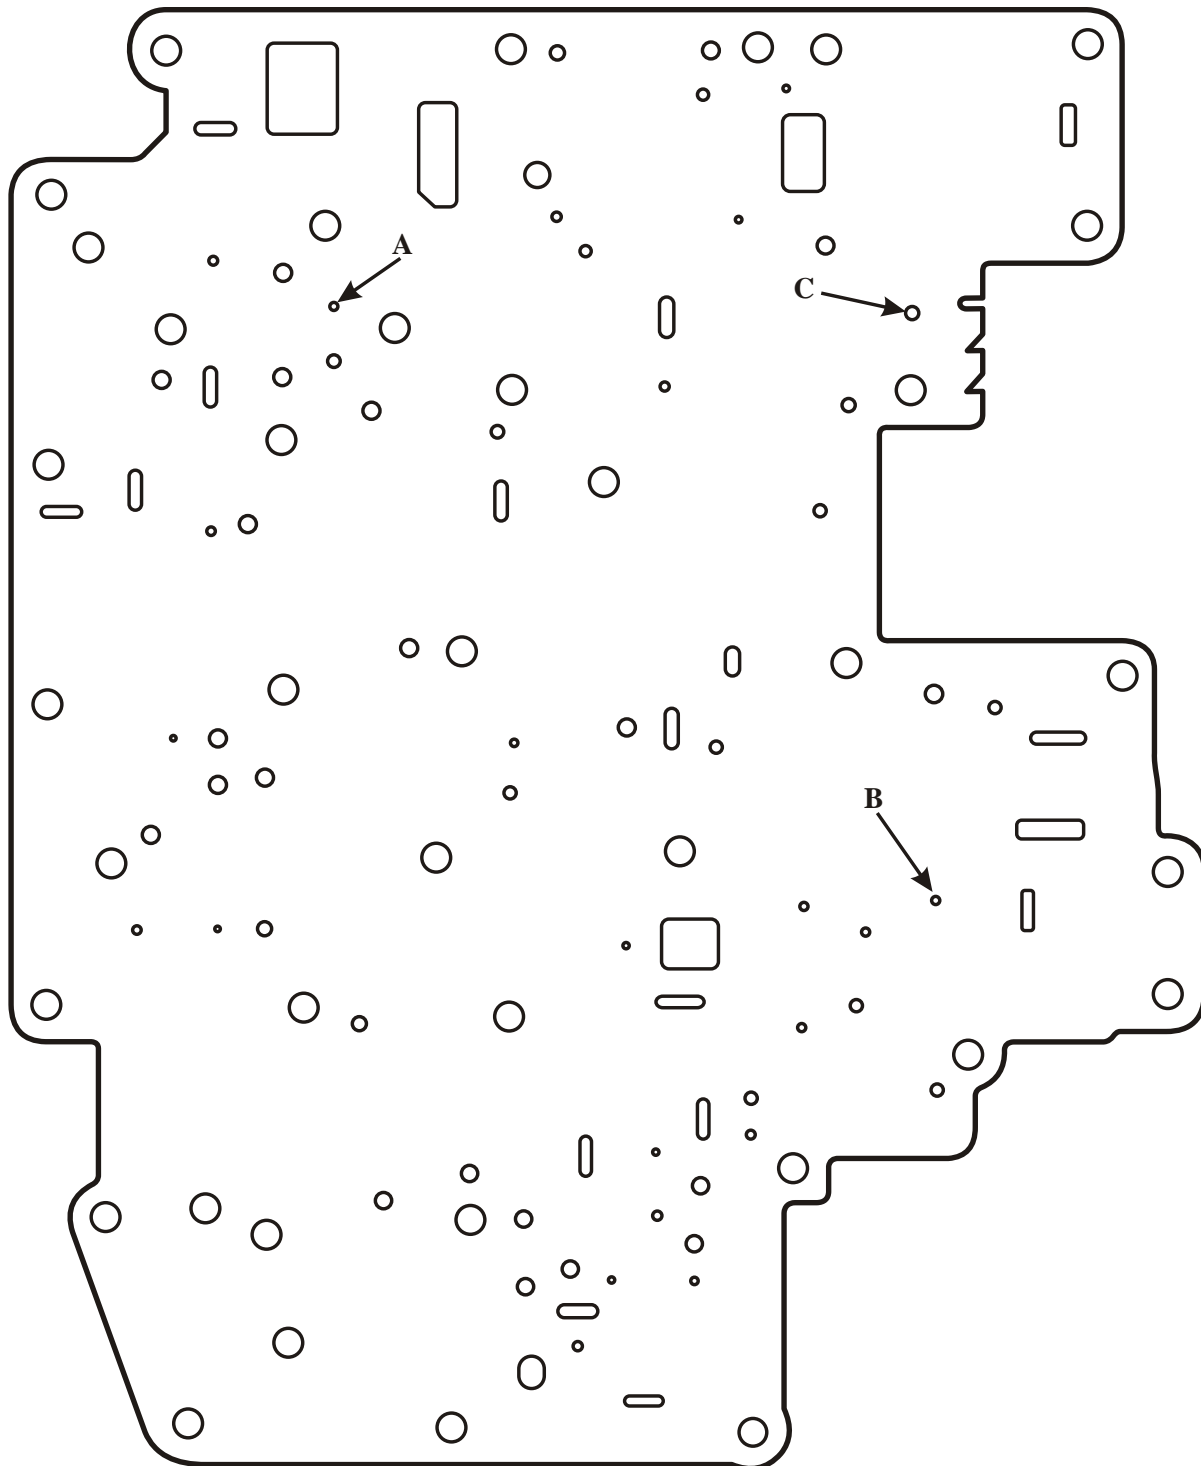
**FORD A0DE/4R70W
TCC SHUDDER**

COMPLAINT: Before and/or after rebuild, the vehicle exhibits a converter clutch shudder condition, even with the proper Mercon® transmission fluid installed.

CAUSE: The cause may be, not enough oil to the converter clutch apply circuit.

CORRECTION: Drill the hole marked "A" in Figure 1 out to .062", which increases the volume of oil to the bypass clutch control valve apply circuit.

Drill the hole marked "B" in Figure 1 out to .062", which increases oil volume to the MCC/PWM solenoid. This increased oil to the valve's apply circuit ("A" orifice).

Restrict the hole marked "C" in Figure 1, to approximately .030" using a cotter key, which ensures that apply oil can overcome this balance circuit.

1. DRILL HOLE MARKED "A" OUT TO .062".
2. DRILL HOLE MARKED "B" OUT TO .062".
3. INSTALL COTTER PIN IN HOLE MARKED "C"
TO REDUCE SIZE TO APPROXIMATELY .030".
