4T65-E

P1887 TCC RELEASE SWITCH MALFUNCTION

Technical Service Information

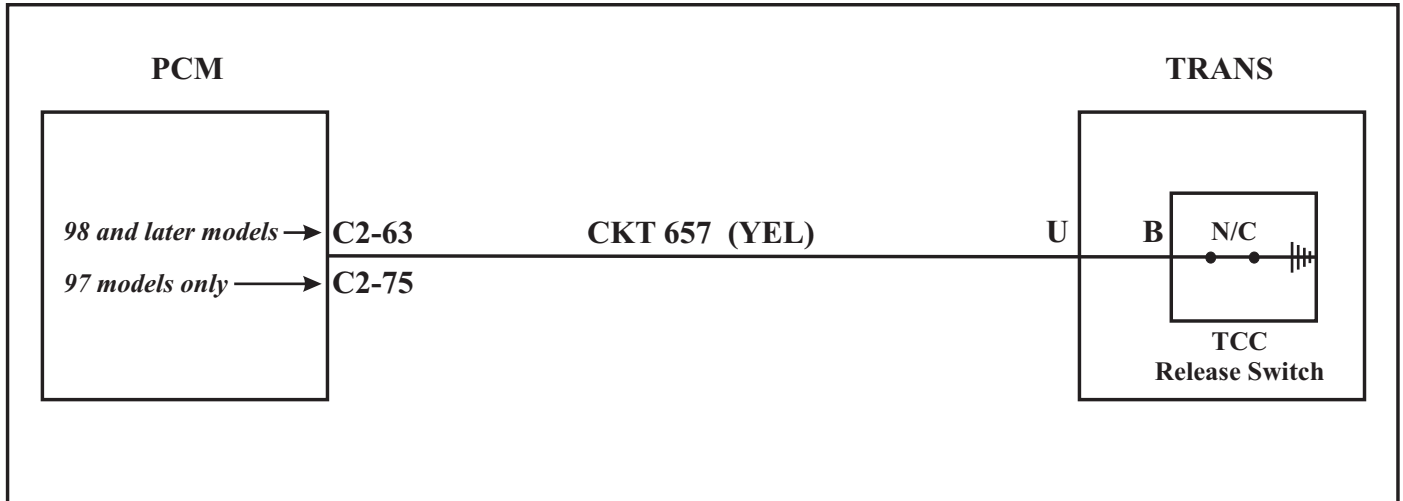
Figure 1

CAUSE: The PCM supplies 12 volts on CKT 657 to the TCC release switch with the ignition switch on or in the run position. (See figure 1) The TCC release switch is located inside the transaxle as part of the fluid pressure switch assembly. (See figure 2) This code is typically set when voltage on CKT 657 remains high for 6 seconds or longer when TCC is commanded on and TCC slip speed is -20 to +60 RPM.

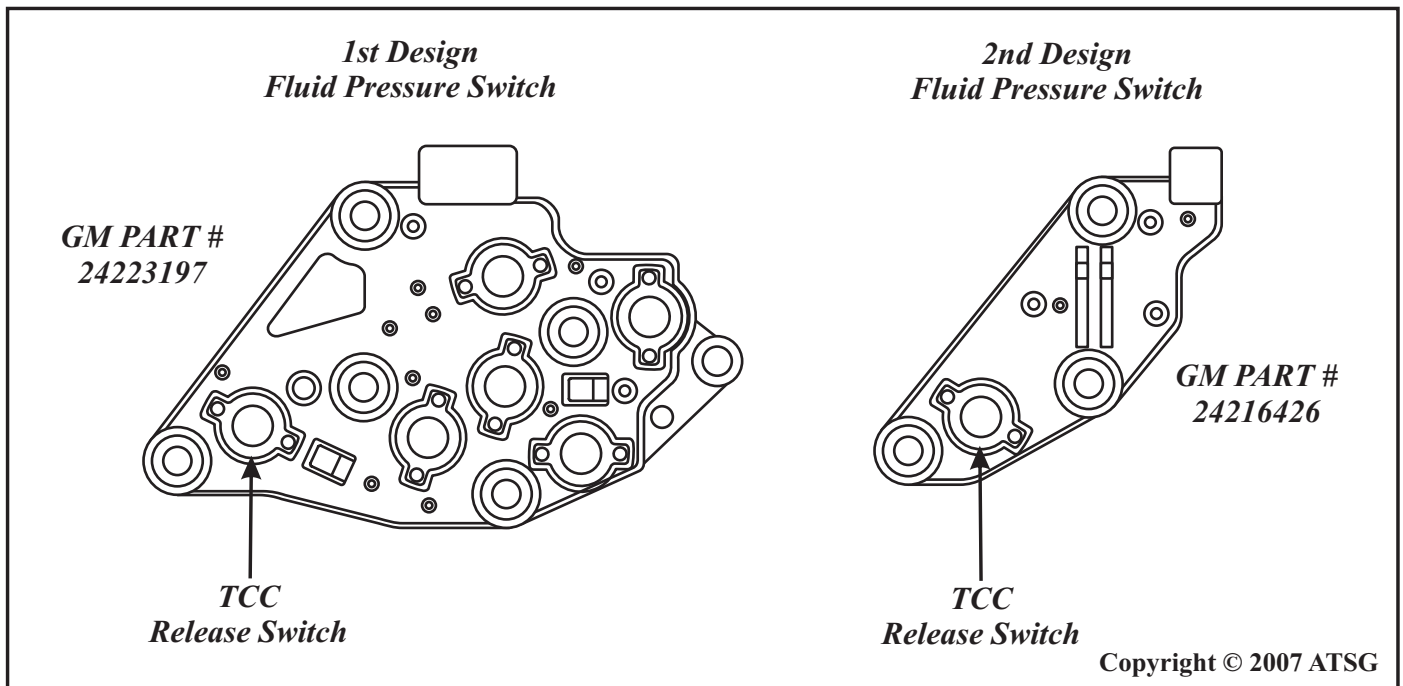
Figure 2

SERVICE INFORMATION: (See Figure 2)

24223197 = 1st Design Fluid Pressure Switch Assembly

24216426 = 2nd Design Fluid Pressure Switch Assembly

Turn the key off. Plug in trans harness connector and then turn key on again. Recheck voltage on wire at terminal U from wire entry side of connector. No voltage should be seen. If battery voltage remains, then either the internal harness is open or the TCC release switch is defective as this switch is normally closed to ground without oil pressure present. Repair internal harness or replace fluid pressure switch assembly as necessary

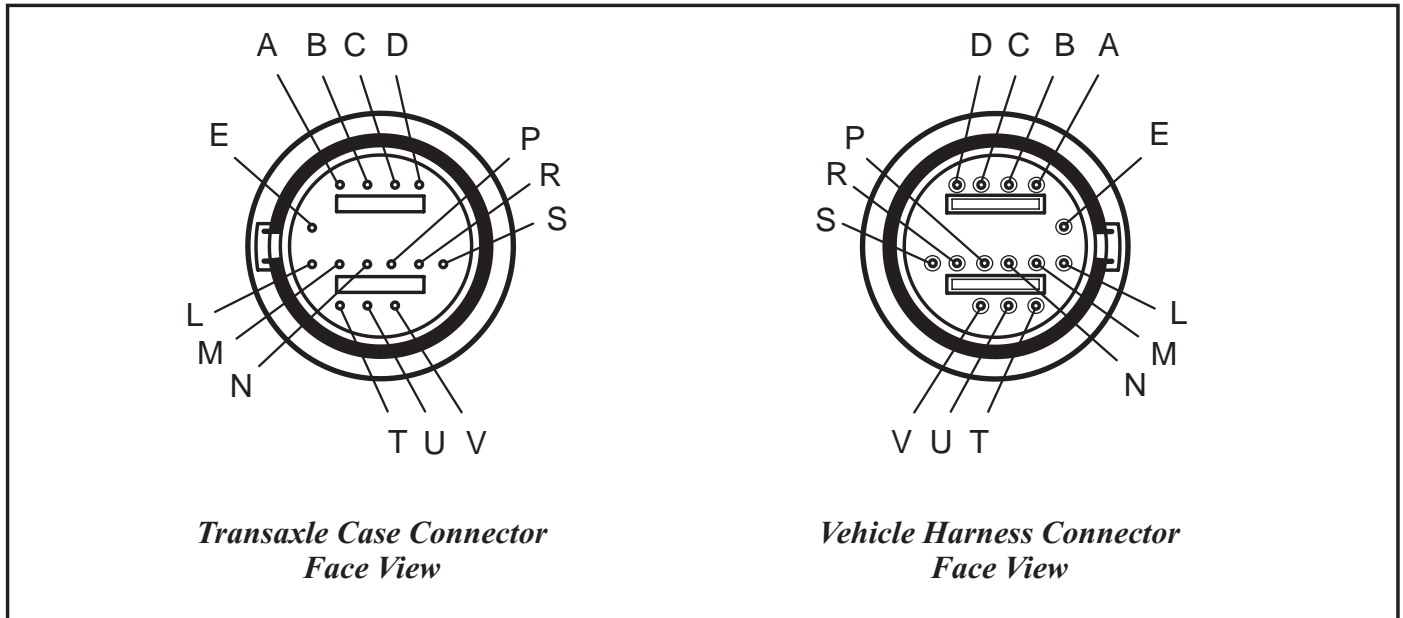
Figure 3

To test CKT 657, unplug the harness connector at the transmission and identify terminal U. (See figure 3) With a DVOM set to DC volts, place the negative lead to a known good ground and the positive meter lead to terminal U in the harness connector. Turn the **key on** with the **engine off**. Battery voltage should be seen.

If battery voltage **is** seen at this time, proceed with **Scenario 1**.

If battery voltage **is not** seen at this time, proceed with **Scenario 2**.

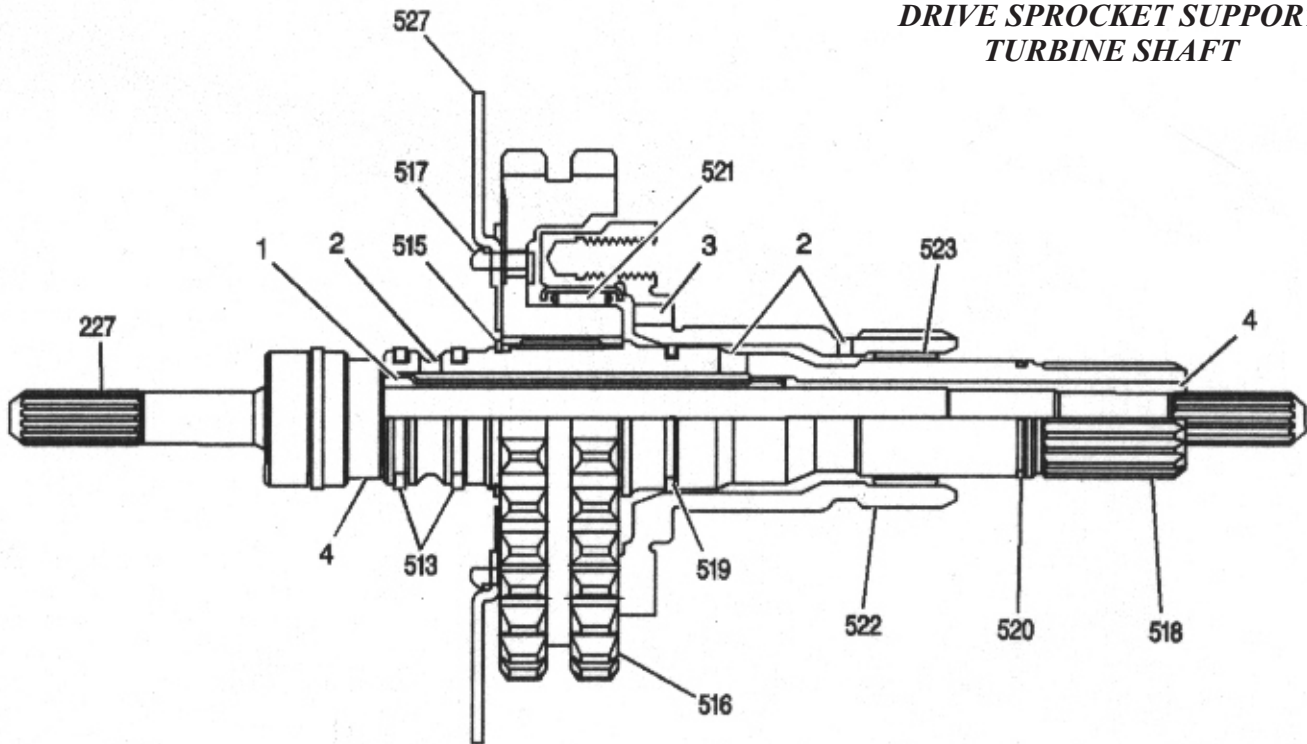
Figure 5

A damaged turbine shaft, teflon seal rings, O-ring or front stator support bushing.

A worn or damaged drive sprocket and/or bearing or channel plate sleeve.

Check for damaged turbine shaft or loose inner steel sleeve. Replace turbine shaft as necessary. Inspect for worn or damaged turbine shaft O-ring or seal rings and replace as necessary. Check for worn or loose drive sprocket support bushing and replace bushing or support as needed. (Stator Support) A worn or damaged drive sprocket where it rides the bearing or a damaged bearing will require replacement of both pieces. (See figure 5) If the channel plate sleeve has been damaged at the turbine shaft seal ring area from turbine shaft misalignment due to drive sprocket bushing or bearing failure, then replacement of the sleeve or entire channel plate assembly may be required. Valve body concerns such as a sticking or worn TCC control valve or bore will require repair or replacement of the control valve assembly. (See figure 6) Look for metal particles or debris that would not allow the # 1 checkball to seat properly. Clean or remove debris from the channel plate area as needed. (See figure 7)

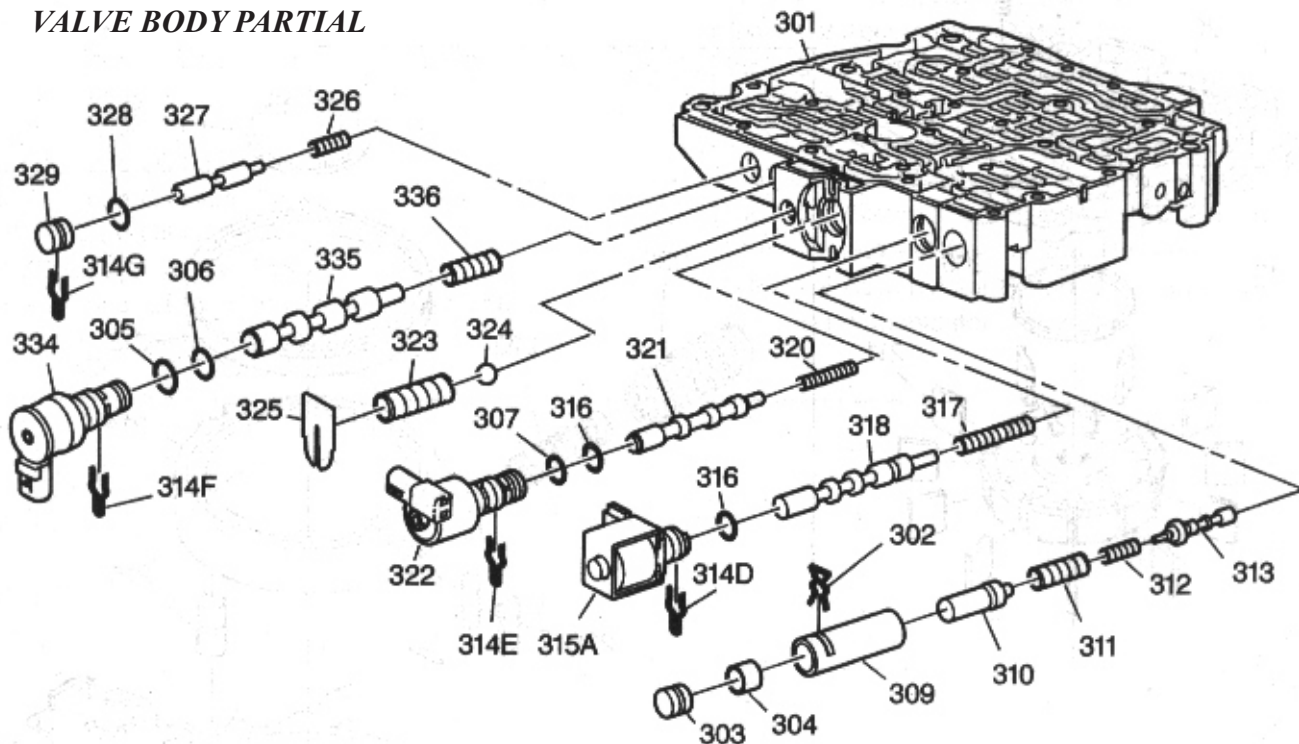
Figure 6

A sticking or worn TCC control valve or bore in the valve body.

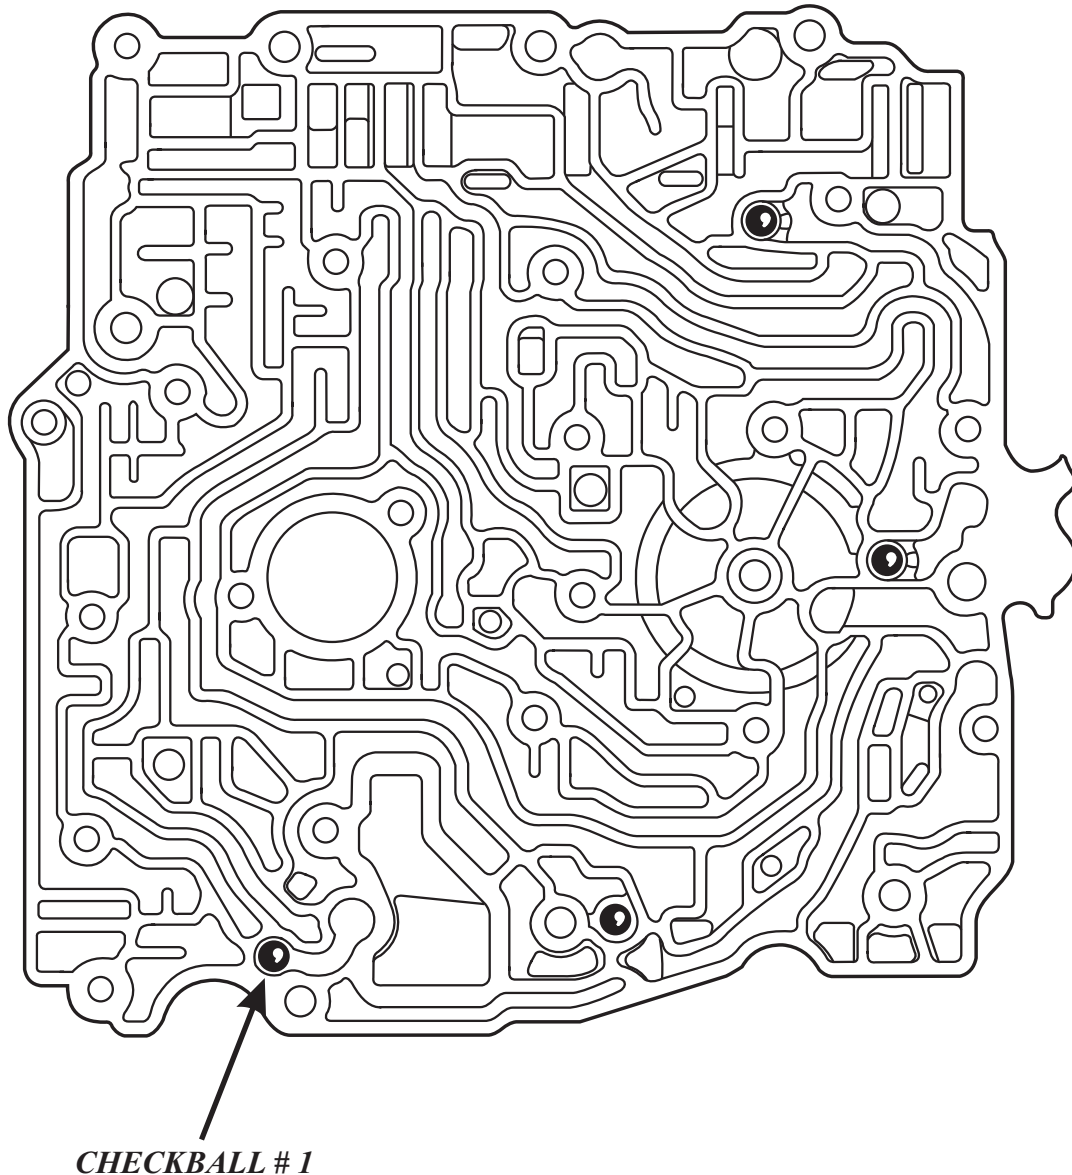
Figure 7

The #1 checkball in the channel plate is leaking or not seating properly.
