Technical Service Information

SATURN WHINE NOISE IN 2ND GEAR "ONLY"

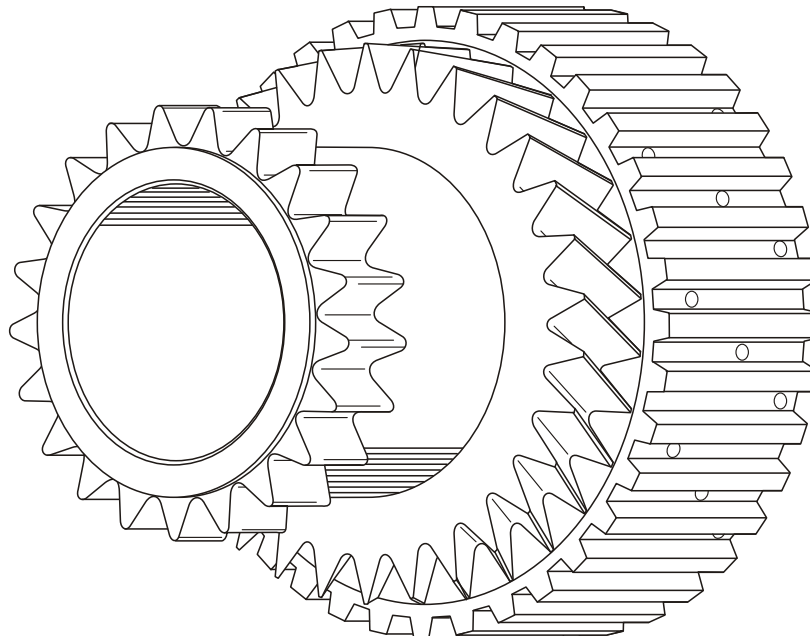
Figure 1

CAUSE: The cause may be, an improperly machined gear surface on the 2nd/Reverse Drive Gear.

**2ND/REVERSE DRIVE GEAR
SATURN PART NUMBER 21003233**

CORRECTION: Remove the transaxle from the vehicle, using the appropriate service manual, and replace the 2nd/Reverse Drive Gear with OEM part number 21003233. Refer to Figures 1 and 2.
