Technical Service Information

CHRYSLER A604 COAST DOWNSHIFT CLUNK

COMPLAINT: Before or after overhaul, vehicle exhibits a harsh coast downshift or a trailer hitching effect when slowing to a stop.

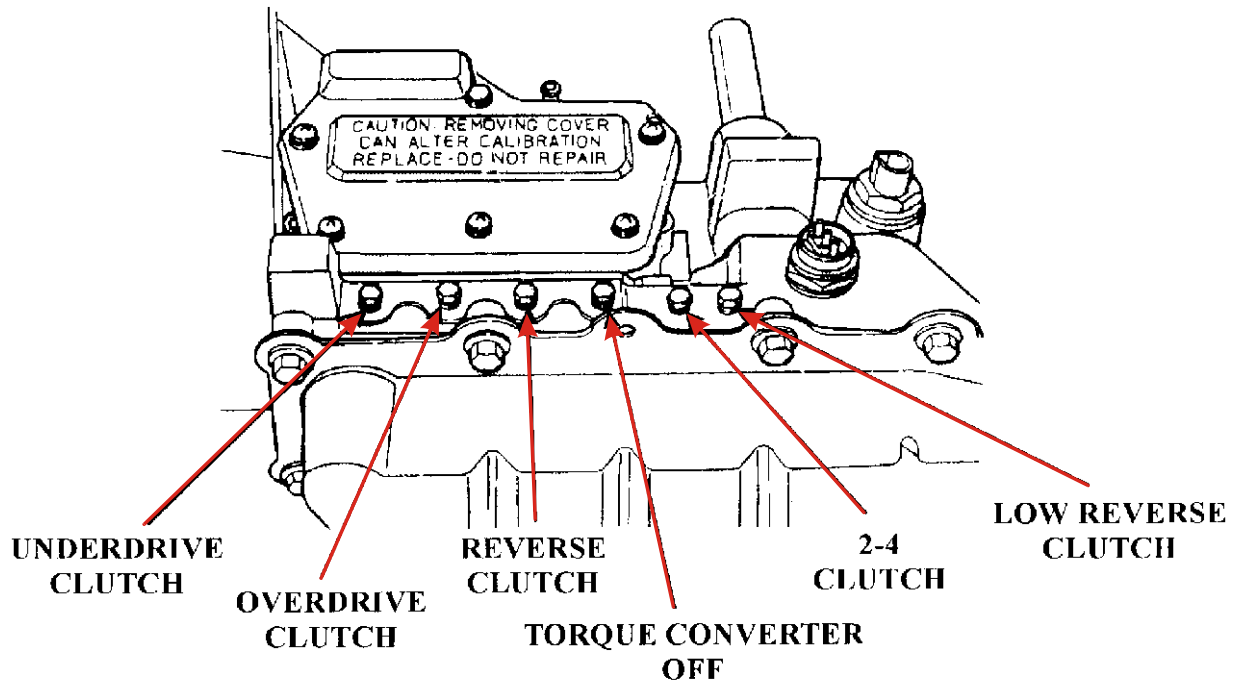
Figure 1

2. Attach a 0-300 lb. pressure gage to the Low Reverse and the Underdrive pressure ports as shown in Figure 1. Record the pressures at an idle seen in Park, Reverse, Neutral and Drive while the vehicle is standing still.

3. Road test the vehicle with the pressure gage's and scanner still attached. **NOTE: For safety concerns, this road test should be performed with two people.** "Observe" the gage on the Underdrive port, when a 4-3 downshift occurs the pressure gage should rise to between 20-30psi. for a split second and then rise quickly up to 75-95 PSI., this is "Normal" operation. When a downshift to 1st occurs, the gage on the Low Reverse port should rise to between 20-30psi. for a split second, and then rise quickly up to 115-145 PSI. This should all happen right **before** the vehicle is at a complete stop, and is "Normal" operation. If the pressure, on the Underdrive port, builds to 20-30 PSI., stays there, and then jumps up from 20-30 PSI. to 115-145 PSI. when the 4-3 downshift clunk is felt, the problem is most likely hydraulic / mechanical (See Correction A for a list of most common possibilities). If the pressure, on the Low Reverse port, builds to 20-30 PSI., stays there, and then jumps up from 20-30 PSI. to 115-145 PSI. **after** the vehicle is at a complete stop, the problem is most likely hydraulic / mechanical (See Correction A). If pressure stays at "0" but rises up to 20-30 PSI., and then to 115-145 PSI., **long after** a complete stop, the problem is most likely electrical. (See Correction B for a list of most common possibilities).

PRESSURE PORT LOCATIONS AND SPECIFICATIONS

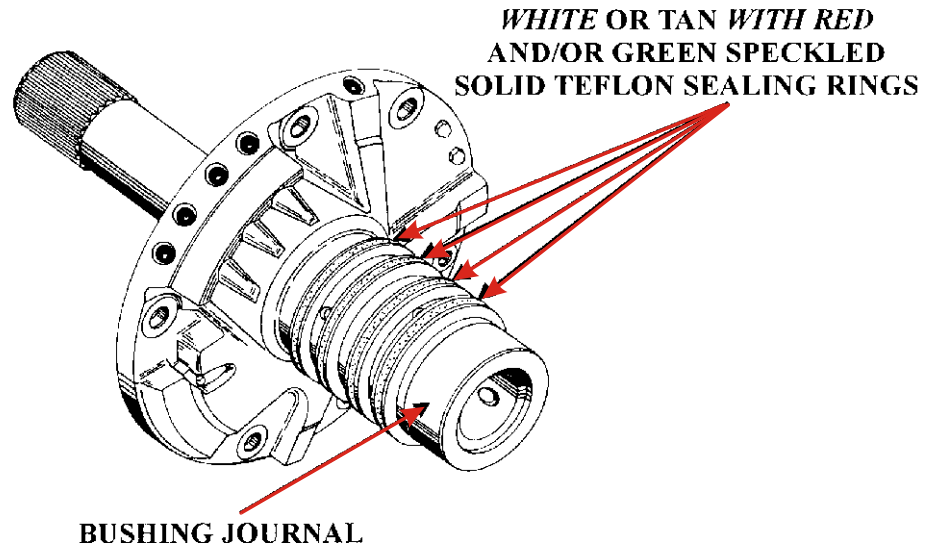
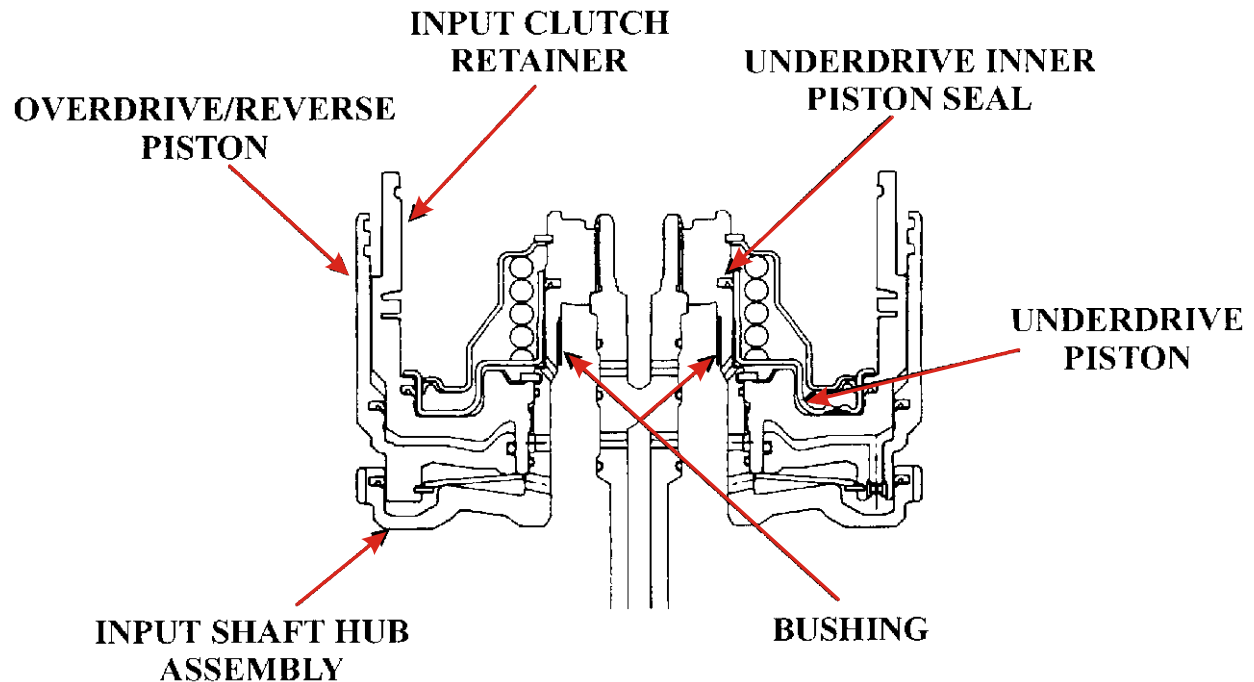
Figure2

1. Leakage at the pump cover sealing rings and or the bushing in the "Input shaft hub assembly," allowing a pressure loss, and allowing the possibility of a harsh re-engagement of the Underdrive clutch when downshifting from Overdrive back to 3rd or 2nd gear.

1. Use "Solid Teflon Sealing rings" on the pump cover. Ensure that they are "While or Tan with Red and/or Green Speckles." If your overhaul kit does not furnish these sealing rings for you, use the "Center support sealing rings" from a "4L80-E." **NOTE :** The solid teflon sealing rings can be easily installed and sized with the "Input shaft hub assembly." Inspect the bushing journal at the end of the pump cover for wear or scoring (see Figure 2). Inspect the bushing in the "Input shaft hub assembly" and check for a snug fit on the pump cover. (See Figure 2)

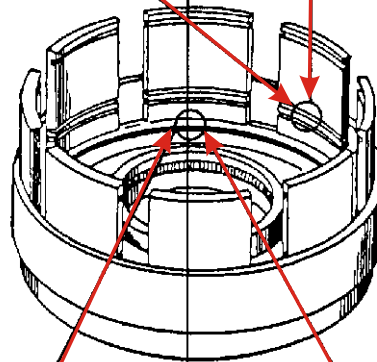
2. Incorrect usage of the Underdrive Overdrive retainer plate and or "Tapered" snap ring.
3. Incorrect usage of the Underdrive "Outer" piston seal, and or leakage of the inner piston seal.

UNDERDRIVE OUTER PISTON SEALS

LIP SEAL GROOVE
.040" SHALLOWER TO
ACCOMMODATE
NEW OUTER LIP
SEAL

2. Refer to Figure 3 to identify and select the correct Underdrive/Overdrive retainer plate and tapered snap ring.
3. Refer to Figure 3 to identify and select the correct Underdrive "Outer" piston seal. Refer to Figure 2 to Identify the placement of the Underdrive "Inner" piston seal.

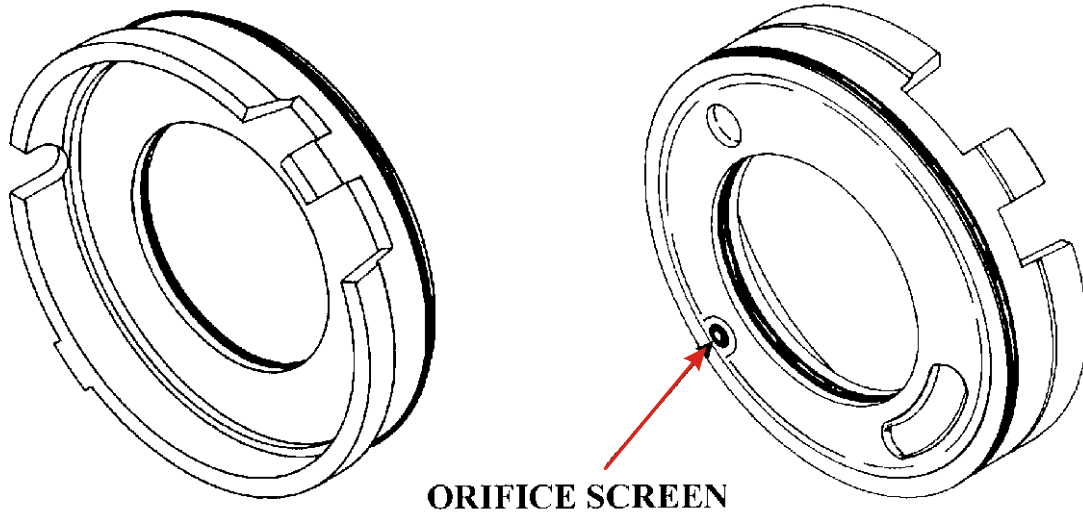
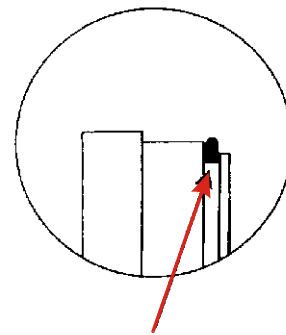
Figure 4

4. Leakage at the Low / Reverse piston seals, orifice screen, or Low / Reverse piston retainer and gasket, due to warpage at the attaching bolt holes or loose retainer attaching bolts.

NOTE: USE PART NUMBER 4431672 1993 & UP LOW REVERSE PISTON. IT IS .002" SMALLER IN DIAMETER ABOVE THE OUTER PISTON SEAL. THIS WAS DONE TO PREVENT THERMAL BINDING IN THE PISTON RETAINER.

4. Inspect the Low Reverse piston and ensure that the updated "D"-rings are used. Inspect the rear of the piston to ensure that the "Orifice Screen" is in place and is not damaged (See Figure 4). Replace piston with part # 4431672 if the transmission was produced prior to 1993. Replace piston retainer with part # 4431648 and replace the gasket under the piston retainer (See Figure 5). Coat the attaching bolts with "Loctite"® and torque them to 40 inch lbs. **NOTE: Be careful not to over-torque as the threads in the case can be easily "Stripped"**

**NEW DESIGN "D-RING" KIT PART NO. 4778883
(Contains both Inner and Outer seals)**

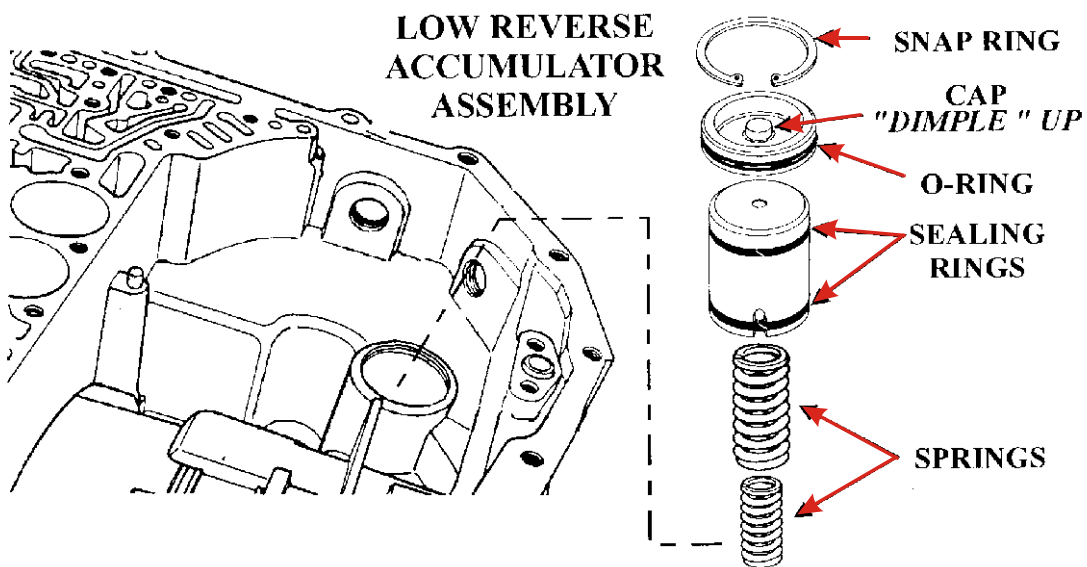
5. Leakage at the Low Reverse clutch accumulator rings and / or the O-ring on the accumulator cap, or the cap installed backwards.
6. Underdrive and Overdrive accumulator pistons installed backwards.

CORRECTION: 5. Inspect the Low Reverse accumulator scarf cut sealing rings for damage and proper fit. Install the accumulator springs, piston, cap and snap ring as shown in Figure 6
6. Check and adjust Low Reverse clutch clearance to .035"-.045."

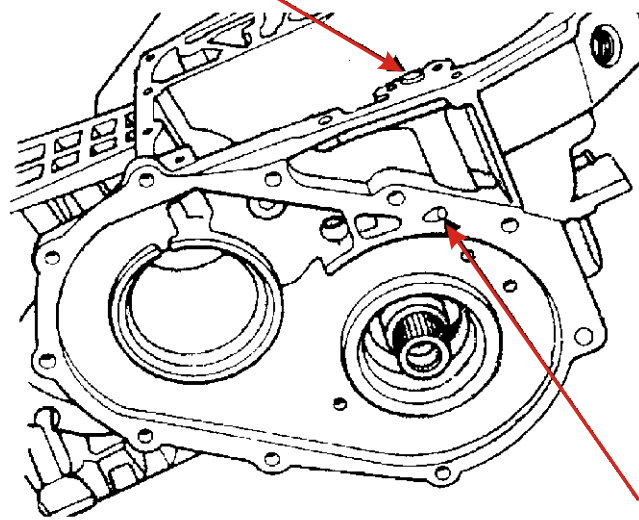
7. Excessive Low Reverse clutch clearance.
8. A "Dented" valve body separator plate where it meets the Low Reverse feed pipe in the rear of the case, or incorrectly torqued valve body bolts.

9. A leak at the large check ball staked into the rear of the case, connecting the Low Reverse feed passage to the Low Reverse accumulator, causing a loss of Low / Reverse clutch oil.

"NO" LEAKAGE ALLOWED FROM
STEEL BALL STAKED IN CASE

NOTE: THE LOW REVERSE ACCUMULATOR, ALL CLUTCH AND STEEL PLATES MUST BE ASSEMBLED BEFORE AIR CHECKING. THE ORIFICE SCREEN IN THE LOW REVERSE PISTON WILL LEAK A SMALL AMOUNT OF AIR, THIS IS NORMAL

1. Inspect the valve body separator plate where it seats around the Low Reverse feed pipe, shown in Figure 7, for "Dent's" that may have been caused by a mis-alignment of the valve body to the case. Torque valve body to case attaching bolts to 105 inch lbs.

8. Refer to Figure 7 to locate the "Large Steel Ball" staked into the rear of the case. Ensure "NO" leakage around the ball when air checking the Low Reverse clutch.

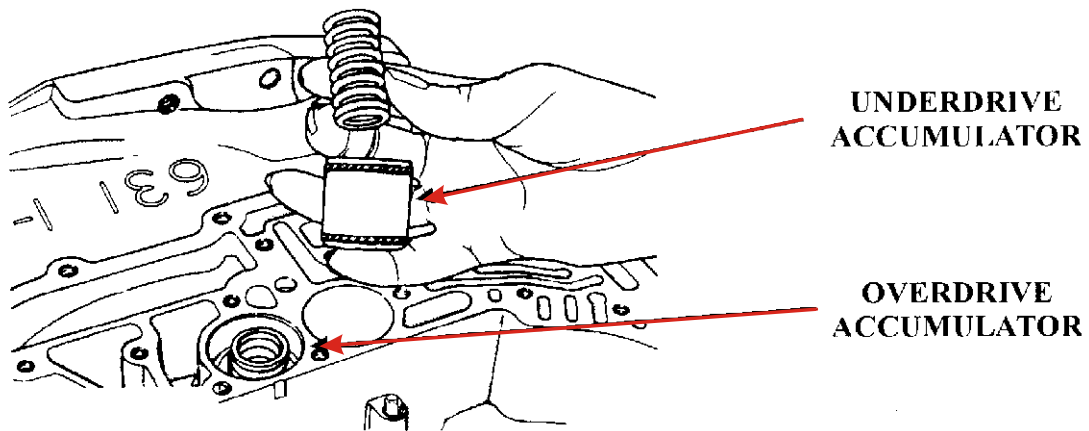
UNDERDRIVE AND OVERDRIVE ACCUMULATOR ASSEMBLY'S

9. Refer to Figure 8 for the correct assembly of the Underdrive and Overdrive accumulator pistons and springs.

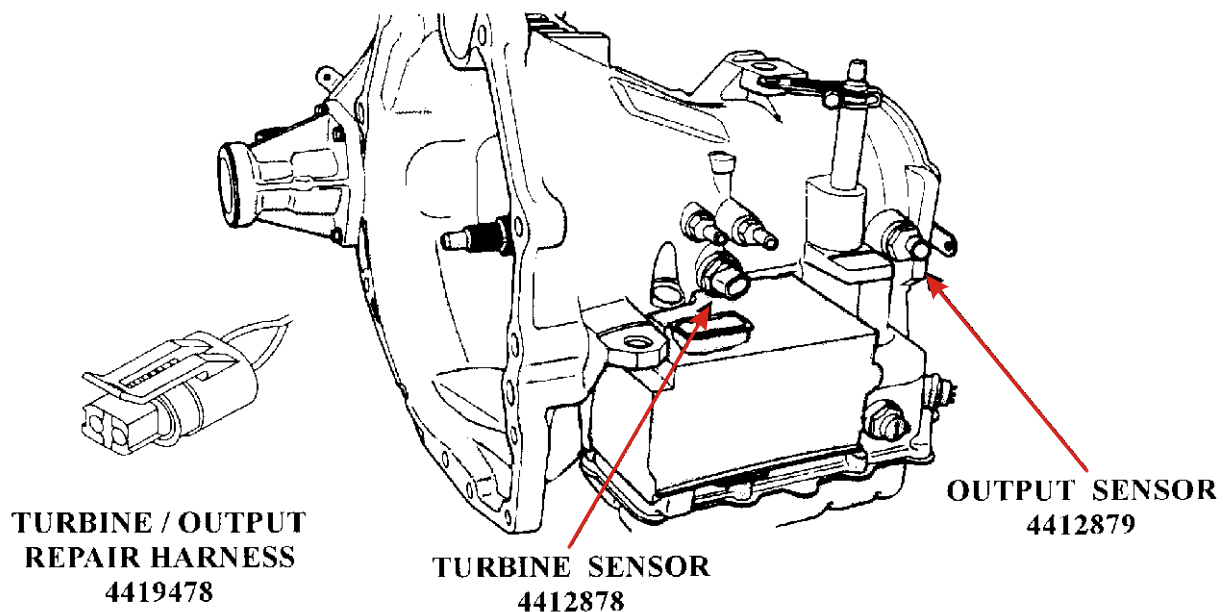
Figure 9

1. Intermittent current "drop's" from the Turbine or Output speed sensors confusing the transmission controller and causing a downshift command to be timed incorrectly.
2. Throttle position sensor faulty, out of range, or mis-adjusted.
3. Solenoid body malfunction's.
4. Faulty transmission controller.

SPEED SENSOR LOCATION

1. Install a scanner to the diagnostic connector and observe the "Turbine" and "Output" speed sensor readings when slowing to a stop and ensure that both readings drop to "0" when the vehicle is completely stopped. If you have a "Snap-on" scanner and have "Scan Graphics" or you have a "Scope" you can more accurately determine whether the speed sensors are working correctly or not, by observing their output signal for erratic patterns. If you do not have the luxury of having these options then "Arm" or "Record" a movie of your road test and pay close attention to the steady drop of the speed sensor rpm's., when slowing to a stop. An erratic rpm. drop or a slow rpm. drop may indicate a speed sensor problem.

NOTE: The scanner is the last "Priority" on the "BUS" system so it may appear to be sluggish at times . This means that the downshift may have already ocured but the scanner did not show that it had happened yet. Do not be confused by this. Before condemning a speed sensor inspect it's environment. A poor connection or a wire harness or spark plug wire laying on or wrapped around speed sensor wires can "Induce" current into the wire harness and can cause some erratic readings and cause many upshift or downshift problems. If the Turbine or Output Speed Sensors have erratic or no output and are found faulty, the part number for the Turbine Speed Sensor is 4412878. The part number for the Output Speed Sensor is 4412879. While the scanner is connected run the vehicle on the lift up to third gear, (If the car is not equipped with ABS.), Turbine and Output Speed Sensor rpm's. should read the same. "Wiggle" the speed sensor connectors and watch the scanner to see if the readings fluctuate. If they do this could indicate the need for replacement harness connectors, Chrysler part No. 4419478 . (See Figure 9)

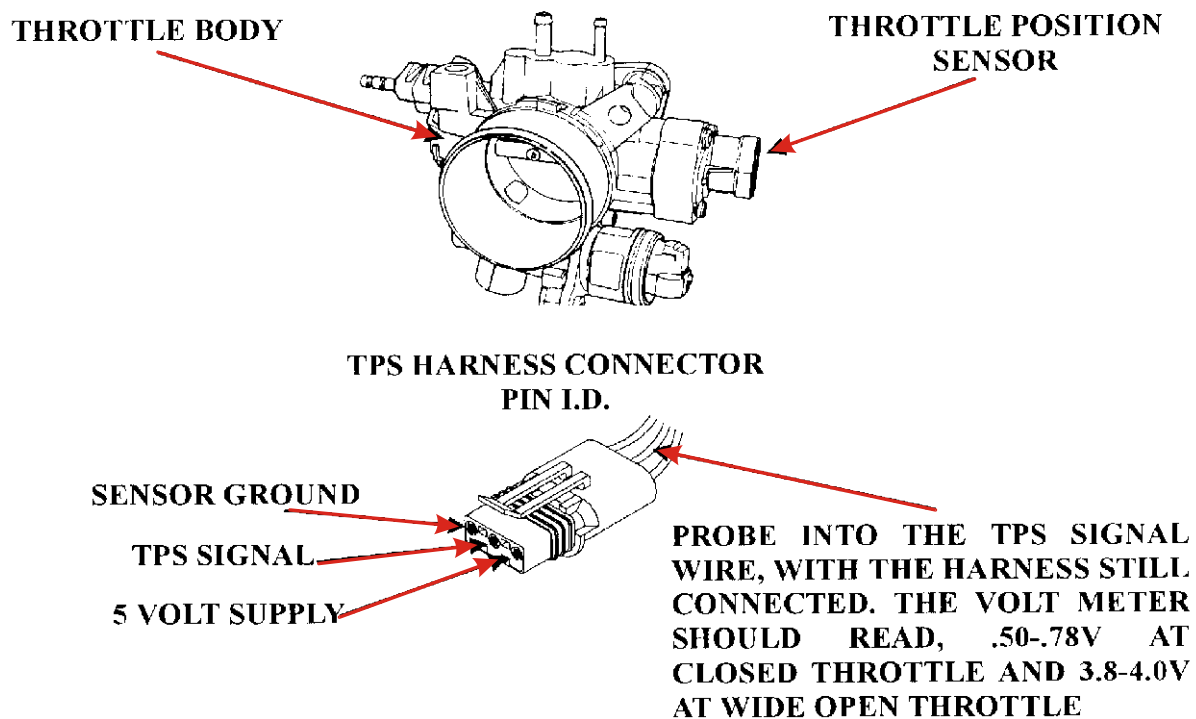
Figure 10

THROTTLE POSITION SENSOR LOCATION AND CHECK

2. Inspect "Throttle Position Sensor" voltage either with a hand held scanner or a volt meter and ensure that the "Base" or "Closed" throttle voltage reading is between .50-.78V, and the "Full" throttle voltage reading is between 3.8-4.0V. (See Figure 10) If the base throttle stays above 1.0 volt or if excessive or intermittent voltage or signal changes occur, harsher downshifts may result.

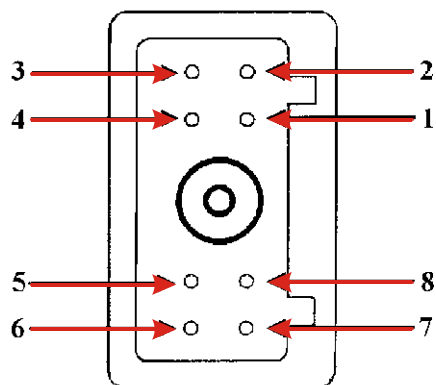
Figure 11

SOLENOID PACK CHECK

SOLENOID CHECK: ALL FOUR SOLENOIDS SHOULD HAVE 1.5 OHM'S RESISTANCE
 SOLENOID 1- CONNECT OHMMETER TO PINS 4 AND 5
 SOLENOID 2- CONNECT OHMMETER TO PINS 4 AND 6
 SOLENOID 3- CONNECT OHMMETER TO PINS 4 AND 7
 SOLENOID 4- CONNECT OHMMETER TO PINS 4 AND 8

RESISTOR CHECK: ALL THREE RESISTORS SHOULD HAVE 270-330 OHMS RESISTANCE
 O.D. RESISTOR- CONNECT OHMMETER TO PINS 4 AND 3
 L/R RESISTOR- CONNECT OHMMETER TO PINS 4 AND 2
 2-4 RESISTOR- CONNECT OHMMETER TO PINS 4 AND 1

CORRECTION: 3. To test the Solenoid pack install a scanner to the diagnostic connector and select "ATM" or "Actuator" test's. Connect a pressure guage to the corresponding pressure port (see Figure 1) and observe the operation of the solenoid and the reaction on the pressure guage. **NOTE: the vehicle must have the drive wheels in the air and the selector in Overdrive and the Parking Brake engaged before starting this test. Consult your scanner reference manual.** If a solenoid does not respond consistently, this may indicate that the solenoid pack needs replacement. It has been noted that not all TCM's will activate the ATM or Actuator test. If you can not initiate the test, refer to Figures 11 and 12 to test the solenoid pack.

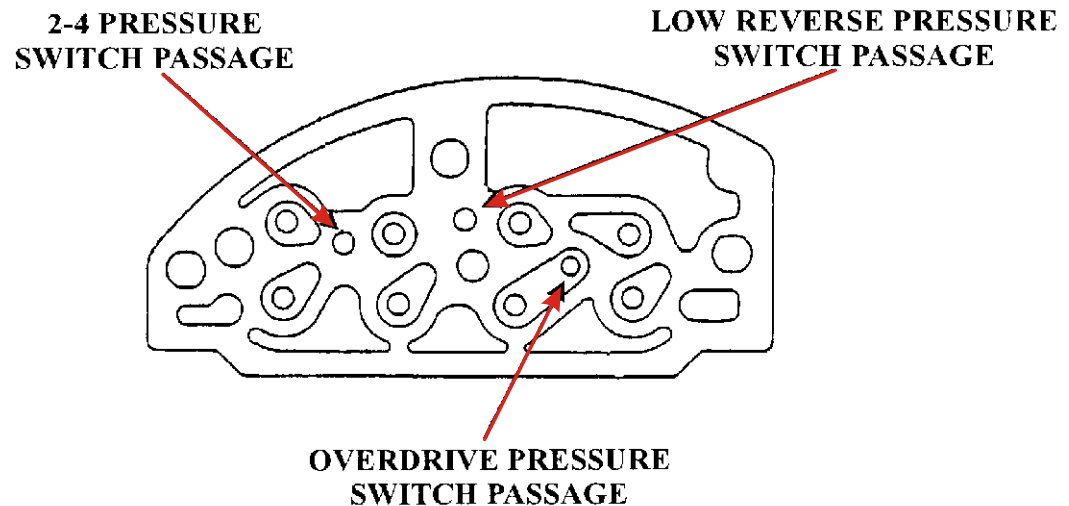
Figure 12

SOLENOID PACK PRESSURE SWITCH TEST AND I.D.

PRESSURE SWITCH TEST: ALL THREE PRESSURE SWITCHES ARE TESTED WITH 50PSI. OF AIR PRESSURE APPLIED TO THE PASSAGES SHOWN ABOVE AND AN OHMMETER. WITH NO AIR APPLIED TO THE SWITCH THE OHMMETER SHOULD READ NO CONTINUITY. WITH AIR APPLIED TO THE SWITCH THE OHMMETER SHOULD READ 0 OHM'S.

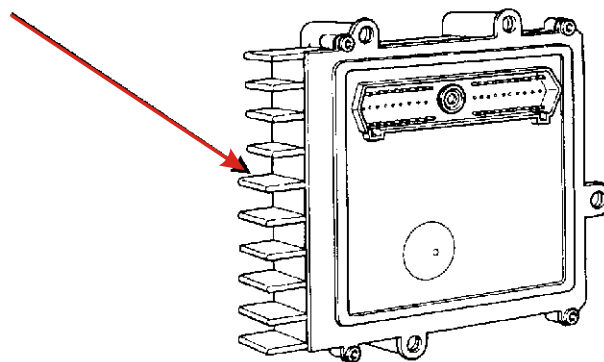
Figure 13

TRANSMISSION CONTROLLER
WITH "COOLING FIN'S"

4. After all Hydraulic / Mechanical concerns have been addressed the Transmission Control Module (TCM) may need "Flashed", (Reprogramed), or replaced. The main requirements for a "Flashable" TCM. are:

1. Must **have** "Cooling" Fin's." (See Figure 13)

If the TCM *does not* have "Cooling Fins," or *has* one of the part numbers listed above, contact your Chrysler dealer for a replacement TCM. Chrysler Technical Service Bulletin 18-24-95 refer's to "Flashing" procedures and a full list of updated TCM part numbers and important information concerning "Pin 49" on Spirit and Acclaim models.
