AUTOMATIC TRANSMISSION SERVICE GROUP

SEMINARS 1989

TECHNICAL INFORMATION PACKAGE

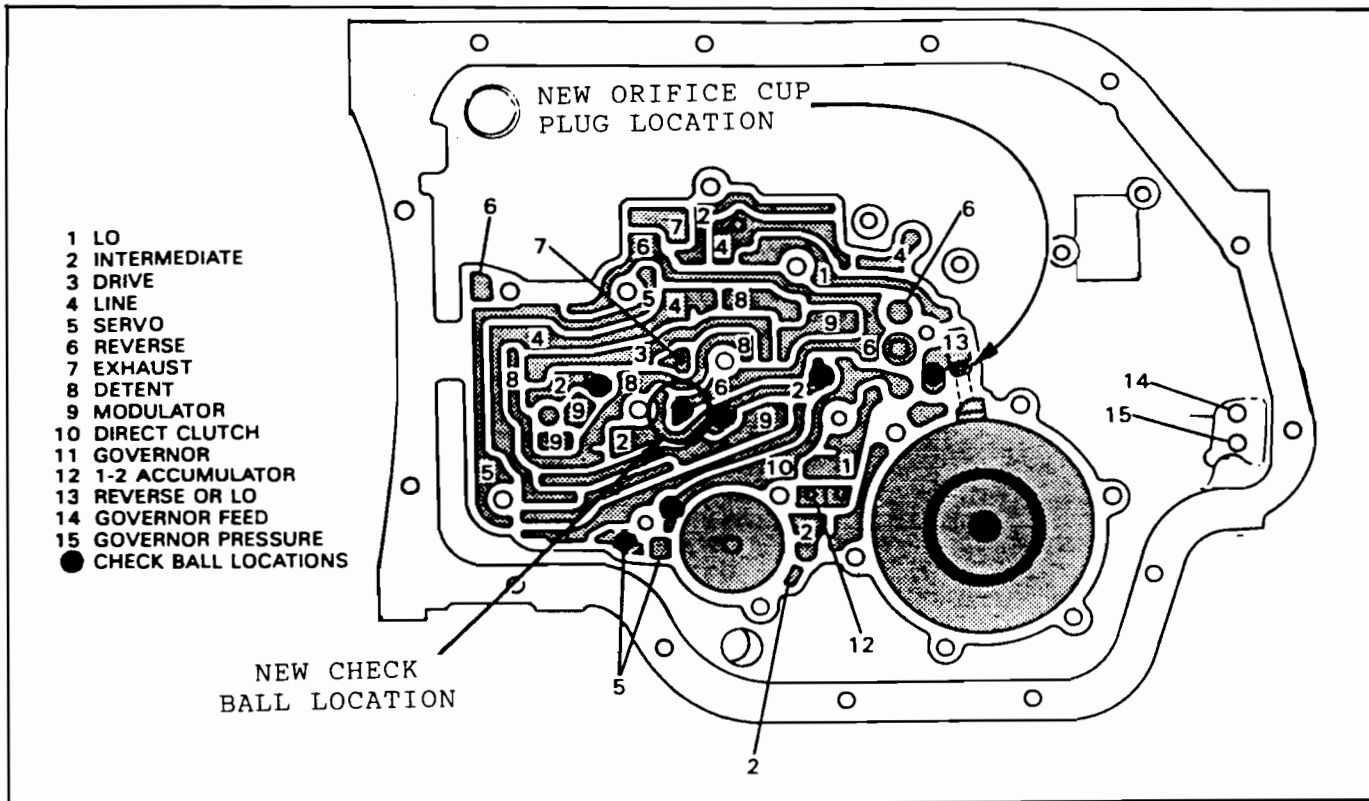
CHANGE: Check ball added to case on 1987-1988 vehicles, and ONLY on vehicles with GVW of under 10,000lbs.

REASON: Softens the apply feel when the selector is moved from Park/Neutral to reverse.

- (1) Transmission Case - Seventh check ball added to the case, and orificed cup plug added in the reverse servo feed bore. See Figure 1 for locations of both items.
- (2) Spacer Plate - Spacer plate is revised for the additional check ball (See Figure 2).
- (3) Valve Body Gaskets - Both gaskets are also revised for the additional check ball.

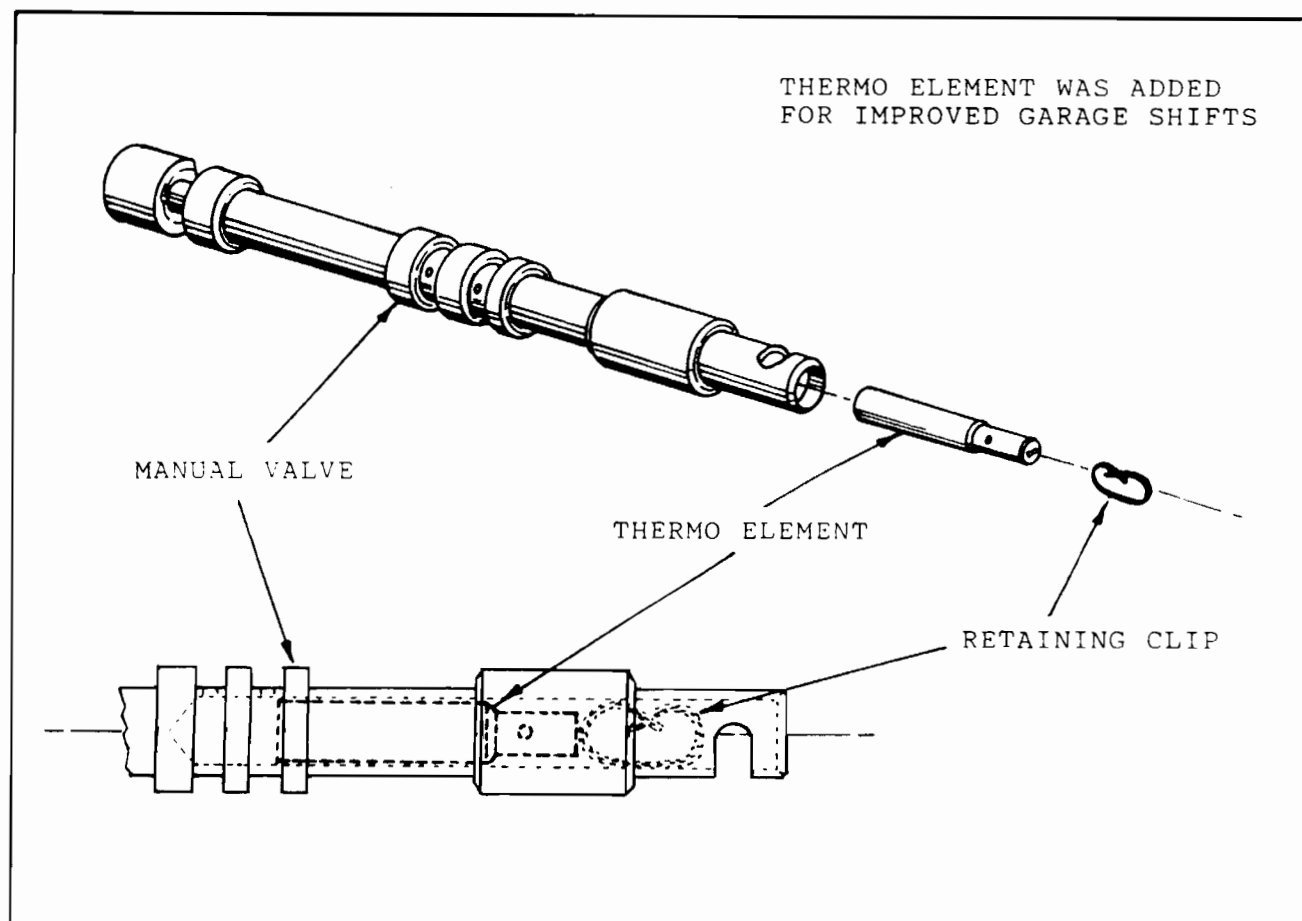
Figure 1

CAUSE: The cause may be a broken Thermo Element Retaining Clip, located "Inside" of the manual valve. This would allow the Thermo Element to move forward, allowing drive and/or reverse oil to exhaust (See Figure 1). A retaining clip that has broken and fallen out can usually be located in the bottom pan.

CORRECTION: Install previous design manual valve, or replace retaining clip and/or thermo element as necessary.

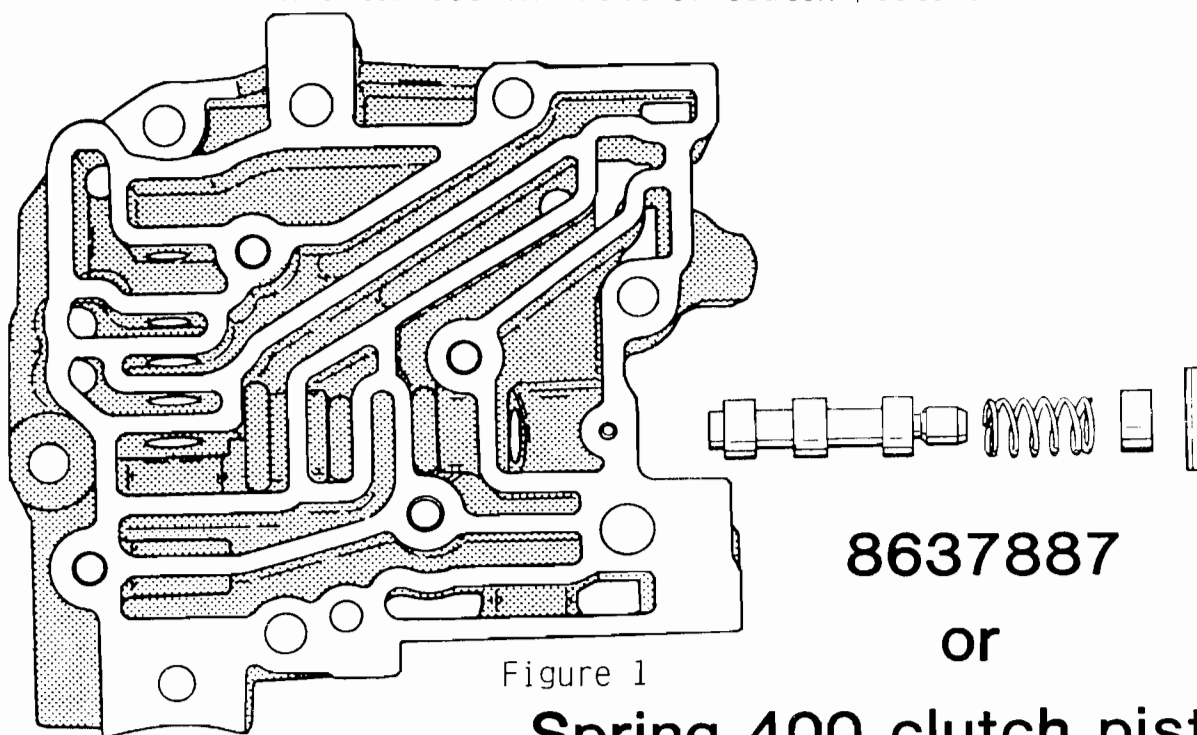
Figure 1

CAUSE: One cause can be low converter regulator charge pressure, Figure 1. Another cause can be slow drain of converter oil in front of clutch piston.

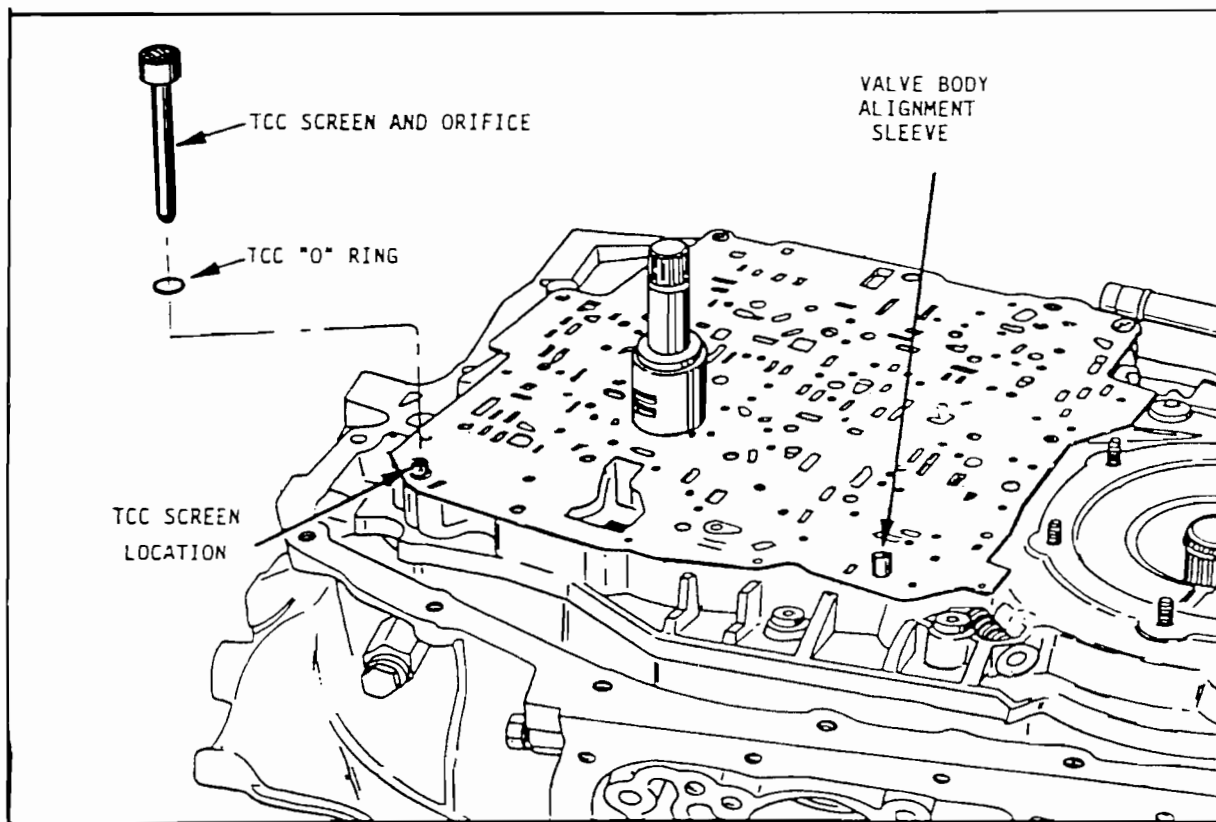
Figure 62

- COMPLAINT: Premature lock-up - Sometimes described as no lock-up.
- CAUSE: The cause may be a missing TCC screen and orifice (See Figure 62). If the TCC screen and orifice are left out of the 440-T4, the converter clutch will apply on the 1-2 shift because of the solenoids inability to exhaust TCC signal oil there by stroking the lock-up valve. The TCC screen and orifice must be in place, as well as the "O" ring (See Figure 62). The TCC screen "Snaps" into the spacer plate.
- CORRECTION: Install the TCC screen and "O" ring into spacer plate in location shown in Figure 62. First install "O" ring on TCC screen and then "Snap" into place in the spacer plate. OEM part numbers as follows;
- TCC Screen and Orifice 8658060
"O" Ring, TCC Screen 8658109

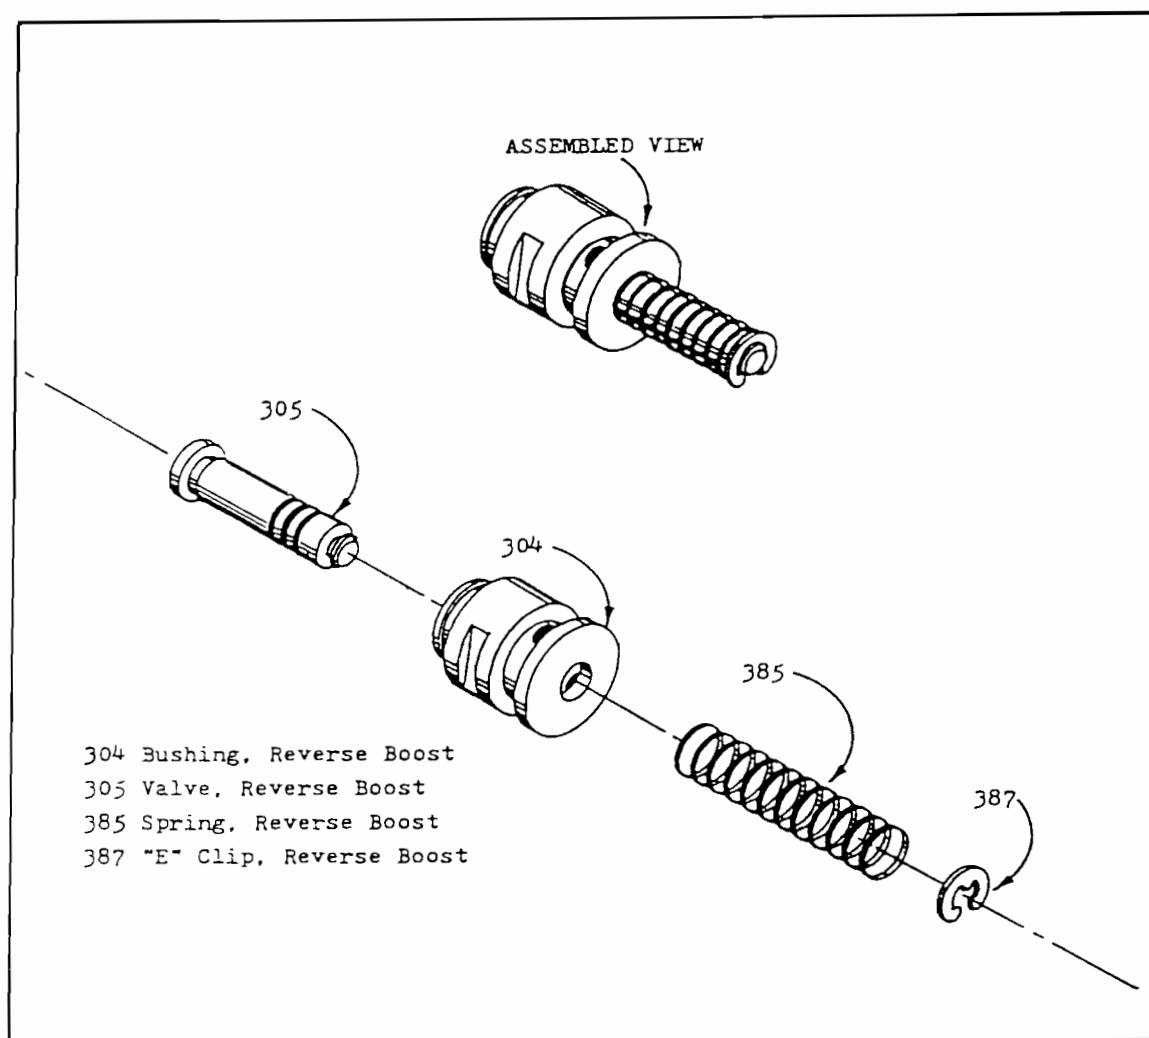
Figure 63

- COMPLAINT: Slips in reverse under light or medium throttle only - heavy throttle OK. Usually 4.1 Cadillac or 3.8 Buick engine.
- CAUSE: Not enough line pressure in reverse to keep reverse band firmly applied.
- CORRECTION: Remove 4 coils from the reverse boost valve spring, (385 in Figure 63). This will raise line pressure in reverse to approximately 85 PSI, which is 15 PSI higher than original and provides more holding power for the reverse band.

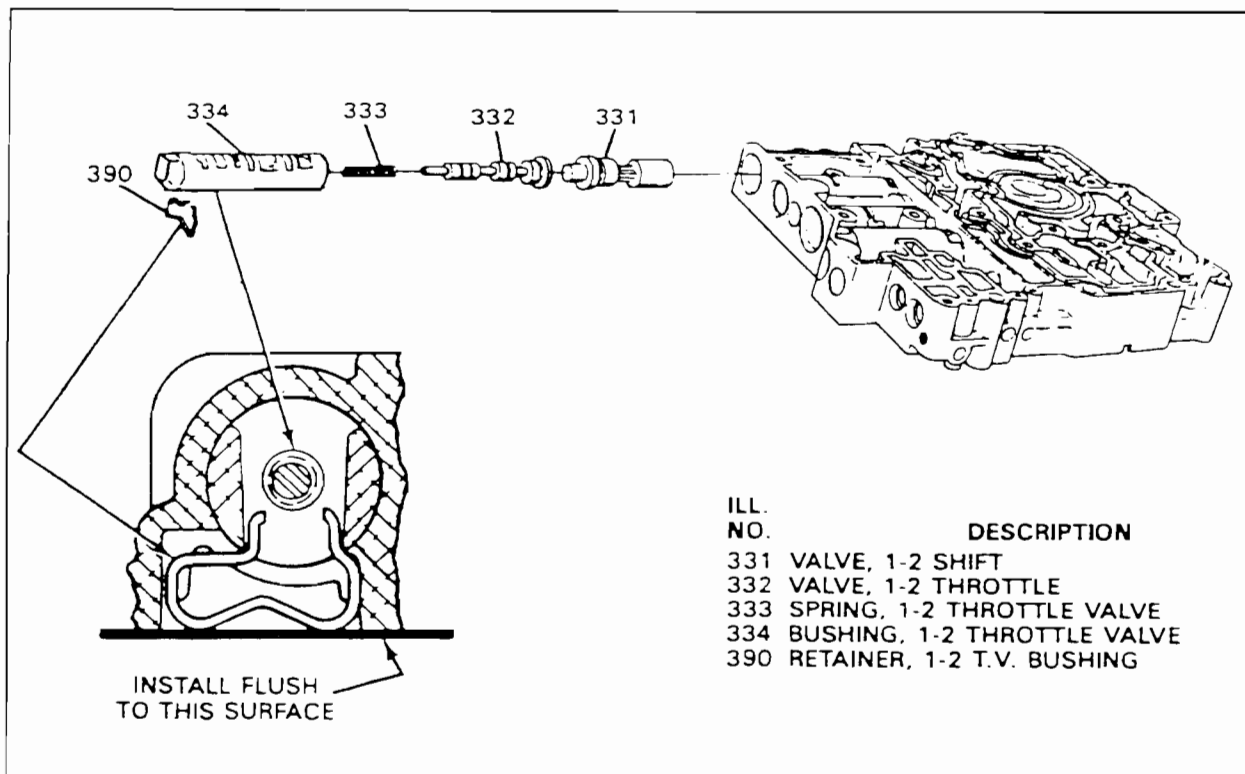
Figure 69

CAUSE: The cause may be the 1-2 throttle valve bushing retainer (390) pushed in too far (See Figure 69). If the retainer is pushed in too far the "Legs" of the retainer will grab hold of the 1-2 throttle valve, and the result will be 2nd gear starts.

NOTE: The bushing must be installed as shown in Figure 69, with the angled surface on the end of the bushing toward the channel plate.

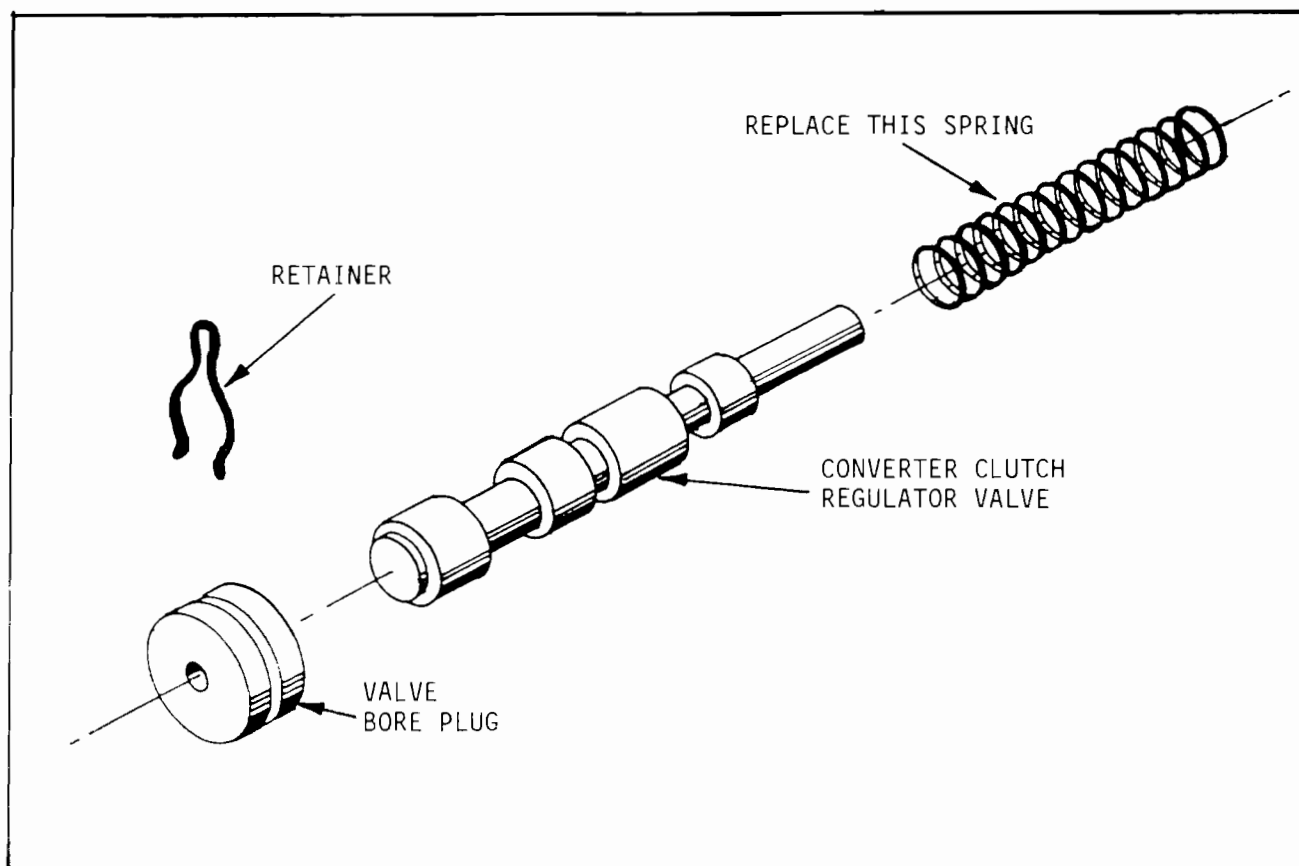
Figure 1

- COMPLAINT: Converter clutch shudder on any THM 440-T4.
- CAUSE: The cause may be, not enough converter apply pressure as the factory has it calibrated at about 45 PSI.
- CORRECTION: There is now available from the aftermarket suppliers a spring for the converter clutch regulator valve that raises the apply pressure to 61 PSI, and eliminates converter clutch shudder (See Figure 1).
- The new spring is available under part number SGSF-440.

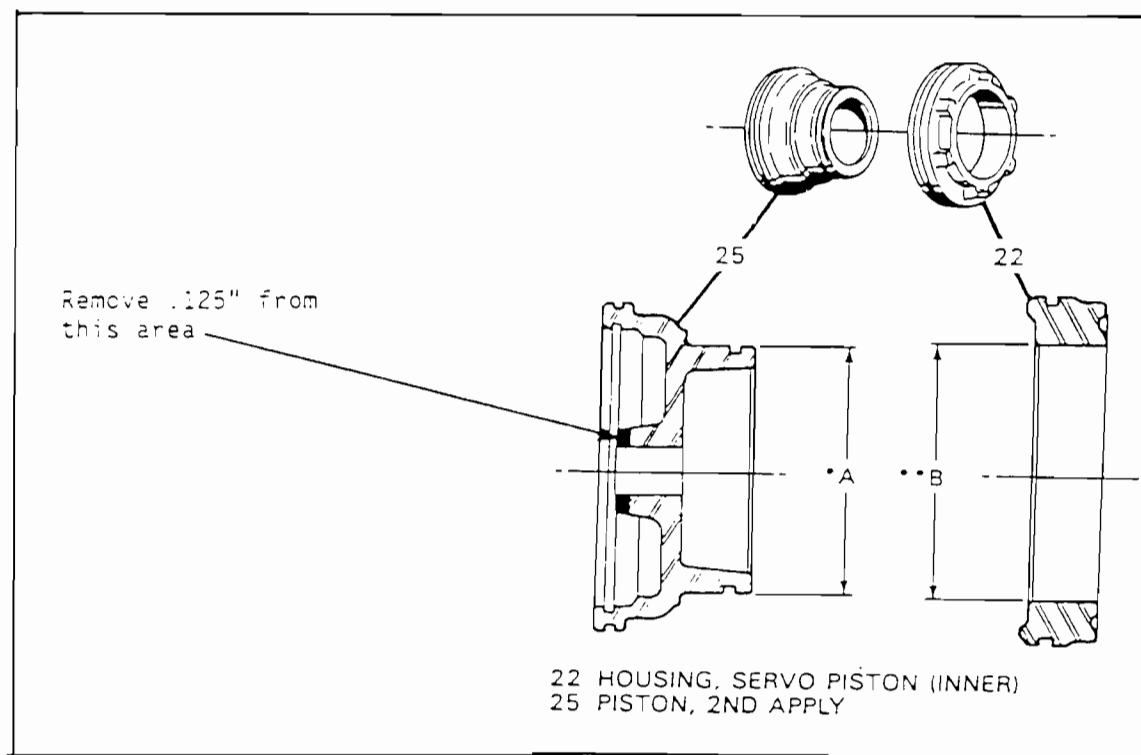
Figure 1

CAUSE: The cause could be the 2nd apply piston.

CORRECTION: Modify the 2nd apply piston by machining the inner hub and remove .125" (See Figure 1).

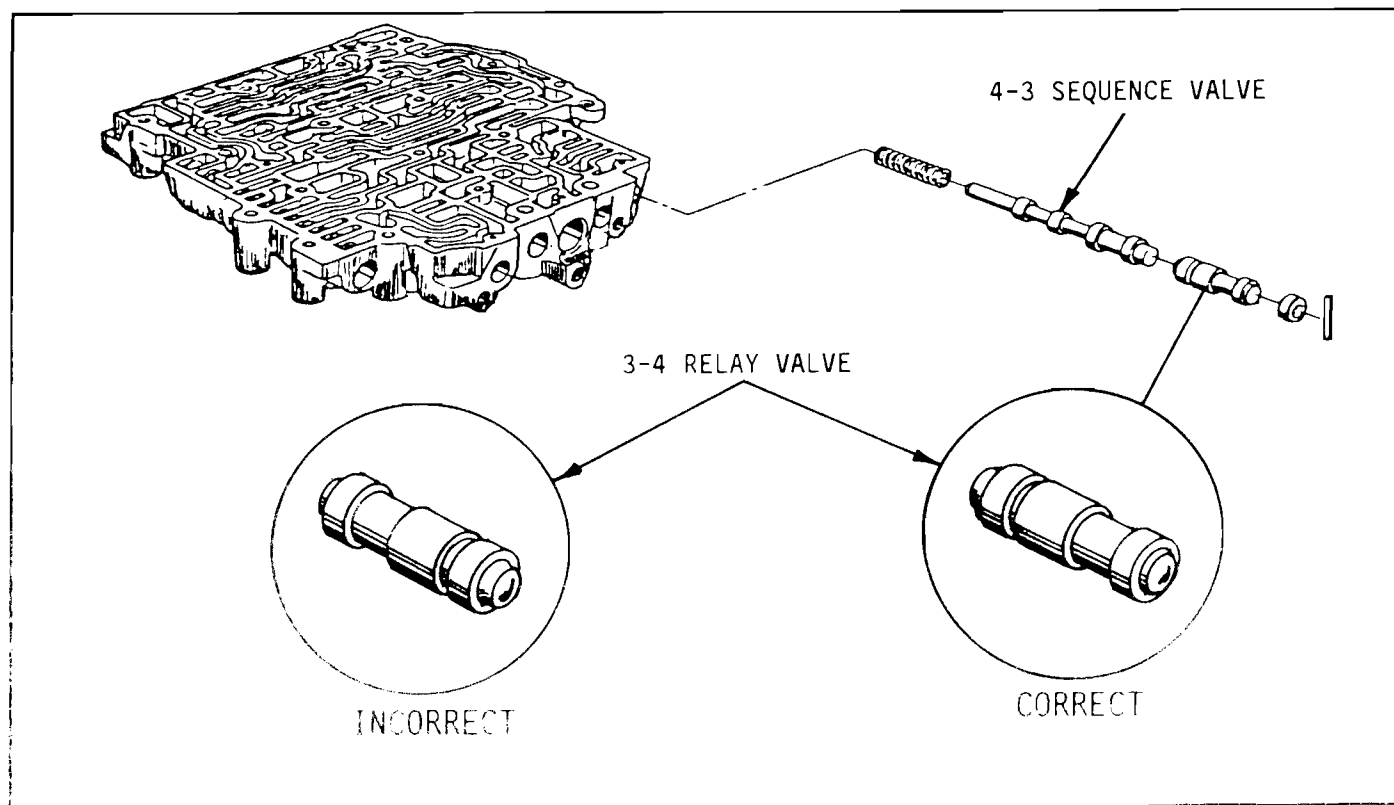
Figure 1

CAUSE: The cause may be that you have installed the 3-4 relay valve in backwards. The 3-4 relay valve is located in front of the 4-3 sequence valve in the valve body (See Figure 1).

CORRECTION: Install the 3-4 relay valve correctly (See Figure 1).

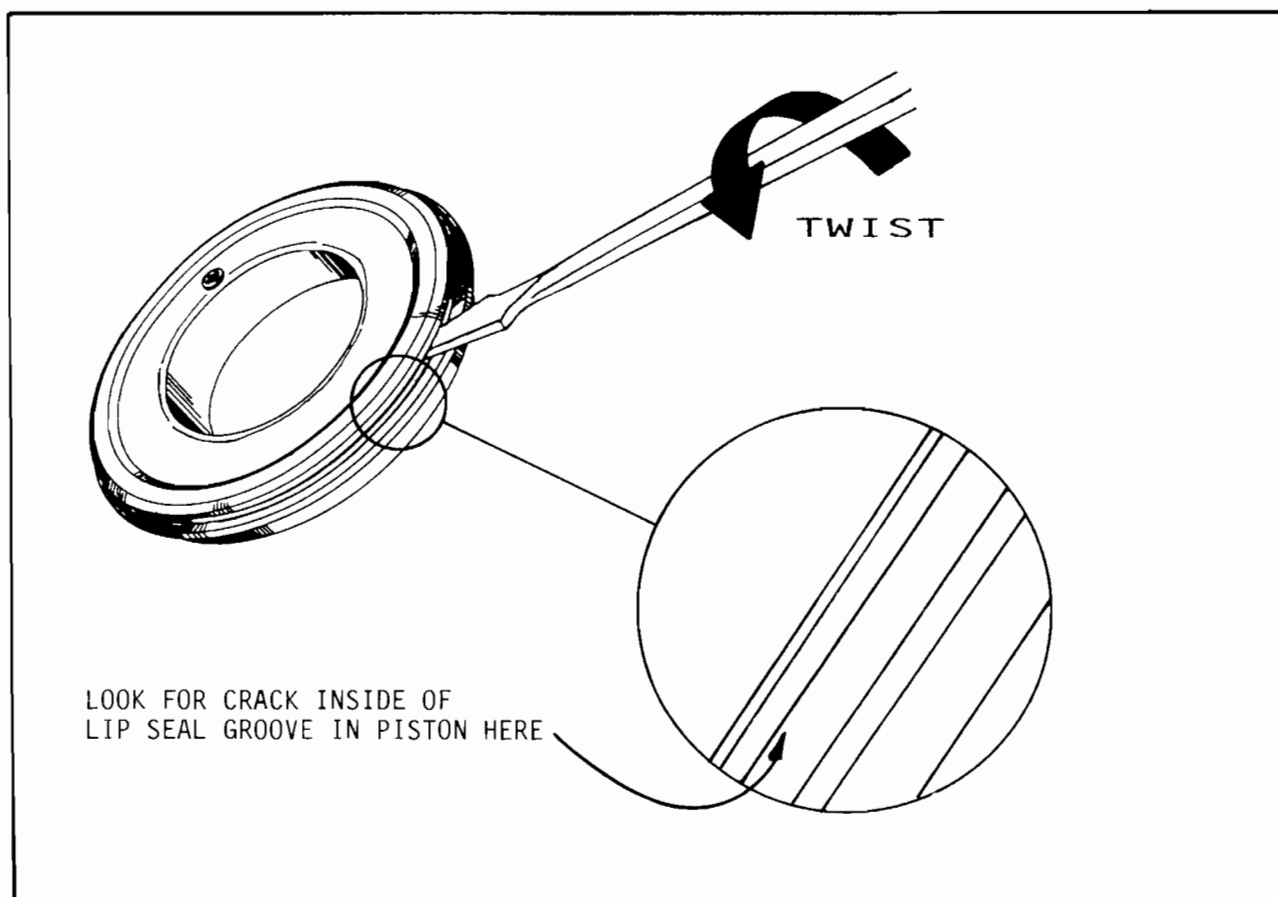
Figure 1

COMPLAINT: Flare or slip on 2-3 shift, or premature failure of direct clutches.

CAUSE: The cause may be a cracked direct clutch piston. For procedure to check the piston, see Figure 1.

CORRECTION: Replace the direct clutch piston.

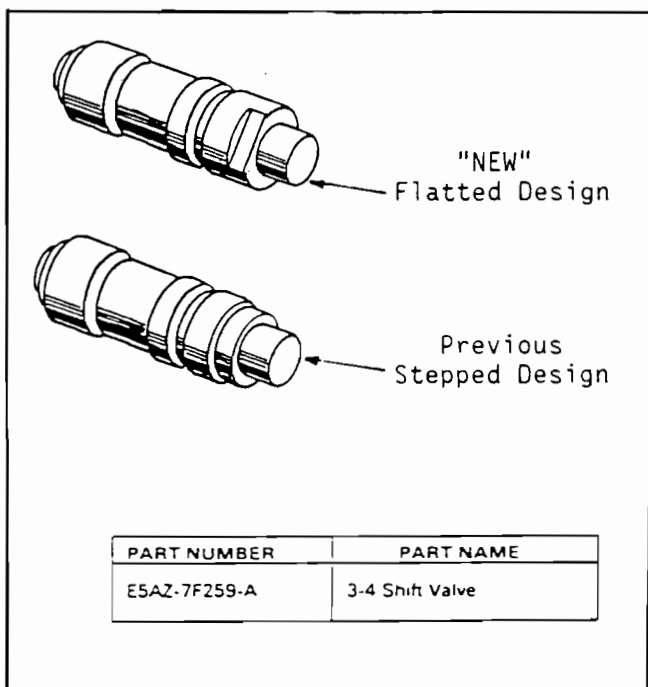
Some AOD-equipped vehicles with transmissions built between March, 1983 and April 19, 1985 may exhibit a no forward drive condition after coast down from fourth gear. This condition may occur if a small particle of contamination causes the 3-4 shift valve to stick in the forward clutch exhaust position.

To service this condition, install a new 3-4 shift valve that has a design with flats on the valve. This will allow contamination to pass and be trapped in the main control filter assembly. The new valve was incorporated in production April 19, 1985. Refer to Figure 1 for visual differences between 3-4 shift valve design levels.

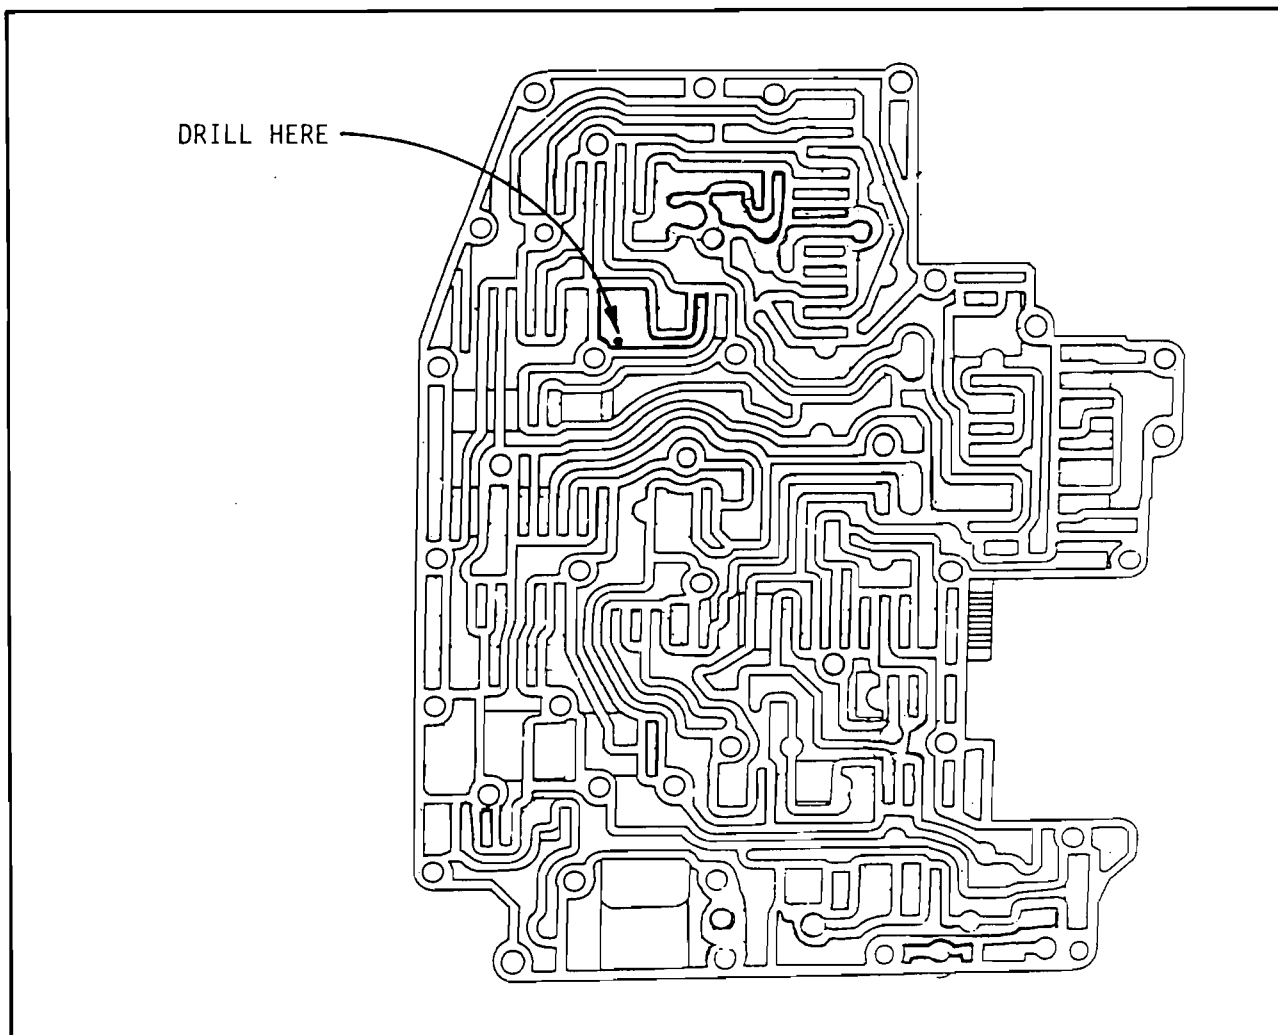
CAUSE: Valve Body and/or Case cross leaks.

CORRECTION: Drill a vent hole through valve body casting, in the 3-4 T.V. modulator circuit, using a .020" drill bit. See Figure 1 for the location. The smaller drill bits can usually be obtained at the local hobby shop.

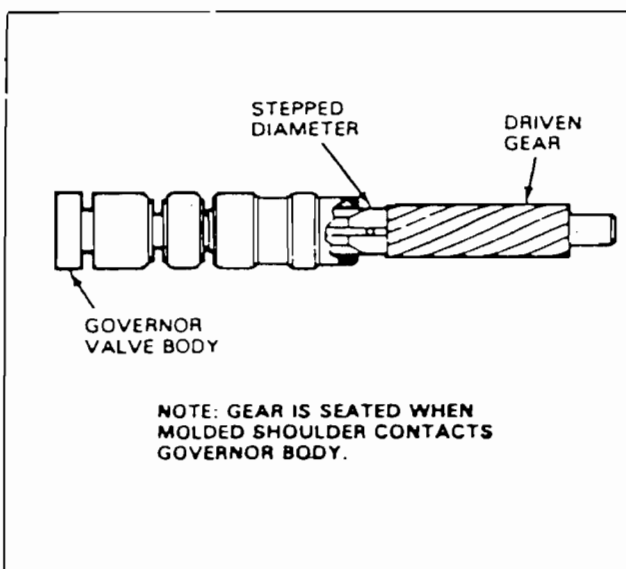
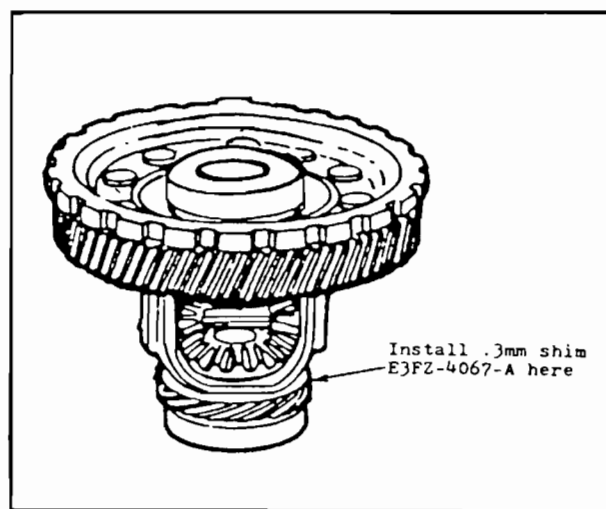
ATX - SPEEDOMETER DRIVE/DRIVEN AND GOVERNOR GEAR DAMAGE WITH BALL BEARING DIFFERENTIAL

Loss of speedometer, speed control, and/or transaxle governor operation or function may be caused from the speedometer drive gear wearing against the differential housing causing gear wear and looseness. This condition will cause speedometer driven gear wear, and a "Hourglass" wear pattern of the governor gear. To service this condition replace the speedometer drive gear on the differential housing (OEM Part No E3FZ-17285-B). Prior to installing the drive gear, install a .3mm shim (E3FZ-4067-A) between the differential and the speedometer drive gear to eliminate repeat repairs. Replace speedometer driven gear and governor gear as required. Refer to ATSG Techtran Manual, Page 92, for differential removal without removing entire transaxle.

PART NUMBER	PART NAME
E3FZ-17285-B	Speedometer Drive Gear
E3FZ-4067-A	Shim
E2FZ 7F419-A	ATX Governor Drive Gear

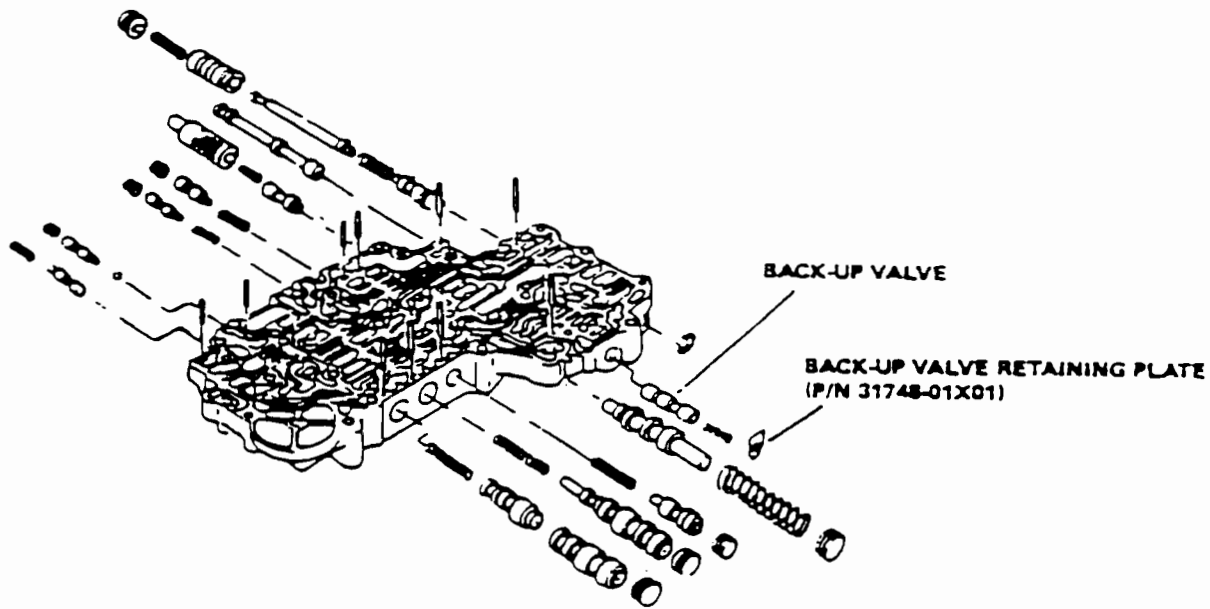
FIGURE 1

CAUSE: A broken back-up valve retaining plate.

CORRECTION: Install a new plate, part # 31748-01X01
