"2000" SEMINAR INFORMATION "FIXES TODAY FOR Y2K"

"2000" SEMINAR INFORMATION
"FIXES TODAY FOR Y2K"

INTRODUCTION

The third and final manual for the "FIXES TODAY FOR Y2K" seminar continues to present practical information on Chrysler vehicles. The seminar and this manual ends with the Import section.

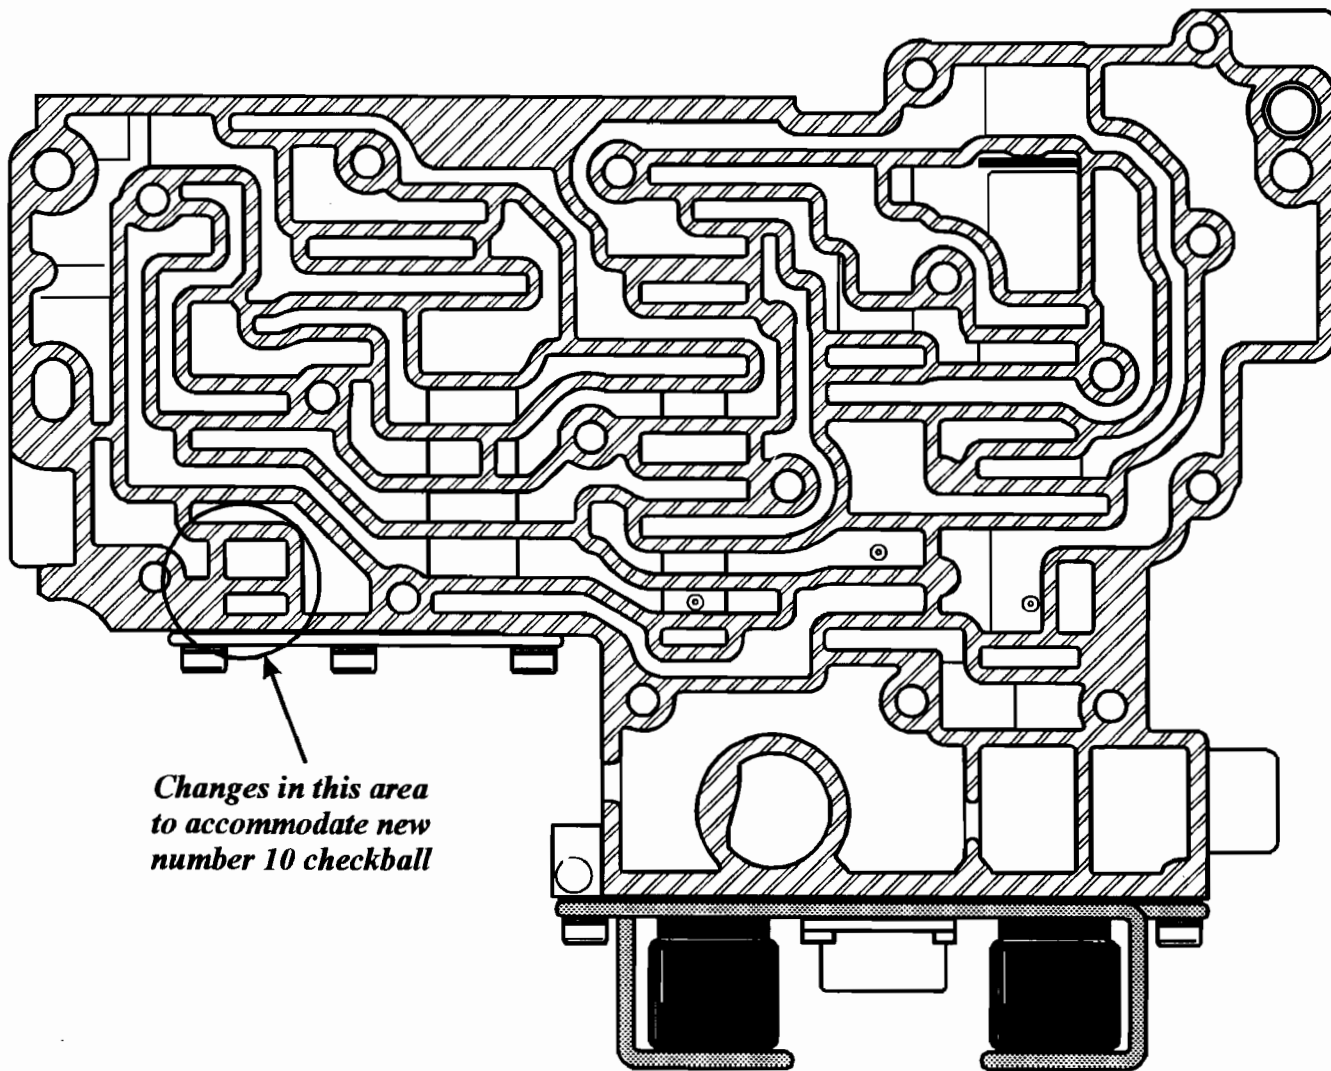
Figure 5

*Changes in this area
to accommodate new
number 10 checkball*

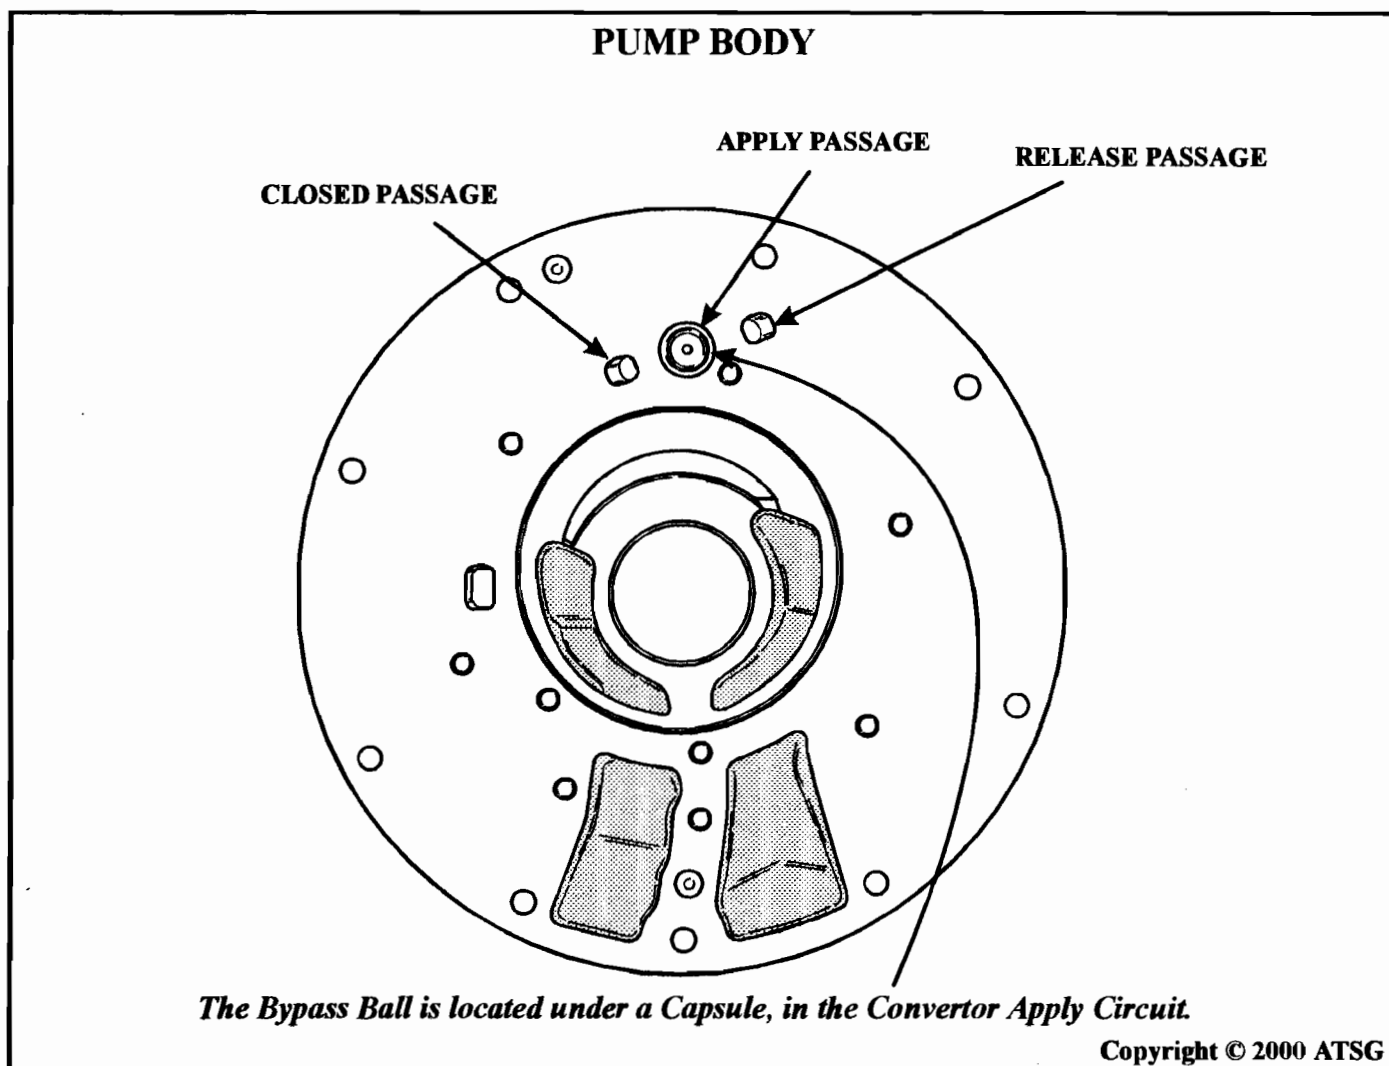
Figure 1

COMPLAINT: Vehicles equipped with ZF5HP18 may exhibit a No movement or a delayed engagement condition, before or after overhaul.

CAUSE: The cause may be, that the "Bypass Ball," located in the pump as shown in Figure 1, may have shrunken down and traveled back through the pump passage leading to the Torque Converter Valve, sticking the valve in the "stroked" position (See Figure 2). When this valve is stuck in this position it may cause the Torque Converter to drain-back after sitting for a prolonged period of time. When the vehicle is started after sitting, it may take 10 to 15 minutes for the Torque Converter to fill back up, this all depends on the positioning of the stuck Torque Converter Valve.

CORRECTION: Locate the Torque Converter Valve, as shown in Figure 3 , and free the valve up, removing the shrunken Bypass Ball from binding the valves movement. Contact **Mario Aristides Ph.# 305-666-3544 or Fax# 305-666-8238** for a replacement ball if the capsule can be removed from the pump body.

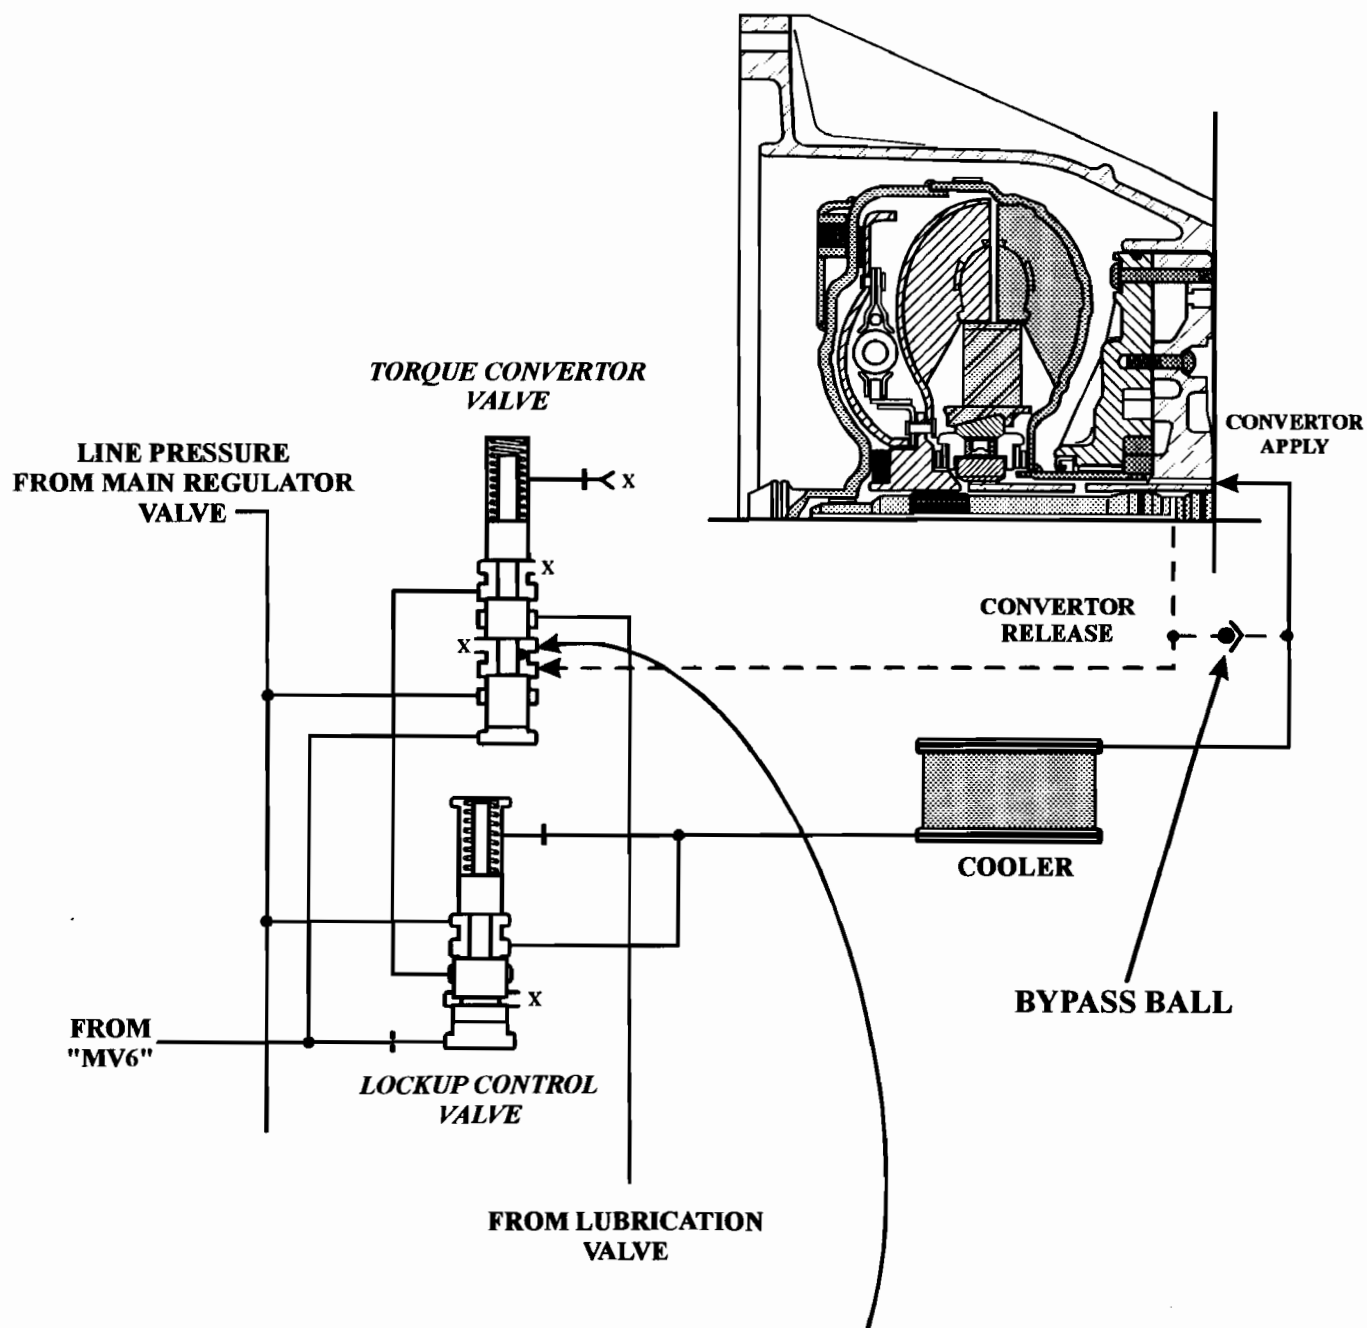
Figure 2

The "Bypass Ball" shrinks and travels back through to the Torque Converter Valve and lodges itself in this passage, sticking the valve in this approximate position.

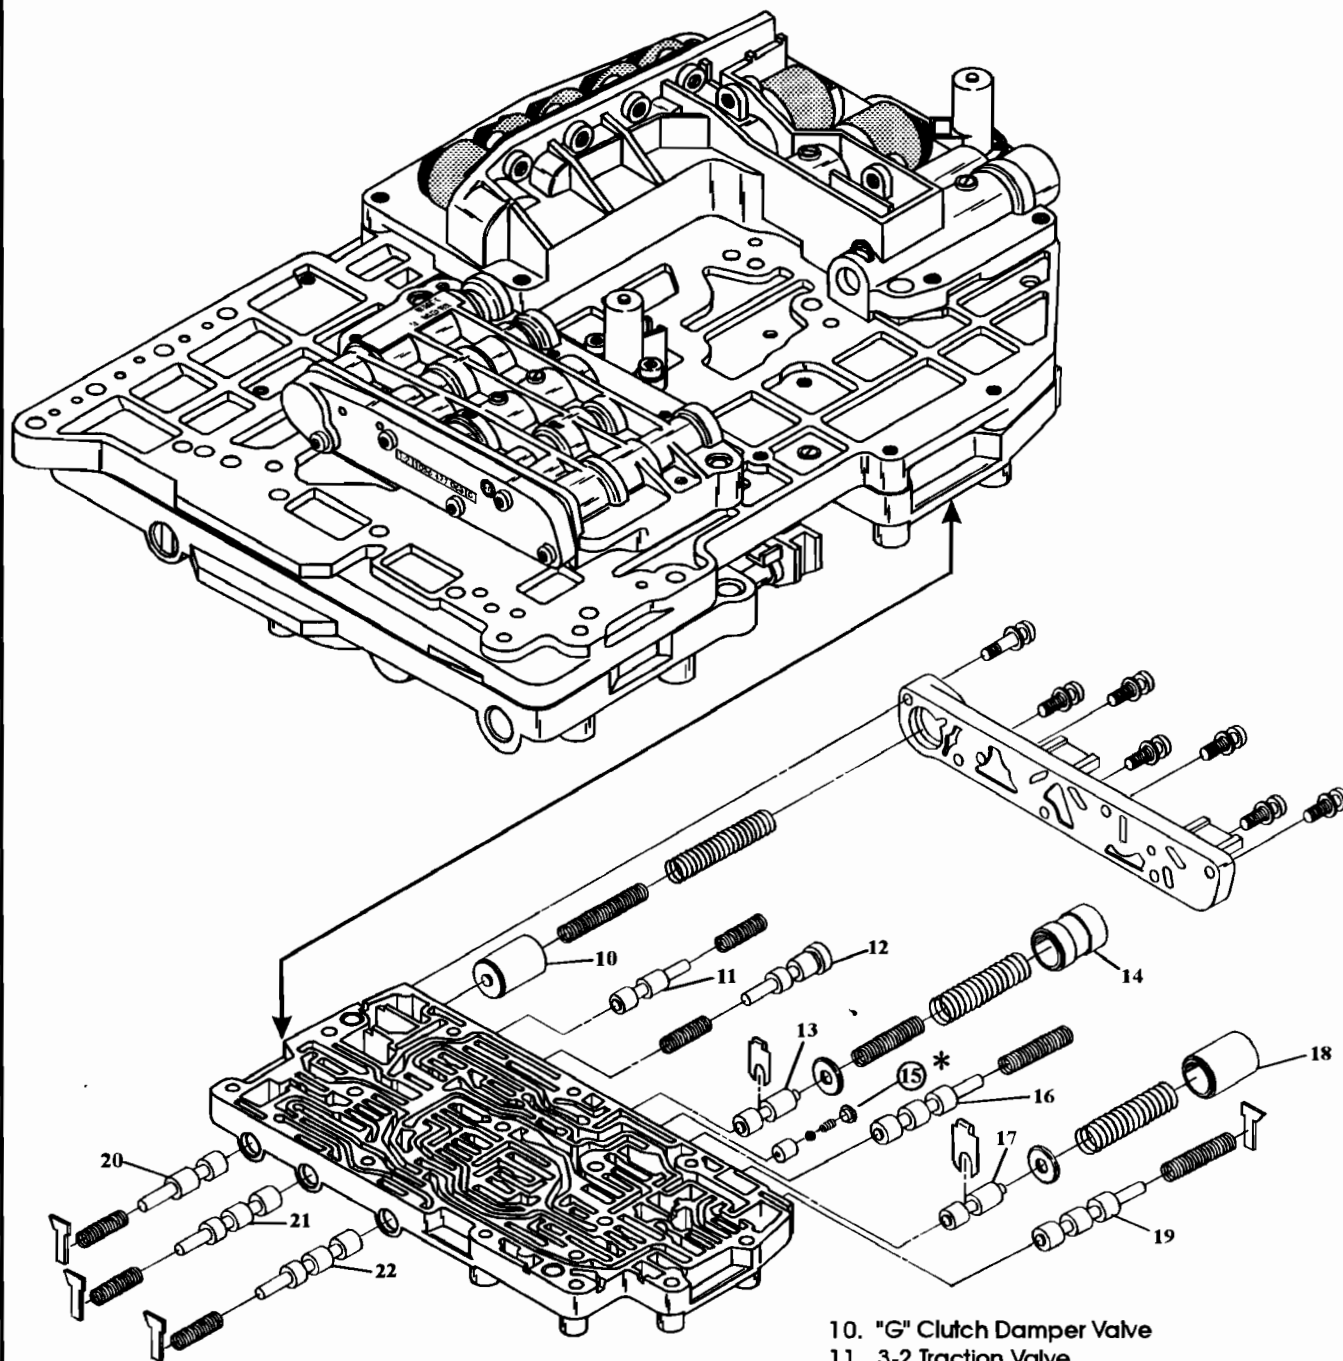
LOWER REAR VALVE BODY

COMPLAINT: Before or after overhaul, vehicles equipped with ZF5HP18, may exhibit a binding condition in the Manual "2" position, 1st gear.

CAUSE: The cause may be, the plastic "D" Clutch One-way Check Valve assembly located in the Lower Rear valve body, shown in Figure 1, may be broken allowing the "B" Clutch (Reverse Input Clutch) to be on while the "D" Clutch (Low / Reverse Clutch) is on in 1st gear.

CORRECTION: Replace the "D" Clutch One-way Check Valve assembly , as shown in Figure 2, with a new "Alluminum" check valve assembly offered by *Mario Aristides. Ph.# 305-666-3544 or Fax# 305-666-8238.*

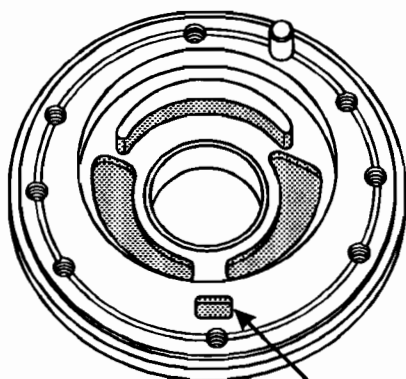
1ST DESIGN PUMP BODY
AND PUMP COVER

- COMPLAINT:** Repeated leakage of transmission fluid, coming from the bell housing area on any vehicle equipped with the ZF-4HP-22 or 4HP-24 transmission. This usually occurs after rebuild coupled with pump parts replacement that was necessary.

- CAUSE:** Beginning in the 1989 model year, ZF implemented a running change to the pump body and pump cover on both the 4HP-22 and the 4HP-24 transmissions. This change was made to increase the durability of the converter bushing with increased lubrication to this area. This change however, created the possibility of mis-matching parts that are not compatible. The 1st design pump body and cover has the drain back hole located at the 6 O'clock position and the drain back passage was moved to the 3 O'clock position in the 2nd design pump body and cover, as shown in Figure 1. Installing 2nd design pump body with 1st design pump cover will completely block the drain back passage and the repeated leakage will occur. Installing the 1st design pump body with 2nd design pump cover will function, but you will now be faced with the possibility of premature converter bushing failure.

- CORRECTION:** To eliminate both conditions, always install the 2nd design pump body, matched with the 2nd design pump cover, as shown in Figure 1.

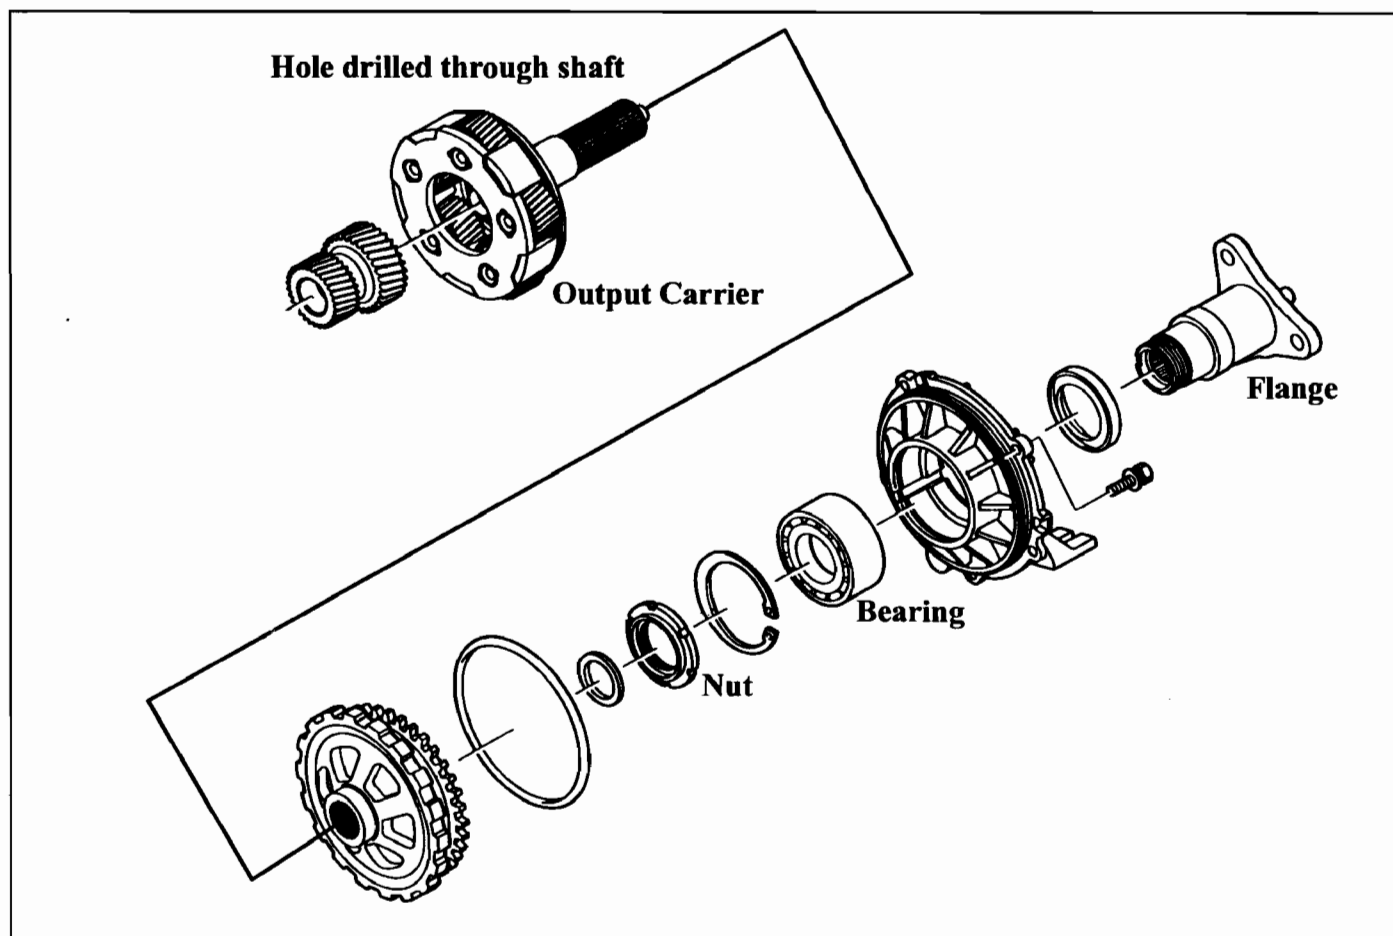
Figure 1

CAUSE: One cause may be the Ball Bearing for the output flange in the extension housing has rusted. The one way baffled vent restricts moisture from escaping allowing condensation to form on the bearing which eventually leads to rust.

CORRECTION: Disassemble and replace the nut and bearing. As an update on models past specification number ending with 029, ZF has now placed a hole drilled through the output shaft to allow increased flow of transmission fluid to the bearing. This keeps the bearing flushed with fluid preventing condensation from forming on the bearing (See Figure 1). The output carrier and flange must be replaced on previous models allowing this additional fluid to reach the bearing.

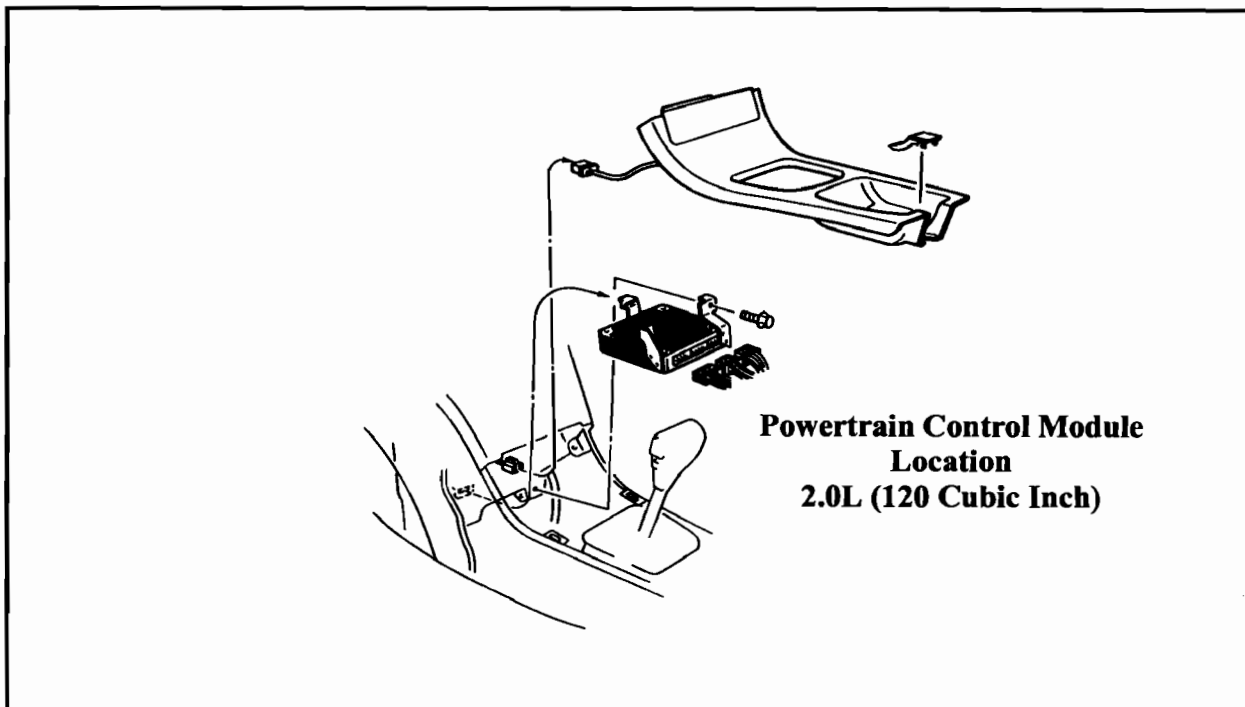
Figure 1

COMPLAINT: Vehicles having a 2.0L engine with a GF4A-EL transaxle may produce a code 6 for the VSS (Vehicle Speed Sensor), a code 25 for the FPCS (fuel pressure control solenoid) and a 55 for the PSG (Pulse Signal Generator) all at the same time placing the unit in failsafe.

CAUSE: It has been ATSG's experience that when these three codes have been stored together, the replacement of the Powertrain Control Module has corrected this complaint. It must be noted that each circuit has been checked and verified for proper operation before taking the action of computer replacement.

VSS: Approximate
5 volt pulse should be
seen as the wheels are
rotated slowly.

CORRECTION: The PCM can be located below the front center of the console (See Figure 1). From here all three circuits can be verified for proper operation before changing the computer (See Figure 2). If the following checks are observed, change the PCM.

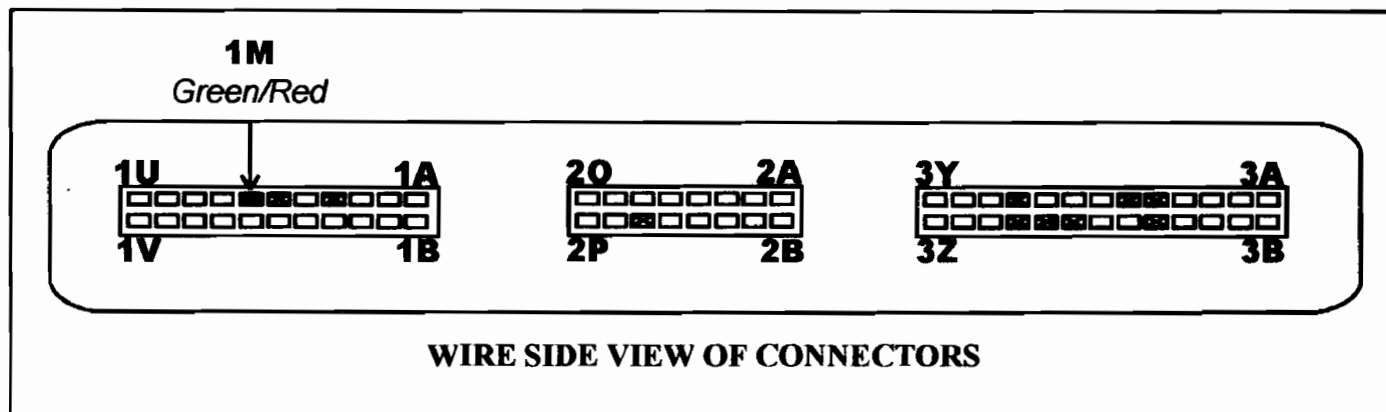
Figure 1

COMPLAINT: The transaxle goes to failsafe with a code 6. Code 6 means a faulty speed sensor circuit. This speed sensor is located in the speedometer cluster. Upon disassembly of the dash a speed sensor is not found.

CORRECTION: If a wire does not exist at terminal 1M, inspect the pulse generator circuit. If terminal 1M contains a wire, there is a speed sensor in the dash. A quick check of the speed sensor can be made at this wire with a volt meter set to DC volts. Carefully probe into the wire with the positive lead and place the negative lead to ground. An approximate 1.5 to 4.5 volt pulse should be seen when turning the speedometer cable. If a pulse is not seen, the speed sensor in the dash is defective. If 0 volts is seen, snip the wire downstream the harness away from the computer leaving yourself enough room to repair the wire. With the wire snipped, check for voltage coming from the computer. Approximately 5 volts should be seen. If no voltage is seen on the snipped wire coming from the computer, the computer is defective. If approximately 5 volts is seen, the wire going to the speed sensor may be shorted to ground or the speed sensor is defective.

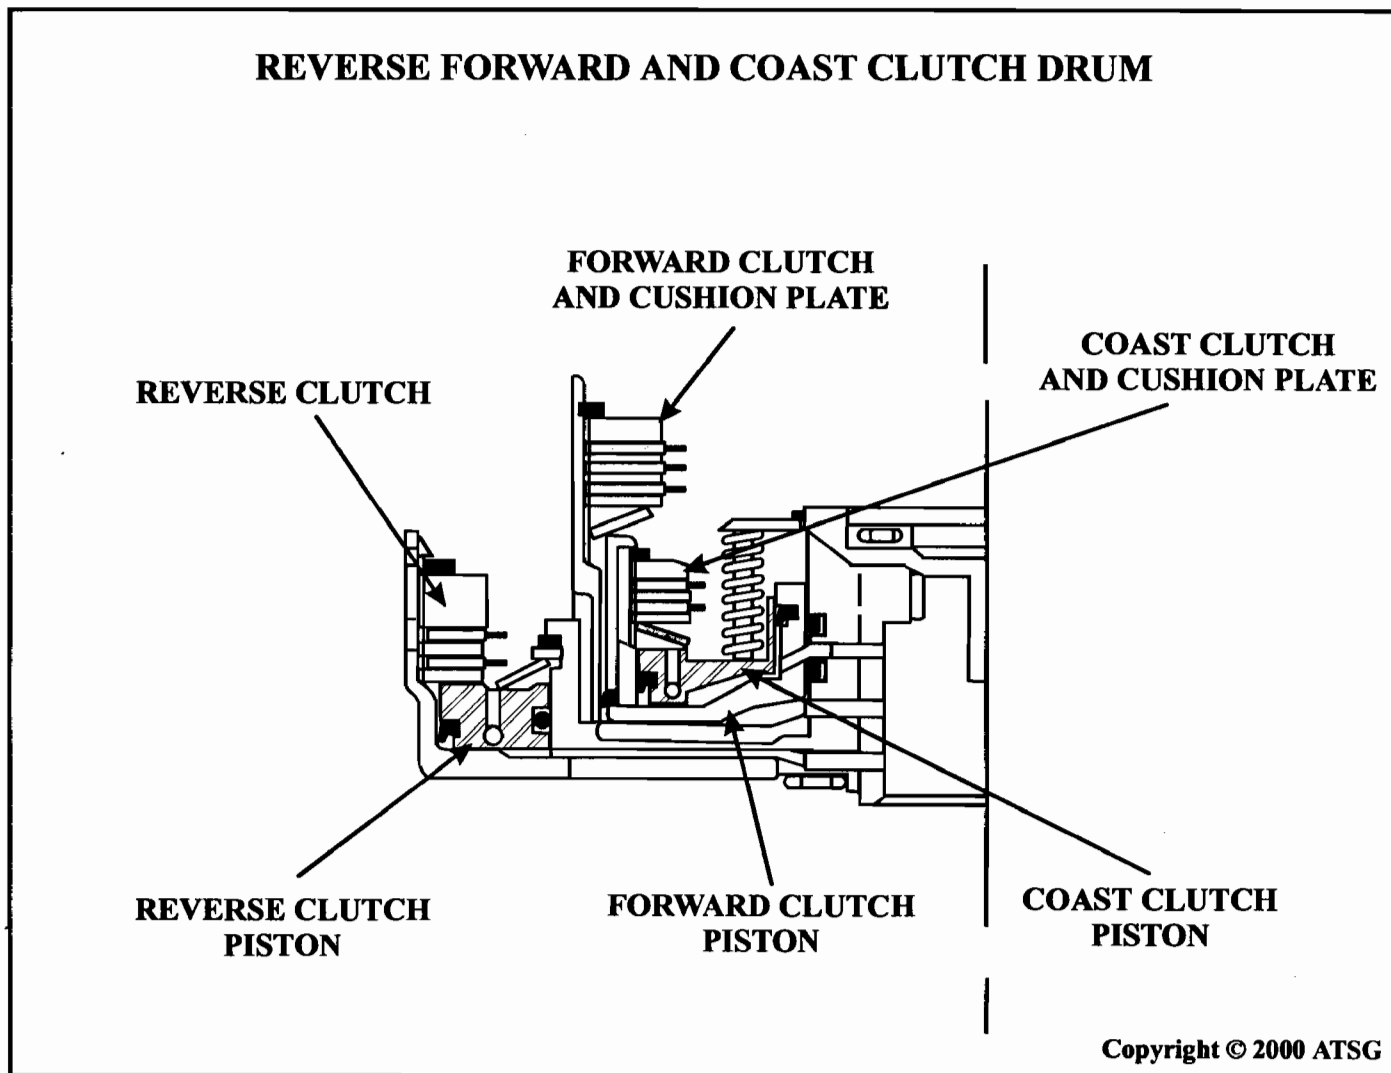
Figure 1

COMPLAINT: Vehicles equipped with GF4A-EL transaxles may exhibit premature and repeated Coast Clutch failure before or after overhaul.

CORRECTION: Replace the Reverse Forward and Coast Clutch drum and or Forward Clutch piston as shown in Figure 1.

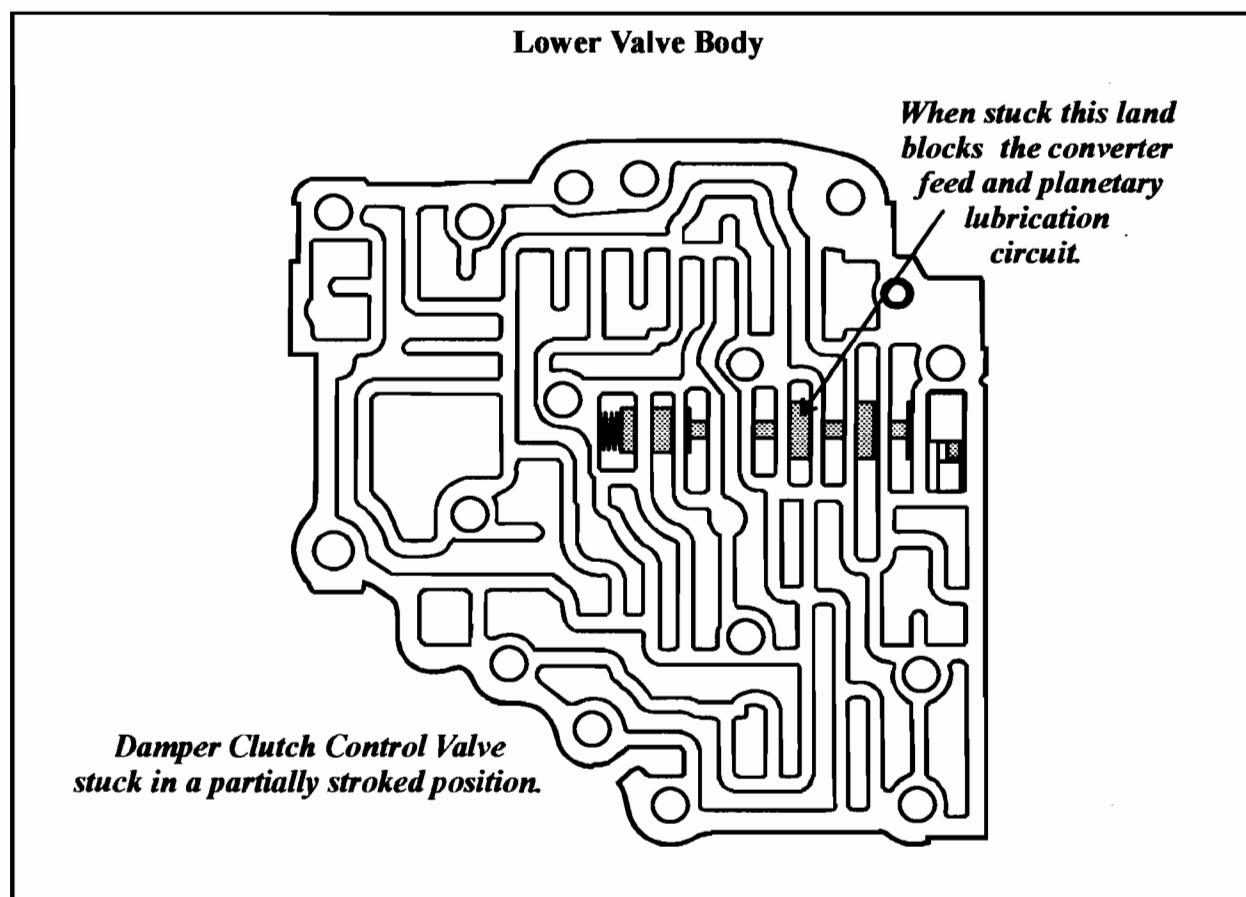
Figure 1

COMPLAINT: Premature planetary failure after overhaul.

CORRECTION: The desired corrective measure would be to ensure free movement of the Damper Clutch Control Valve after the filter bolts have been tightened. However, there are times that as hard as one tries, the valve may continue to stick. As a preventive measure, cross drill the area shown in Figure 2. This will allow the planetary system to continue to receive lubrication fluid should the valve stick. This drilling will not cure the loss or restricted converter clutch fill fluid should this valve stick. Cross drilling will only lessen the damage to the unit when and if the Damper Clutch Control Valve sticks.

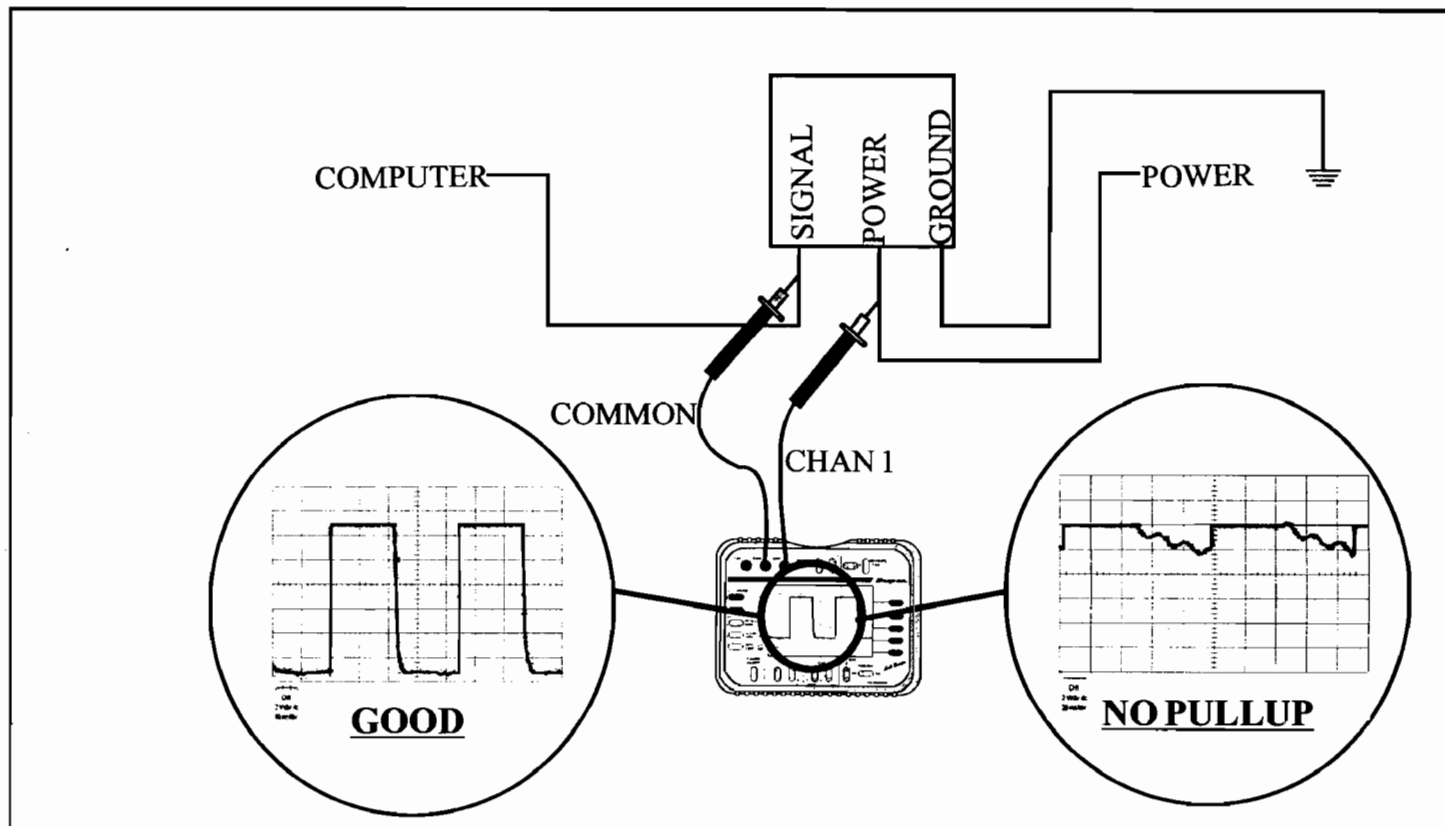
Figure 1

If you have an inverted saw tooth (Figure 1), then there is no pull up resistance. The pull up resistor may either be in the computer OR in the sensor. If you are bench testing, move to in vehicle testing. If you get the same waveform in the vehicle the only thing left to test is the wiring between the sensor and the computer. If the wiring tests OK it is either a bad sensor or a bad computer.
