Technical Service Information

THM 440-T4 NEW 1-2 BAND ASSEMBLY

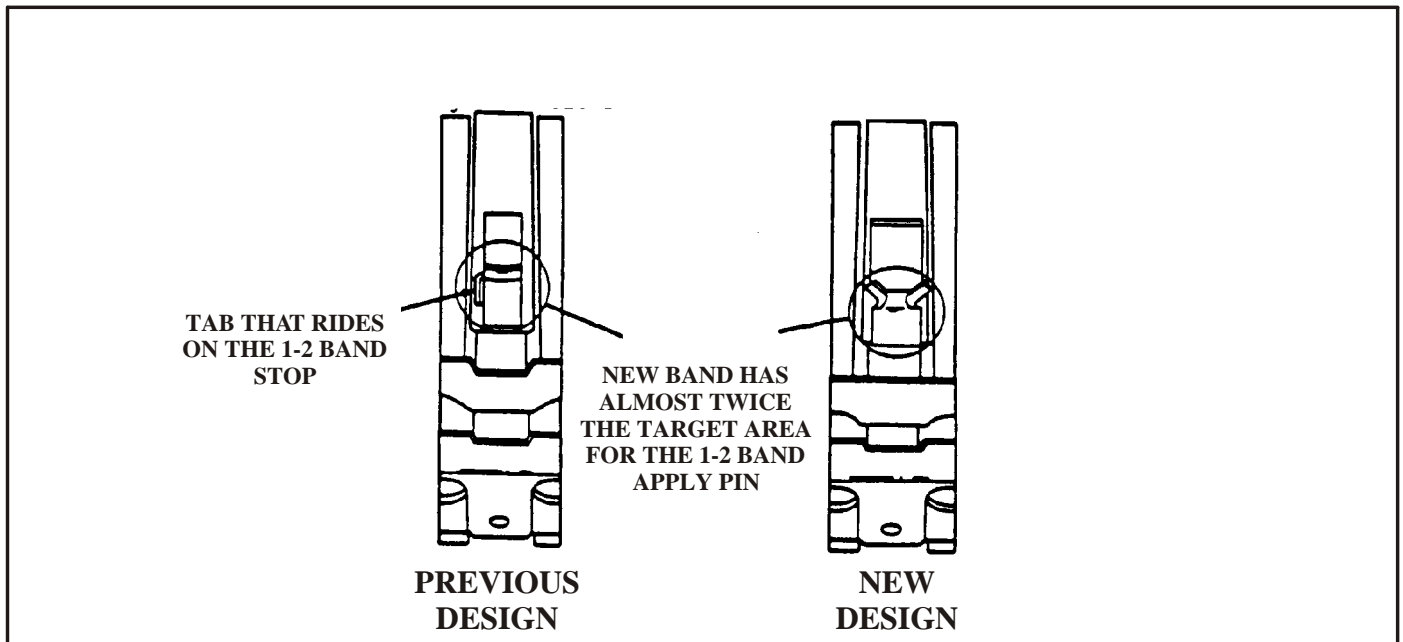
Figure 1

REASON: To eliminate the possibility of a intermittent "No Drive" condition.

PARTS AFFECTED: (1) 1-2 BAND ASSEMBLY - The target area on the new 1-2 band, where the band apply pin engages, has been made wider and has "Win8s" added to prevent the pin from ever missing the "Target" area (See Figure 1).
(2) 1-2 BAND STOP ASSEMBLY - The 1-2 Band Stop has been eliminated as it is no longer needed (See Figure 2).

1-2 BAND ASSEMBLY (New Style)..... 8668984
