HONDA CIVIC A4RA/B4RA/M4RA

DELAYED FORWARD ENGAGEMENT, SLIPPING IN LOW GEAR

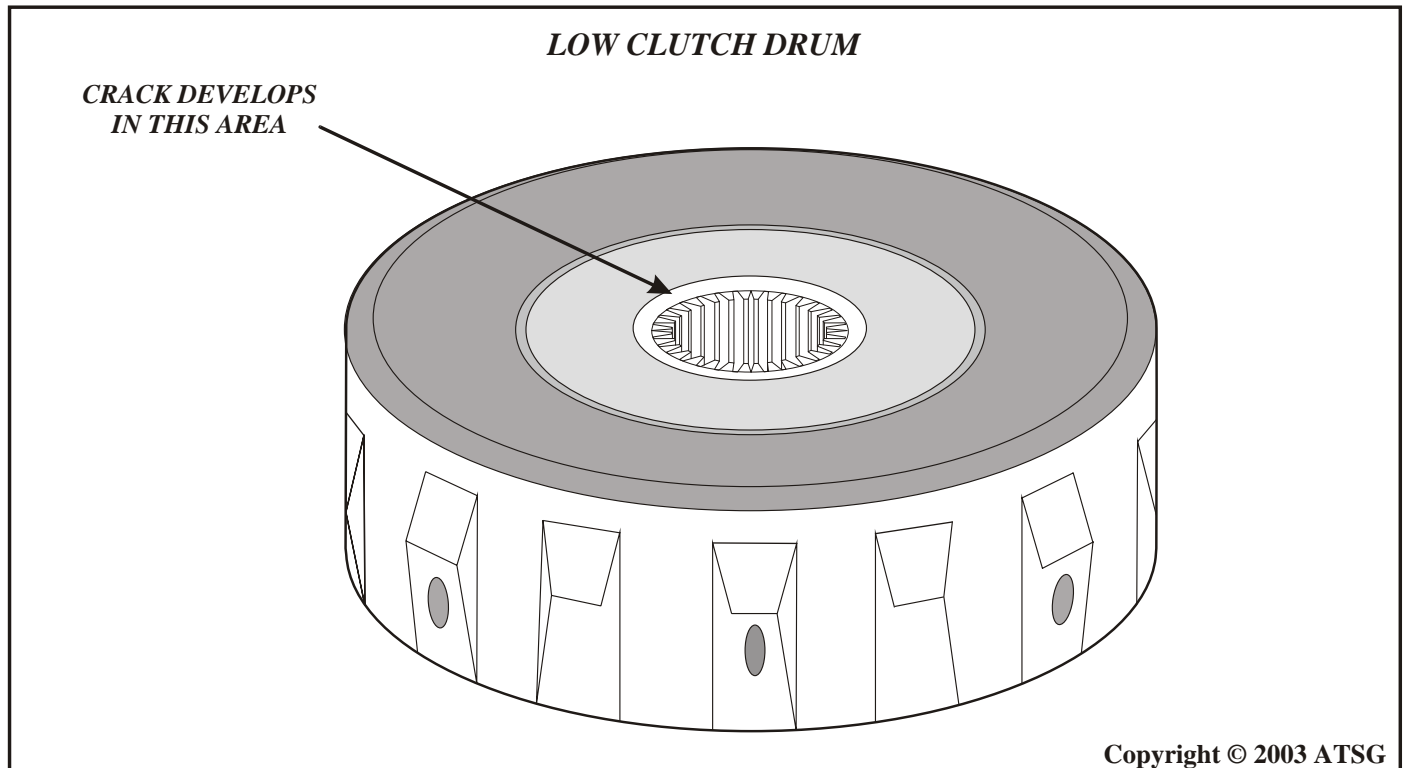
Figure 1

COMPLAINT: The transmission exhibits a delayed forward engagement and slipping in low gear. A low clutch pressure check indicates pressure that is well below the 130 psi that is **required** when the transmission is in low gear.

When the transmission is disassembled, it is discovered that the low clutch plates are burnt. Inspection of the low clutch feed tube, feed tube o-rings and feed tube bushing indicate these components are in good condition. Low sprag is also in good condition.

CAUSE: The low clutch drum has developed a hairline crack on the back of the drum close to the mainshaft opening as seen in Figure 1. This crack cannot be seen with the mainshaft nut and conical washer in place.

CORRECTION: Replace the low clutch drum as necessary, with OEM part number listed below.

NOTE: *In most cases, the crack can be repaired with a MIG welder. By removing the end cover and low clutch drum, with the transmission in the car, this can be an in vehicle repair.*
