Technical Service Information

FORD 4R44E/4R55E/5R55E DELAYED ENGAGEMENTS AND / OR SLIPPING

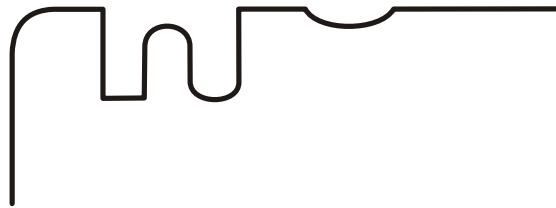
Figure 1

NOTE: *1997 EXPLORER BUILT BETWEEN 4/15/97 AND 6/2/97 MAY NOT CONTAIN AN EXTENSION HOUSING LUBE ORIFICE DUE TO A CASTING FLAW IN THE MAIN CONTROL CASTING. IN THESE CASES THE LUBE ORIFICE IS IN THE FORM OF A SMALL HOLE IN SPACER PLATE AND THESE SPACER PLATES ARE IDENTIFIED IN FIGURE 1.*

***THIS SPACER PLATE & MAIN CONTROL CASTING DO
NOT REQUIRE A EXTENSION HOUSING LUBE ORIFICE
AS THE LUBE ORIFICE IS IN THE SPACER PLATE.***

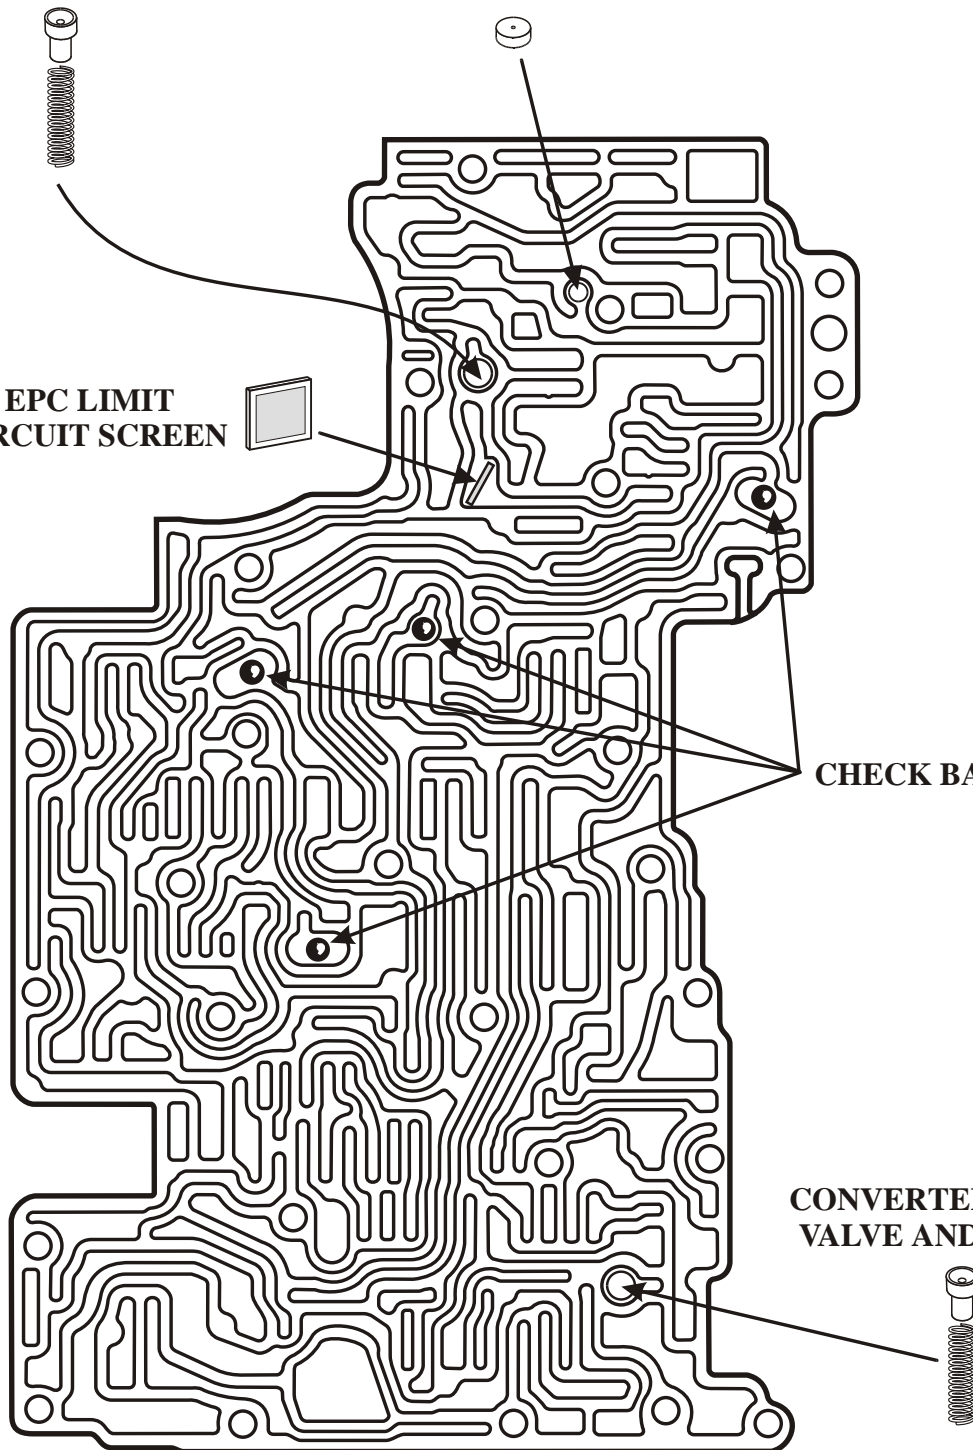
Figure 2

COMPLAINT: Some vehicles equipped with the 4R44E/4R55E may exhibit delayed engagements in forward and/or a slipping condition.

CAUSE: One cause may be, that the Extension Housing Lube Orifice may have been left out of the valve body causing a loss of line pressure.

CORRECTION: Remove the valve body and ensure that the Extension Housing Lube Orifice is in the proper location, as shown in Figure 2.

NOTE: *IN THE EVENT THE EXTENSION HOUSING LUBE ORIFICE IS LOST OR MISSING AND HAS TO BE REPLACED, THE ORIFICE SIZE IS .020".*
