Technical Service Information

FORD 4R44E/4R55E NO FORWARD ENGAGEMENT IN THE OVERDRIVE RANGE

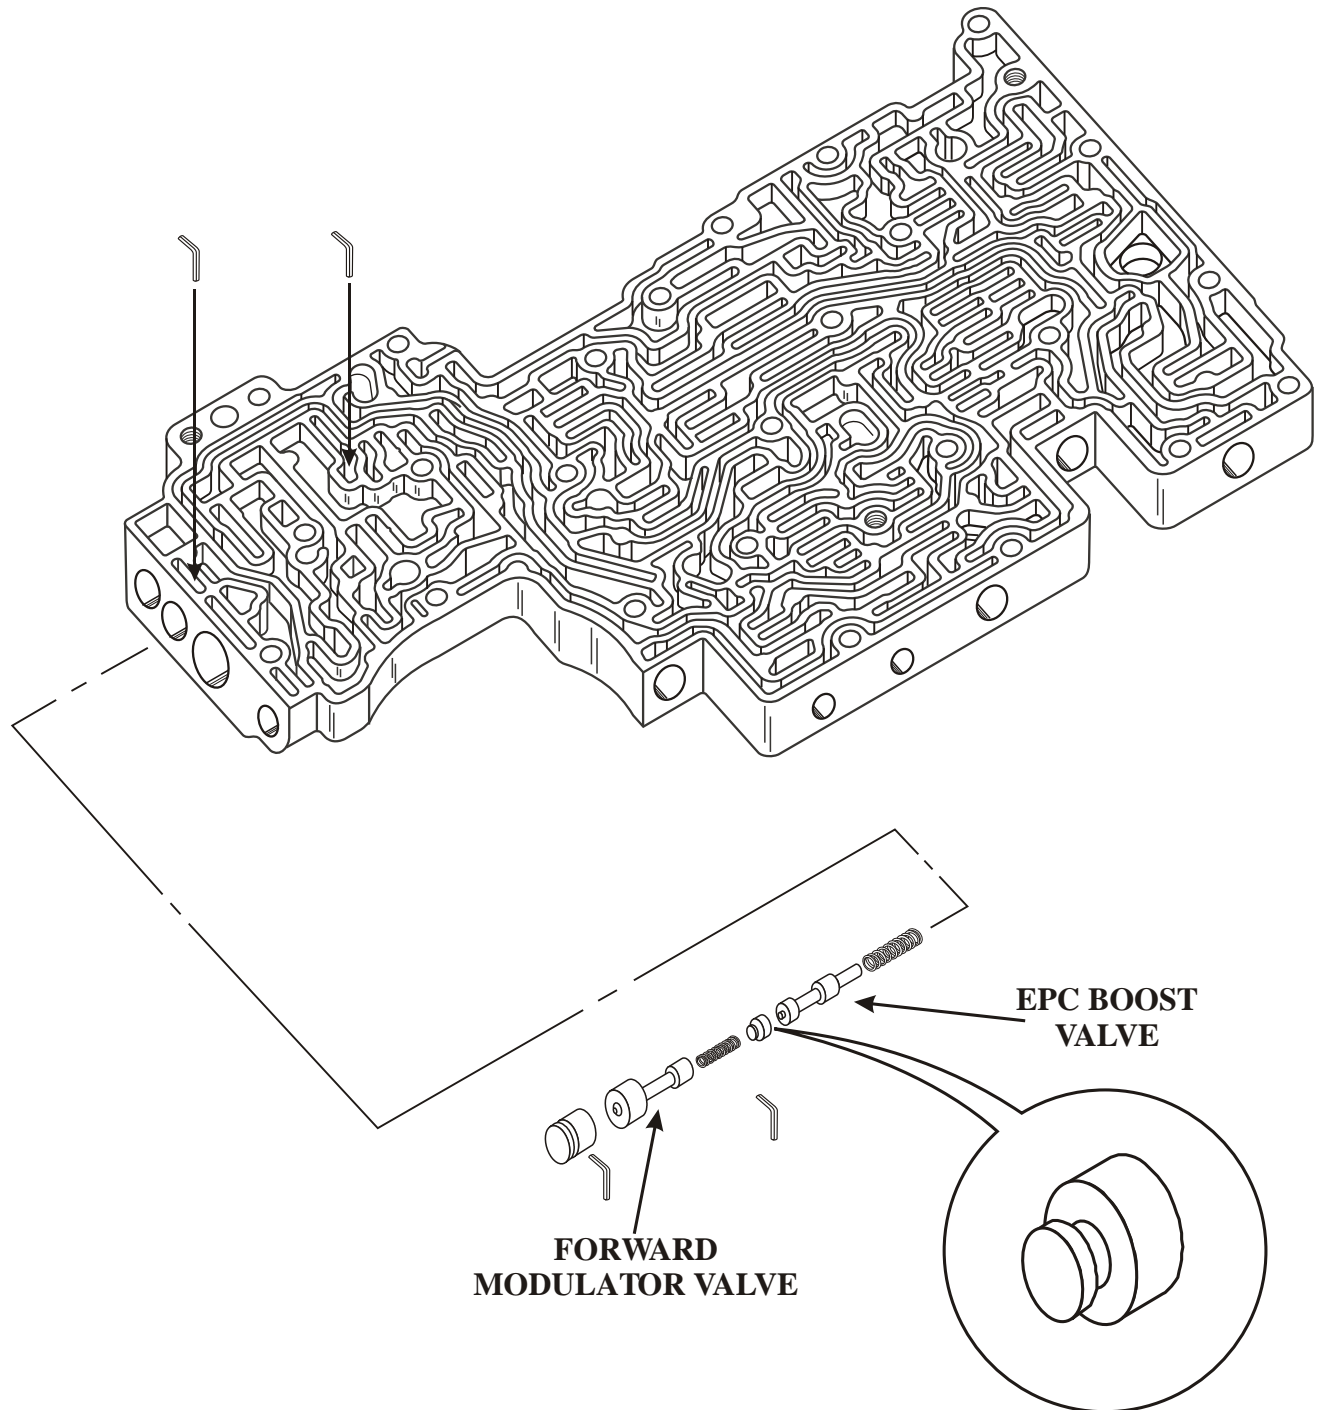
Figure 1

- COMPLAINT:** Some Vehicles equipped with the 4R44E/4R55E, may exhibit a no forward engagement condition in the Overdrive range but will move in manual 2nd, Low, and Reverse,
- CAUSE:** One cause may be, that the bore plug that retains the Forward Modulator Valve, in the valve body, was installed backwards.
- CORRECTION:** Remove the valve body and inspect the Forward Modulator Control Valve line up and ensure the retaining plug between the Forward Modulator Control Valve spring and the EPC boost valve is installed correctly as shown in Figure 1.
