Technical Service Information

GM 6T70/75

I/O SPEED SENSOR ISSUES

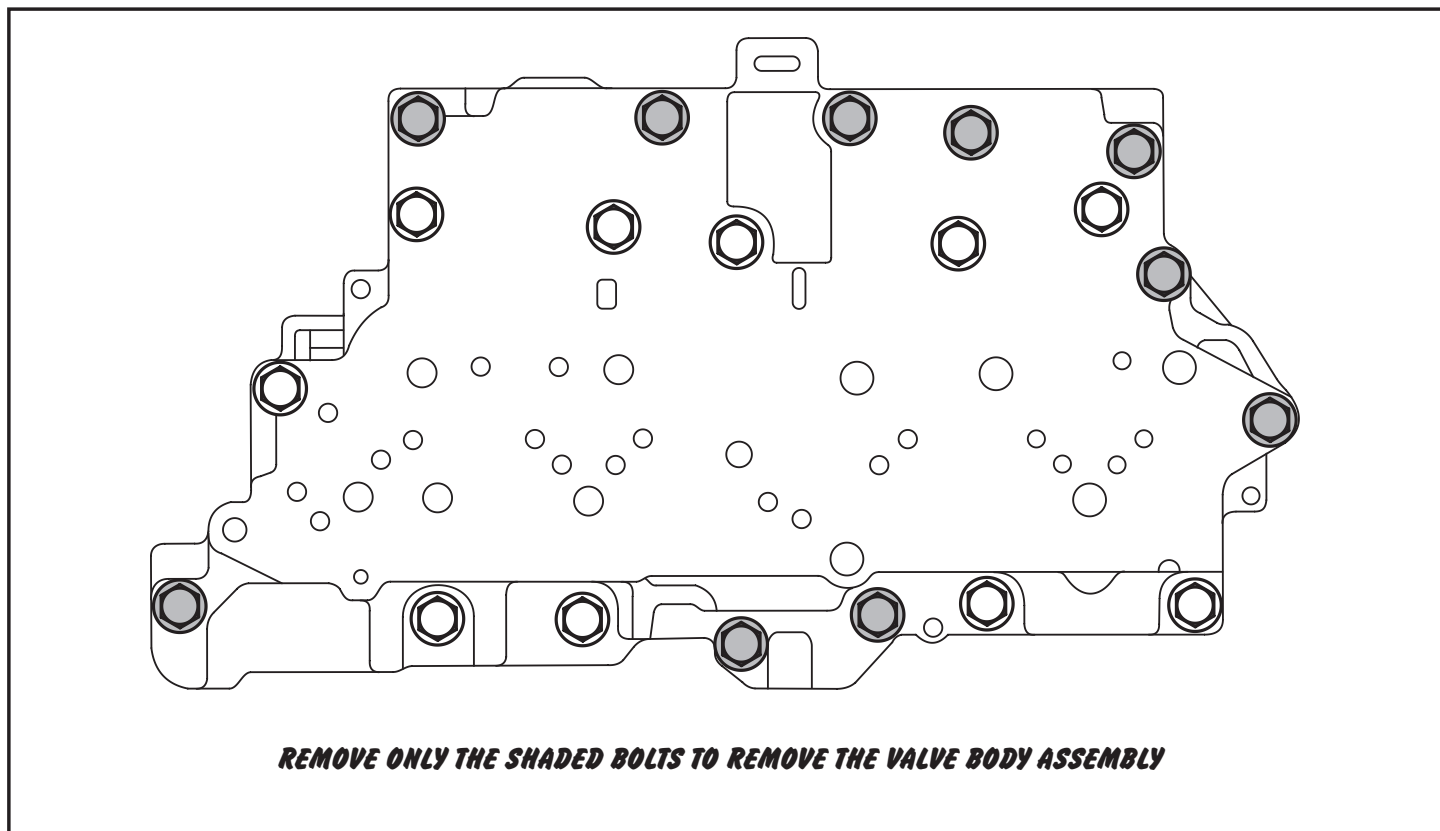
To replace the ISS or OSS speed sensor, the valve body will have to be removed. Remove only the shaded bolts shown in Figure 1 to remove the valve body assembly.
The location of the speed sensors is explained in Figure 2.
