Technical Service Information

EAGLE PREMIER ZF 4HP-18

NEUTRALIZES ON 3-4 UPSHIFT

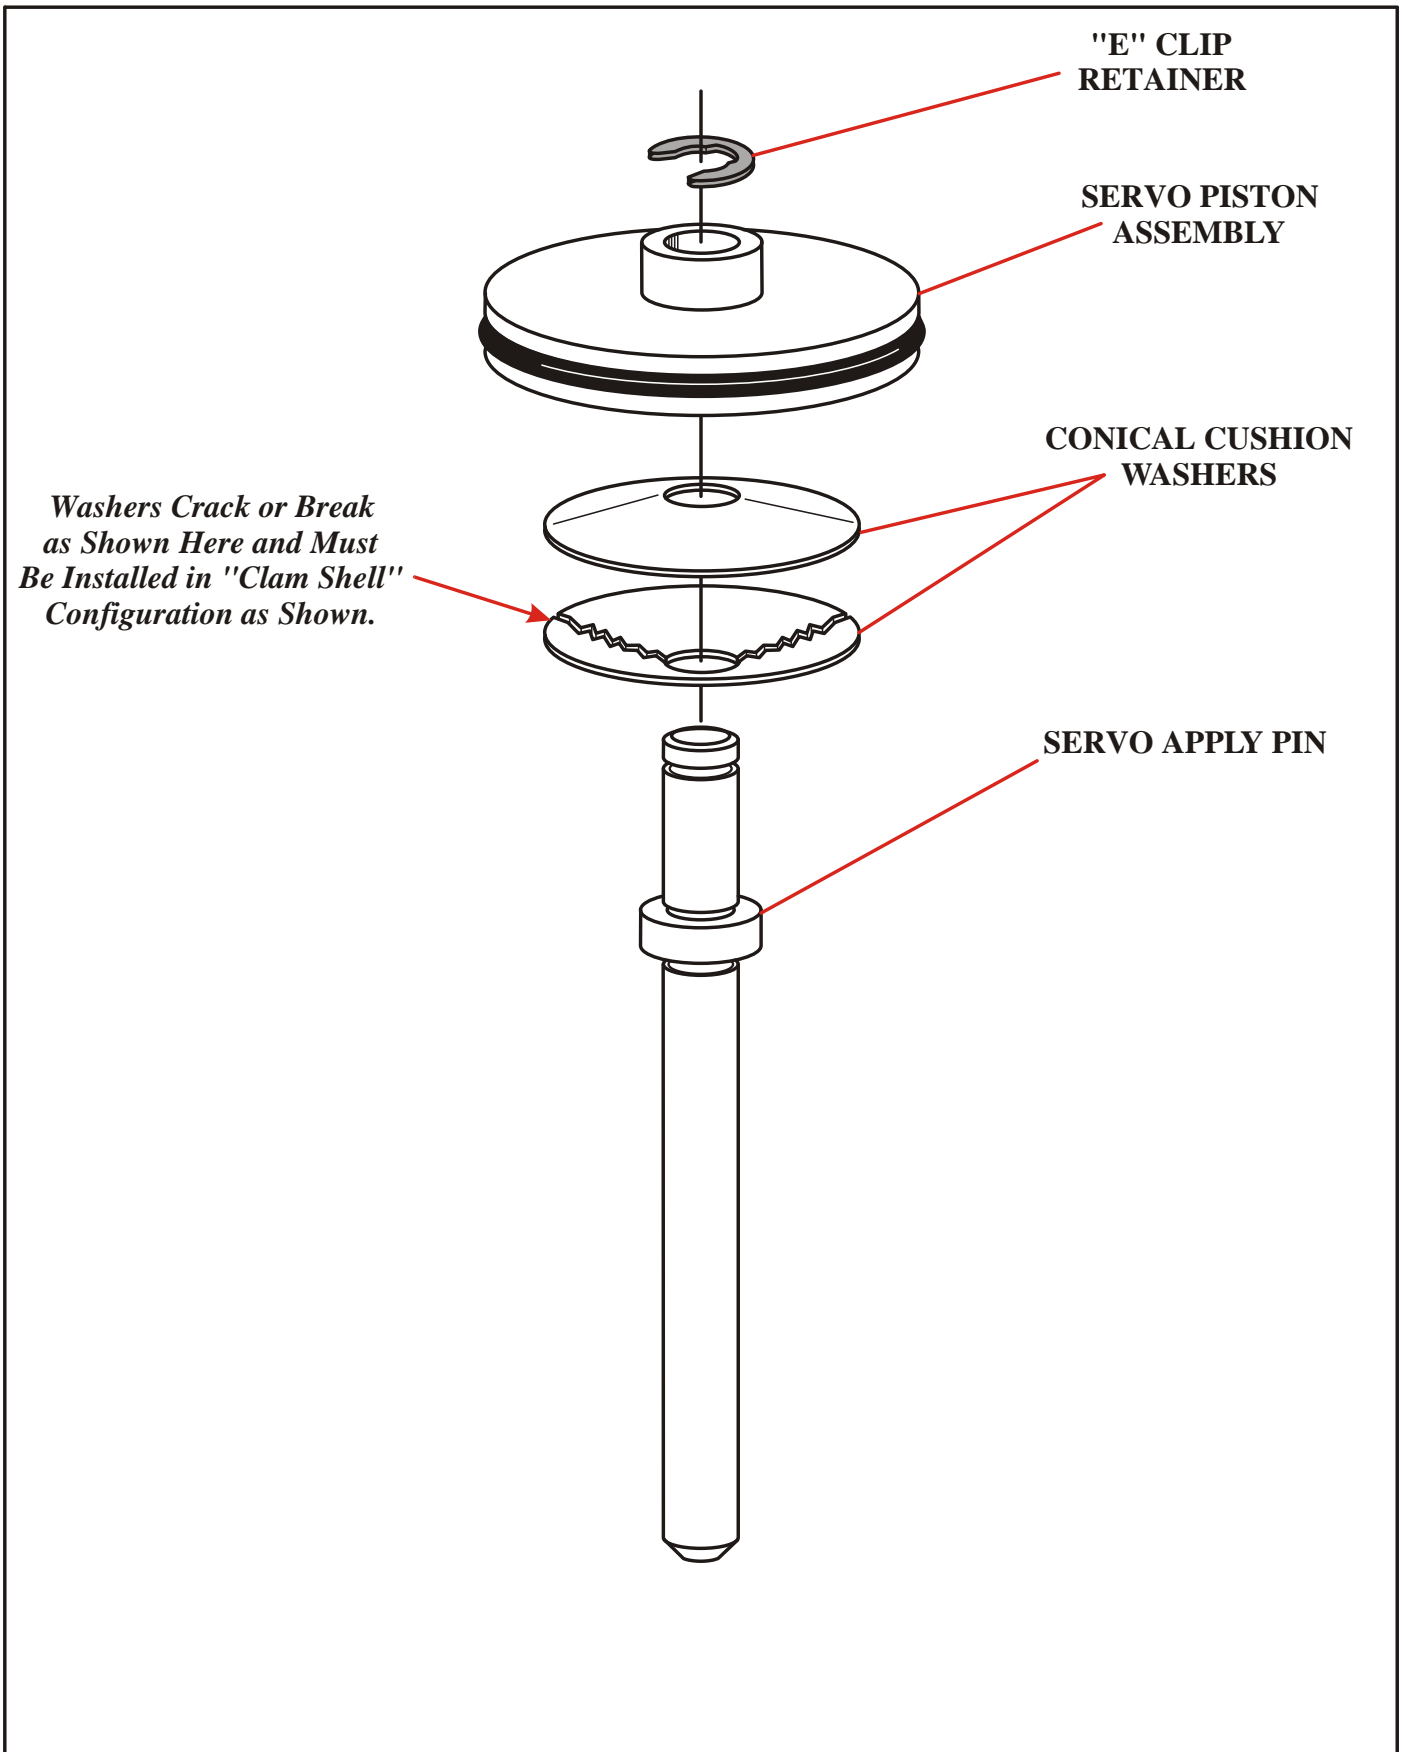
Figure 1

COMPLAINT: The transaxle neutralizes when a shift is made from third gear going into fourth.

CAUSE: It is not uncommon to find split conical cushion washers in the servo bore from the overdrive servo which interferes with the full travel of the servo piston preventing band apply (See Figure 1). The servo may be overlooked in the diagnostics as component application charts indicate the band is used for 2nd gear and second gear is operating correctly. A closer look at the application chart reveals that the band is used in second gear in addition to the intermediate clutch. If the band can not apply for second, the intermediate clutch will provide the hold on the sun gear achieving the 1-2 up shift.

CORRECTION: The conical washers are not serviced separately. If solid washers are used as a replacement, a tail end bump may occur on the 1-2 and more noticeably on a 3-4 up shift. The entire servo assembly can be purchased through an authorized ZF parts distributor. If good used conical washers are found, ensure that the washers are assembled in a "clam shell" configuration, as seen in figure 1.
