Technical Service Information

TOYOTA A-40 SERIES

HARSH 1-2 SHIFT

88-67
Page 1 of 1

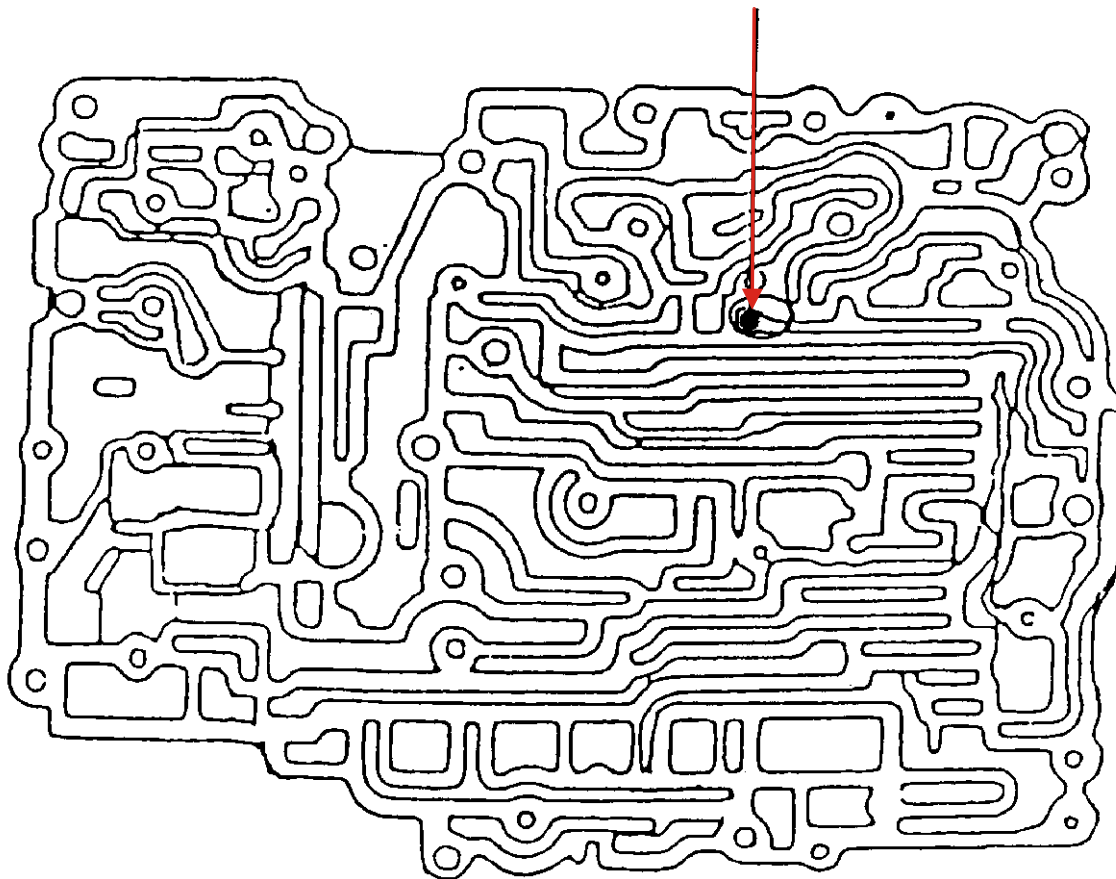
Figure1

COMPLAINT: HARSH 1-2 SHIFT

CAUSE: MISSING VITON CHECK BALL

CORRECTION: INSTALL CHECK BALL IN CORRECT LOCATION
