Technical Service Information

THM 3L30 (180C) HARSH NEUTRAL DRIVE OR HARSH 3-2 DOWNSHIFT

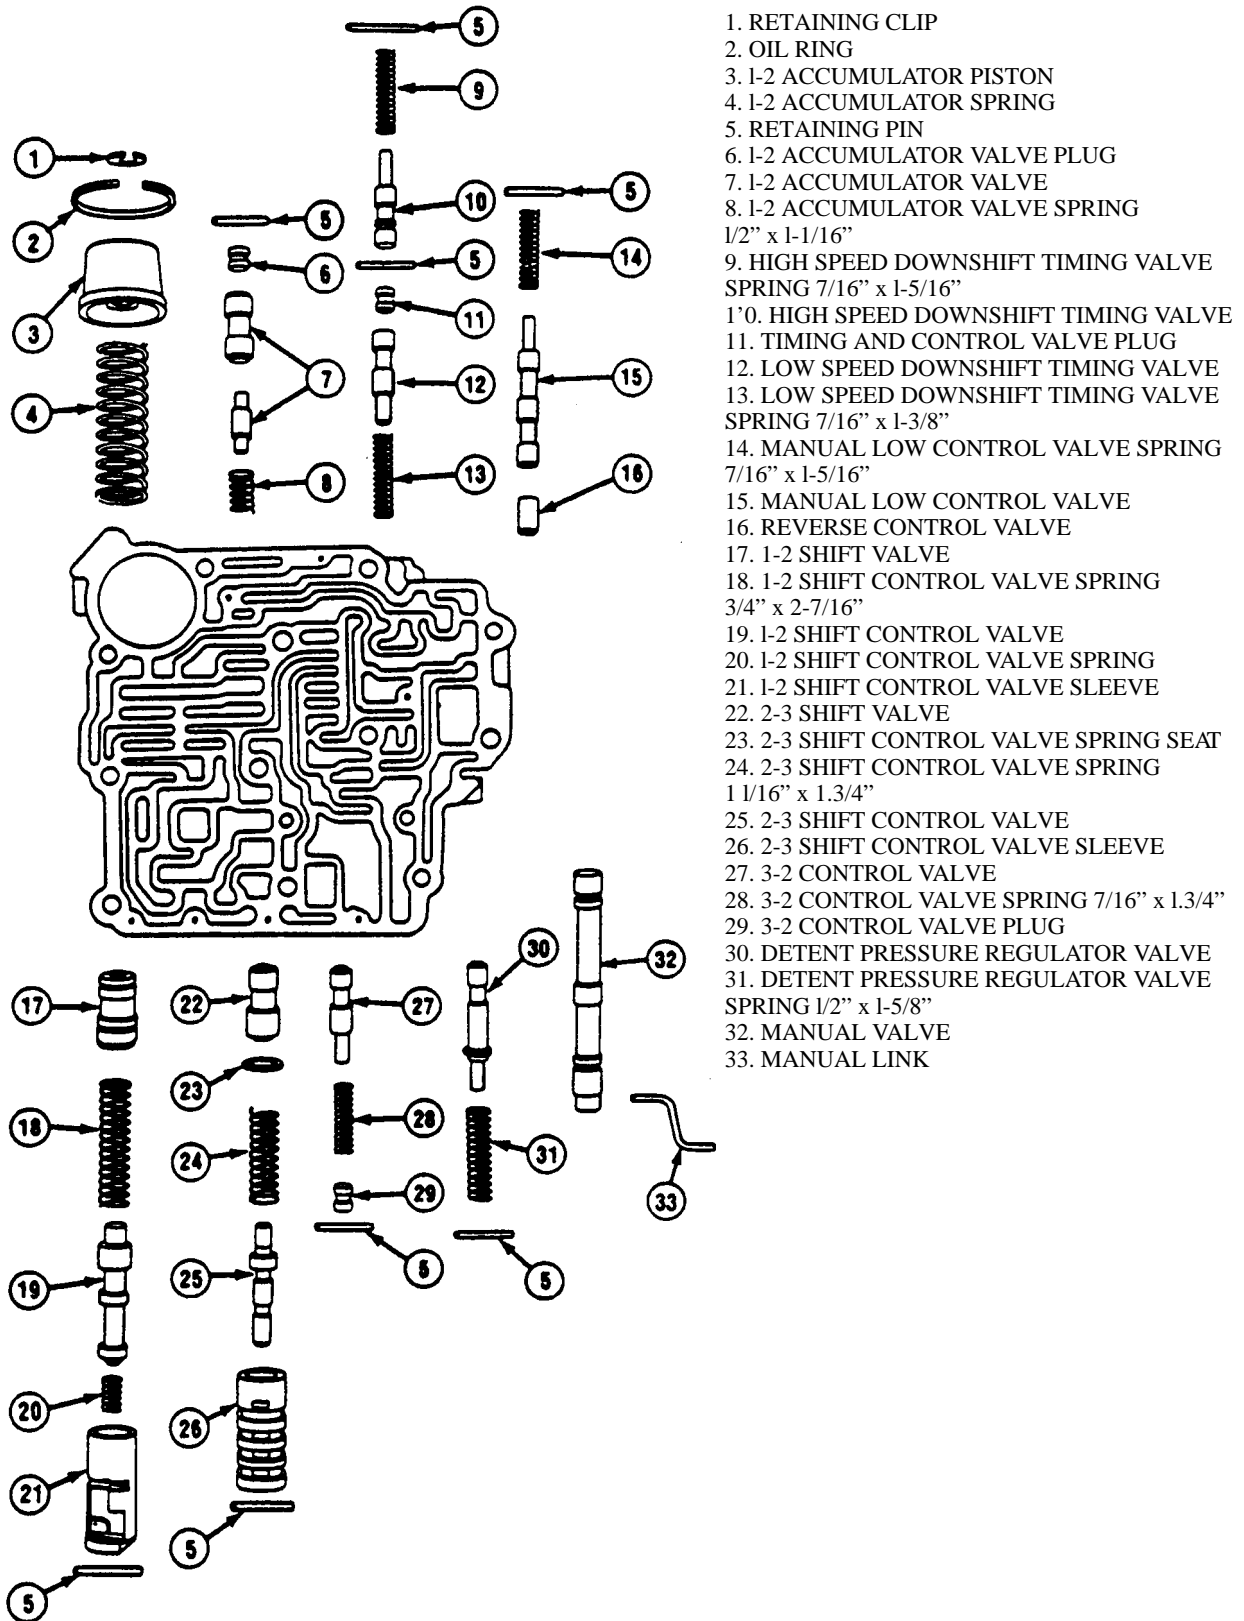
COMPLAINT: Some 1990/1991 model THM 3L30 (180C) transmissions may exhibit a harsh neutral to drive engagement, harsh 3-2 downshifts, or harsh 2-3 lift foot shifts. The transmission may exhibit any or all of the above conditions.

CAUSE: The cause may be mis-calibration.

CORRECTION: There is now available a new calibration update package, OEM part number 96040746, that should be installed. Use Figure 1 for proper assembly and identification.
